SERVICE BULLETIN*** REVISION NOTICE *****WINGS - CENTER WING UPPER AND LOWER RAINBOW FITTING INSPECTION FOR CRACKS AND REPLACEMENT**

Attached is Revision 6, dated July 11, 2013, to Service Bulletin 82-771/382-57-82. Information added or changed in this issue is indicated by a vertical revision bar in the outside margin of affected pages, or pointing hand for illustrations.

WINGS - CENTER WING UPPER AND LOWER RAINBOW FITTING INSPECTION FOR CRACKS AND REPLACEMENT

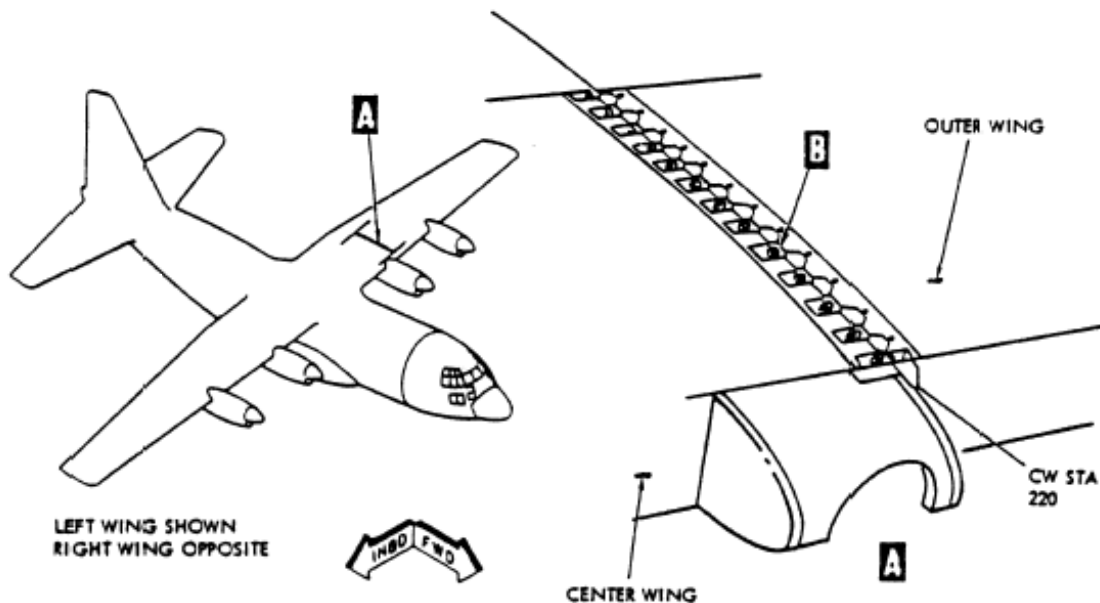
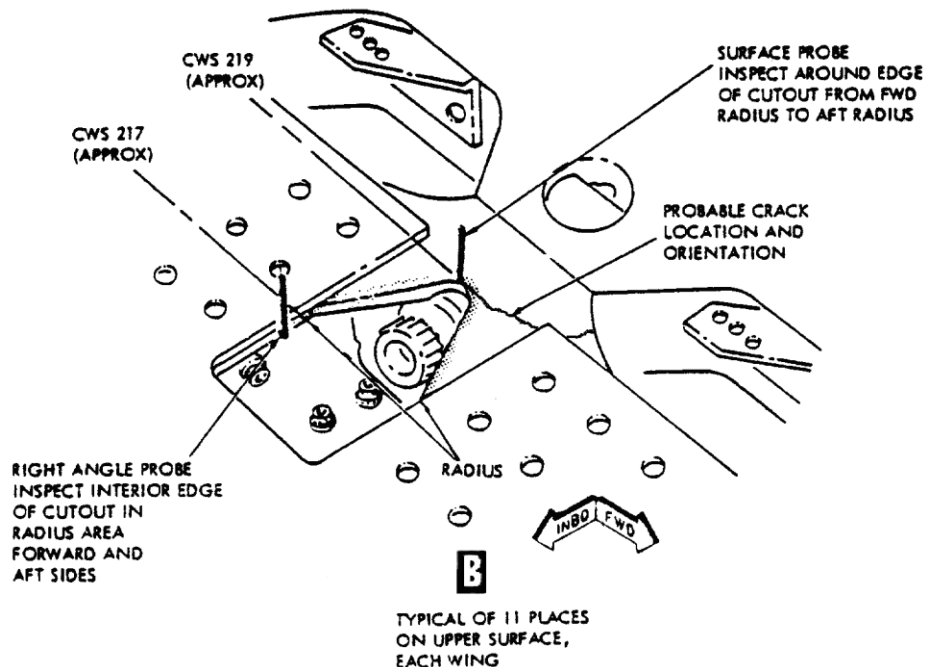
Figure A1. Upper Surface Wing Joint (Rainbow) Fitting, Attachment Bolt Access Cutouts (Sheet 1 of 2)

3. **DEFECTS.** Cyclic loading may cause fatigue cracks to begin in the attach bolt hole counterbore and spot face area or along the edges of the outboard tapered portion of the bolt access cutout in the panel attachment tang and propagate in a chordwise direction.

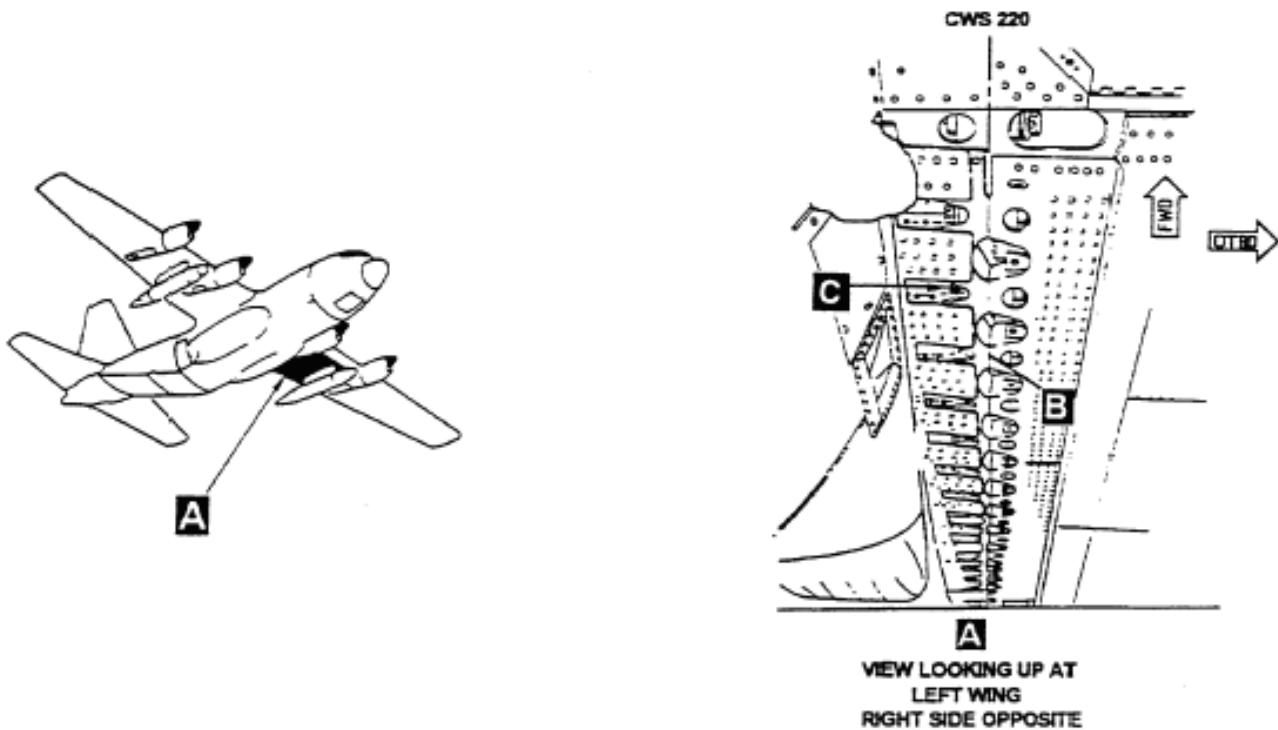
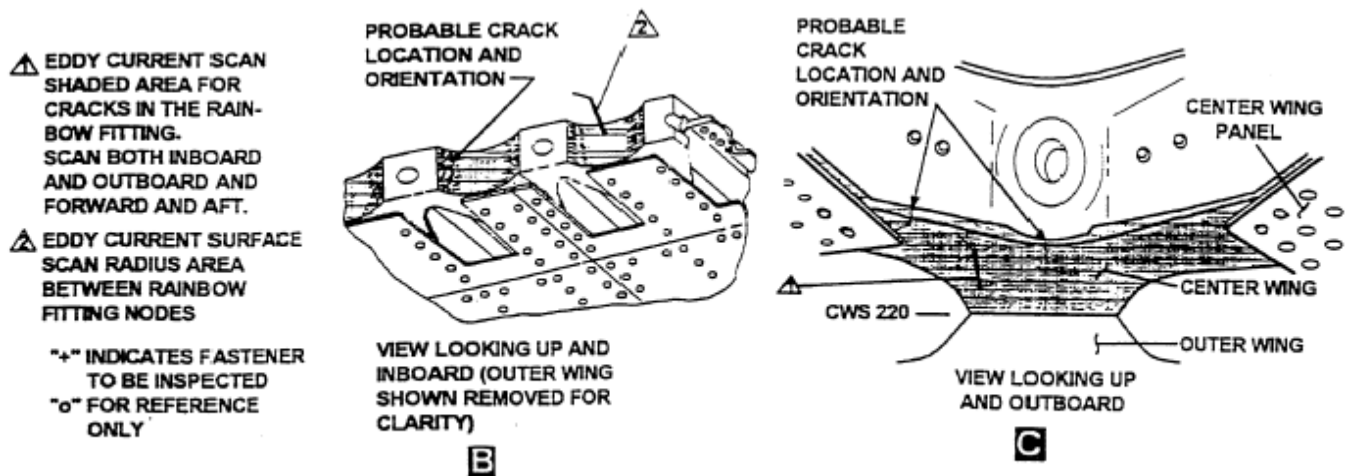
Figure B1. Inspection of Center Wing Lower Surface Rainbow Fitting (Sheet 1 of 2)

1. Perform nondestructive inspection of all nodes of the center wing lower surface rainbow fitting, both left and right side. Fatigue cracks may initiate in the rainbow fitting at the lower surface panel and stringer attachment fastener holes or in the attachment bolt counterbore and spot face areas. Cracks will propagate in the fitting in a fore-aft (chordwise) and/or vertical direction. (See Figure B1.) The most common location of cracking is from the outboard part of the bolt access cutout extending across the horizontal face of the node then up the vertical scalloped area between nodes.

- F. Inspection:
 - (1) Scan the entire exposed exterior surface of the rainbow fitting including the exposed radius area in the wing joint between nodes. Scan in both an up and down direction as well as a forward and aft direction. (See Figure B1, View B.)
 - (2) Scan along the exposed edge of the rainbow fitting tang under the lower surface skin panel. Scan in both an inboard and outboard direction as well as a forward and aft direction. (See Figure B1, View C.)
 - (3) Lockheed Martin Aeronautics Company recommends two inspectors for this procedure: one to perform the surface scan and the other to monitor the display. Any signal, as noted when scanning notches during calibration, will indicate a probable crack in the part being inspected.
- G. Mark and report suspected defects. Proceed to Backup NDI Procedure.
