DEPARTMENT OF TRANSPORTATION

Federal Aviation Administration

[Docket No. FAA-2020-0442; Project Identifier AD-2020-00260-E; Amendment 39-21640; AD 2021-14-13]

Airworthiness Directives; Pratt & Whitney Turbofan Engines

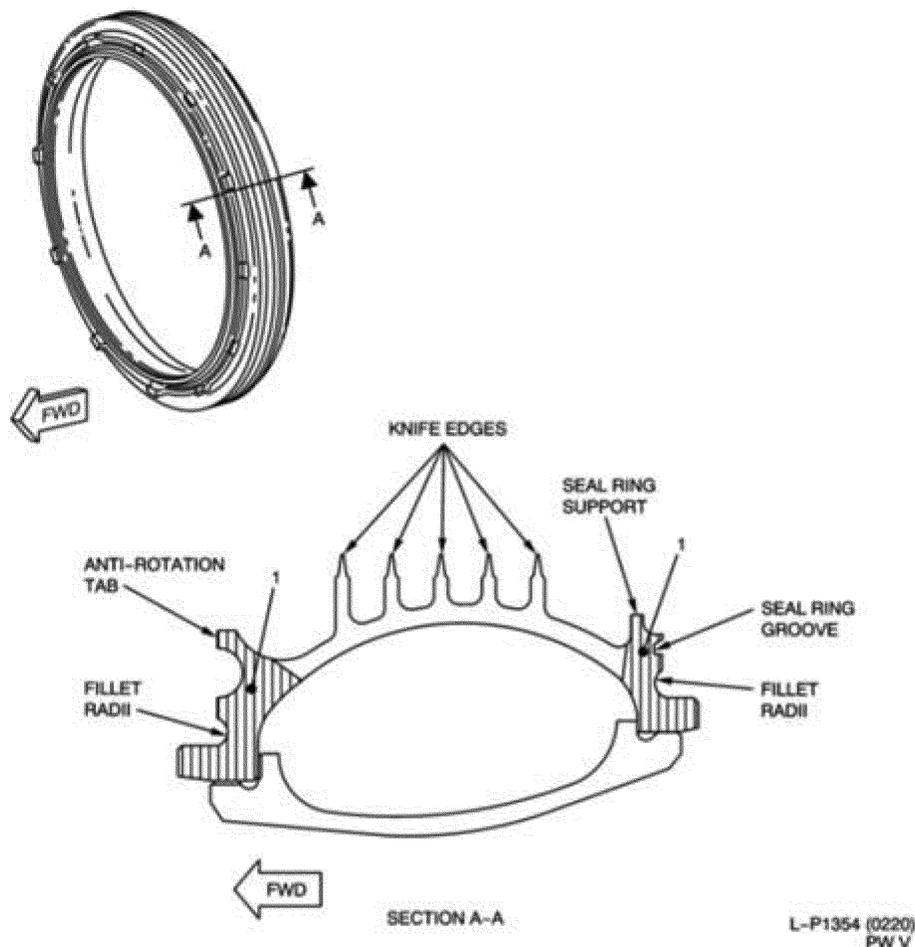
Figure 1 to Paragraph (g)(1)(iii) – Crack Inspection Critical Areas

This AD was prompted by a report of an uncontained engine failure resulting from cracks originating in the knife edge of the high-pressure turbine (HPT) 2nd-stage air seal assembly. The FAA is issuing this AD to prevent failure of the HPT 2nd-stage air seal assembly. The unsafe condition, if not addressed, could result in uncontained HPT 2nd-stage air seal assembly release, damage to the engine, and damage to the airplane.

(iii) During the visual inspection or FPI required by paragraph (g)(1)(i) of this AD, if a crack is found in the shaded regions of the HPT 2nd-stage air seal assembly identified in Figure 1 to paragraph (g)(1)(iii) of this AD (Figure 1), which extends towards the knife-

edge region of the HPT 2nd-stage air seal assembly, remove the HPT 2nd-stage air seal assembly, mating HPT 1st-stage disk, and HPT 2nd-stage hub from service, and replace the parts with parts eligible for installation. In order to return the mating HPT 1st-stage

disk and HPT 2nd-stage hub to service, the inspections of the HPT 2nd-stage air seal assembly cannot reveal a crack identified in the shaded regions of Figure 1, which extends towards the knife-edge region.

The FAA did not revise this AD in response to this comment. A crack, as identified in the shaded regions of Figure 1 to paragraph (g)(1)(iii) of this AD (Figure 1), which extends towards the knife-edge region of the HPT 2nd-stage air seal assembly, impacts the serviceability of the mating HPT 1st-stage disk and the HPT 2nd-stage hub. A crack identified in the shaded region of Figure 1 of this AD of the HPT 2nd-stage air seal assembly results in the

requirement to remove the HPT 2nd-stage air seal assembly, mating HPT 1st-stage disk, and HPT 2nd-stage hub.

If a crack is found as identified in the shaded region of Figure 1 to paragraph (g)(1)(iii) of this AD (Figure 1) that

extends toward the knife-edge region of the HPT 2nd-stage air seal assembly, this AD requires replacement of the HPT 2nd-stage air seal assembly, mating HPT 1st-stage disk, and HPT 2nd-stage hub.
