**Number:** 777-57A0118 RB  
Original Issue: June 23, 2020  
ATA System: 5725

**SUBJECT:** WINGS - Wing Lower Skin - Fuel Tank / Dry Bay Access Door Cutouts - Inspection and Repair.

## Requirements Bulletin

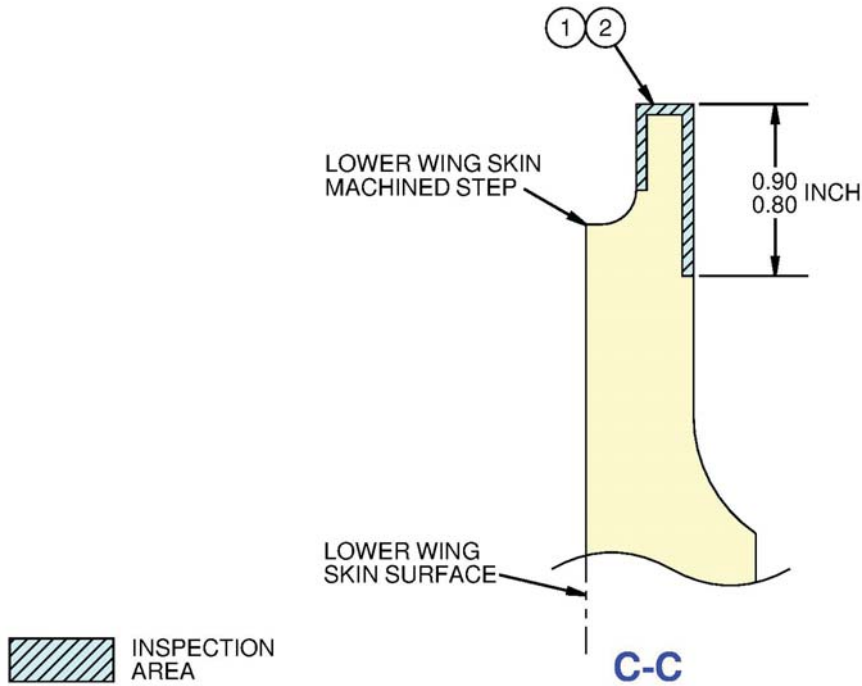
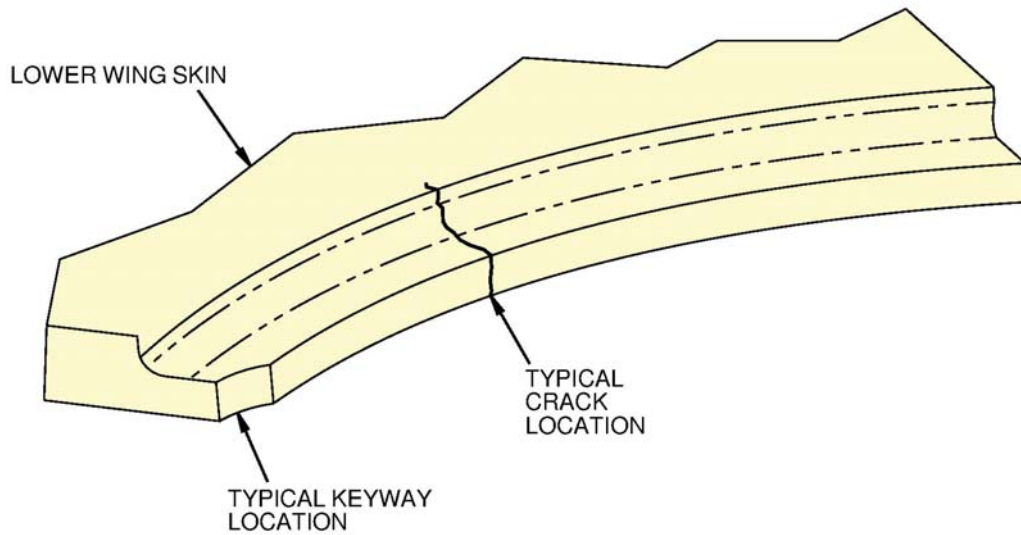
FIGURE 3: LEFT WING - LOWER WING SKIN - FUEL TANK AND DRY BAY ACCESS DOOR CUTOUTS BETWEEN WING STATION (WS) 306.00 AND WS 520.50 WITH NO EXISTING REPAIR FOUND- DETAILED INSPECTION AND HIGH FREQUENCY EDDY CURRENT (HFEC) INSPECTION (SHEET 3 OF 5)

ACCESS DOOR CUTOUT FOR 533AB  
(TYPICAL CRACK LOCATION)

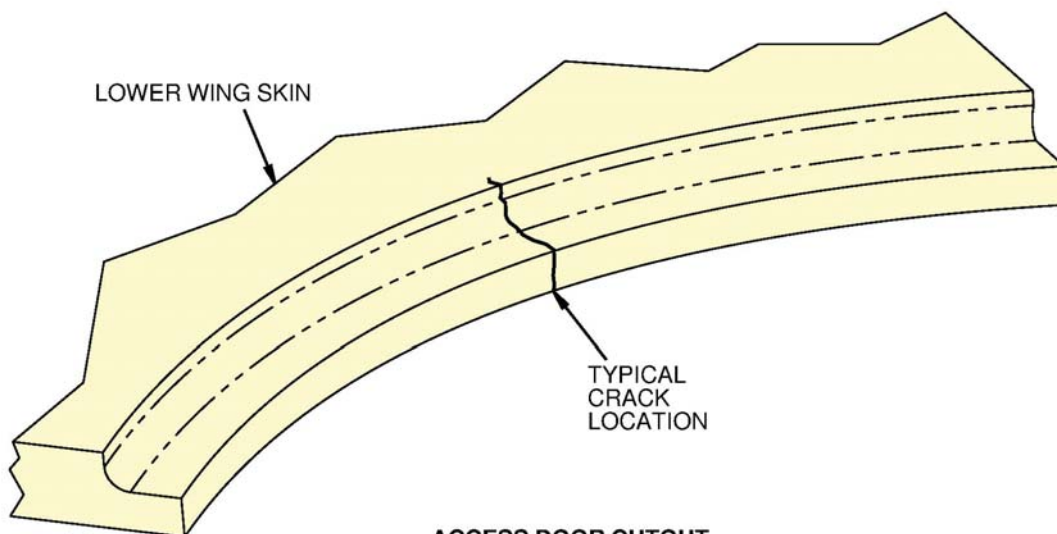
**ACCESS DOOR CUTOUT  
FOR 531AB, 531BB, 531CB, 532AB,  
533BB, 533CB, 533DB AND 533EB  
(TYPICAL CRACK LOCATION)**

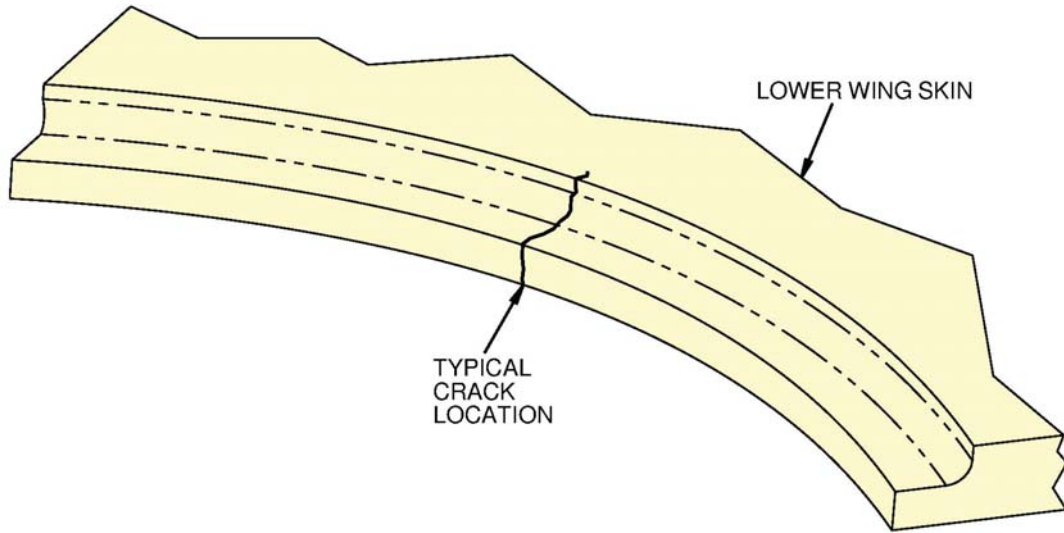
**FIGURE 7: RIGHT WING - LOWER WING SKIN - FUEL TANK AND DRY BAY ACCESS DOOR CUTOUTS BETWEEN WING STATION (WS) 306.00 AND WS 520.50 WITH NO EXISTING REPAIR - DETAILED INSPECTION AND HIGH FREQUENCY EDDY CURRENT (HFEC) INSPECTION (SHEET 4 OF 6)**

ACCESS DOOR CUTOUT  
(TYPICAL CRACK LOCATION)
