U.S. Department
of Transportation
**Federal Aviation
Administration**

Subject: Federal Aviation Administration (FAA) Approval of an Alternative Method of Compliance (AMOC) to Airworthiness Directives (AD) 2008-11-13, 2012-07-06, 2014-09-09, 2015-17-13, 2016-11-07, 2016-11-16 and 2015-25-08

References: (1) Boeing letter DLD4-21-00060, dated March 16, 2021
(2) Boeing 777 Maintenance Planning Data (MPD) Document, Section 9, D622W001-9, dated February 2021 (Watermark Not FAA Approved 3/12/2021 02:14 PM)
(3) Boeing 777 28-AWL-31 and 28-AWL-32 Revision—Teflon Sleeve & Cushion Clamp Assessment, D340W105-23, dated February 26, 2021

777-200/200LR/300/300ER/777F MAINTENANCE PLANNING DATA

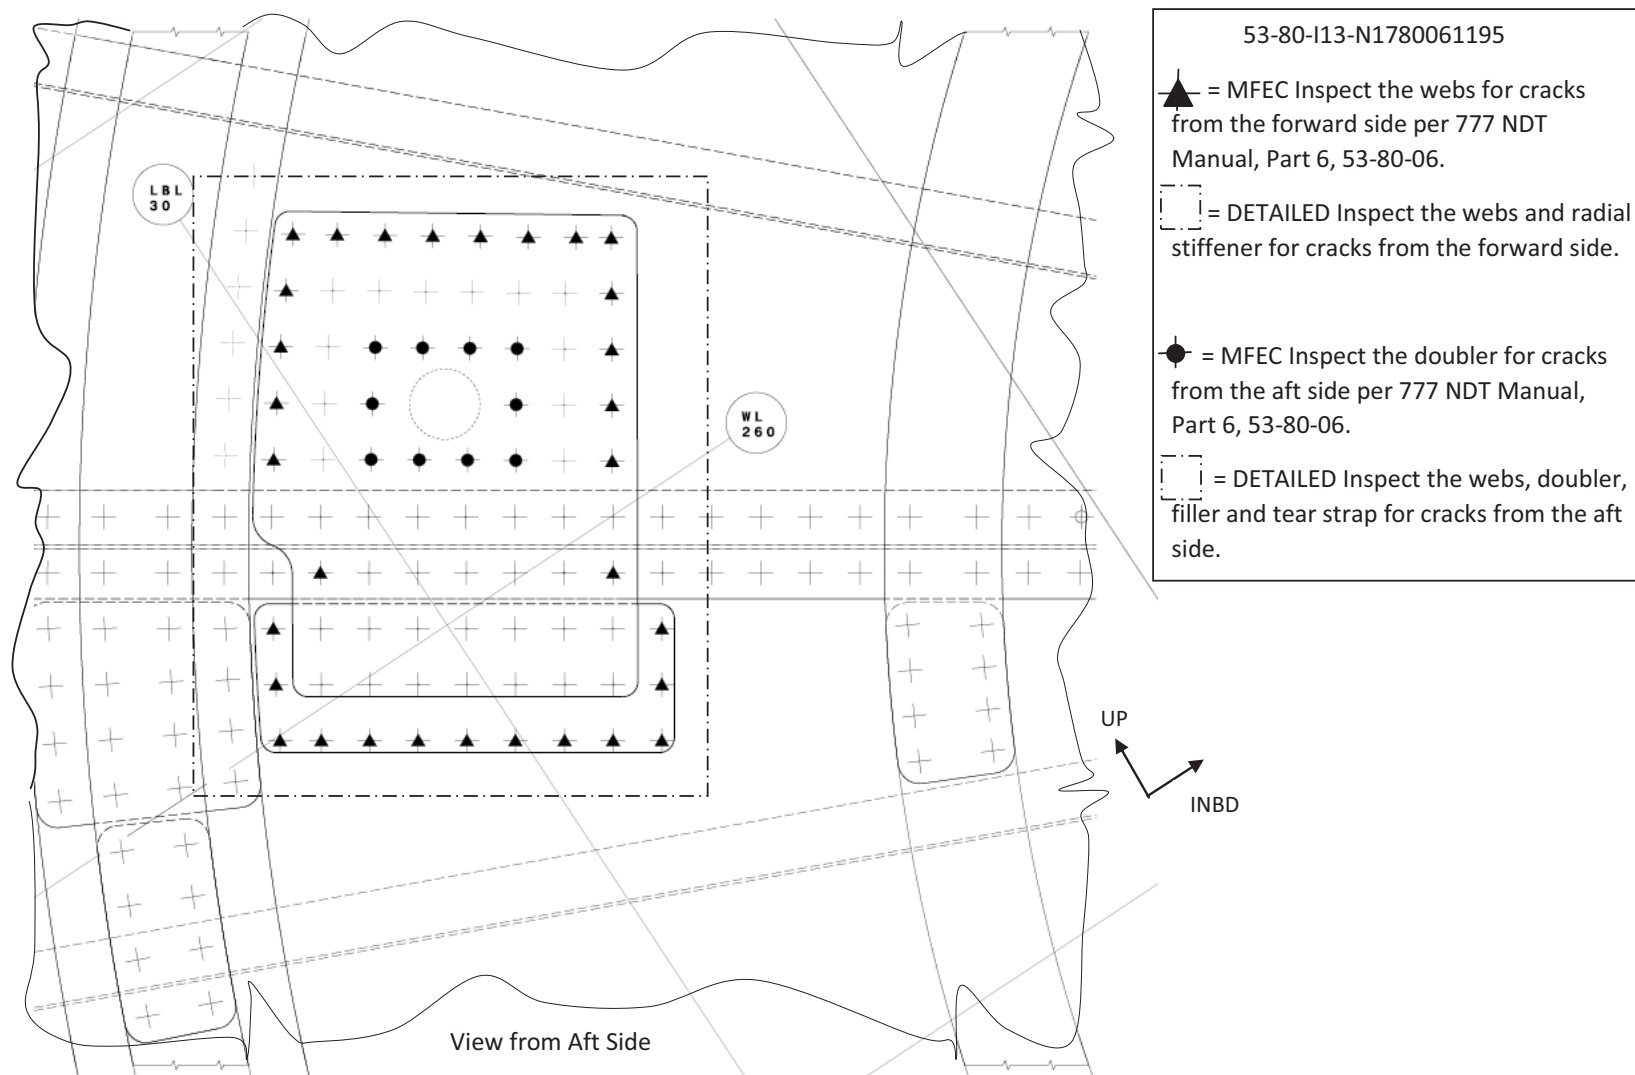
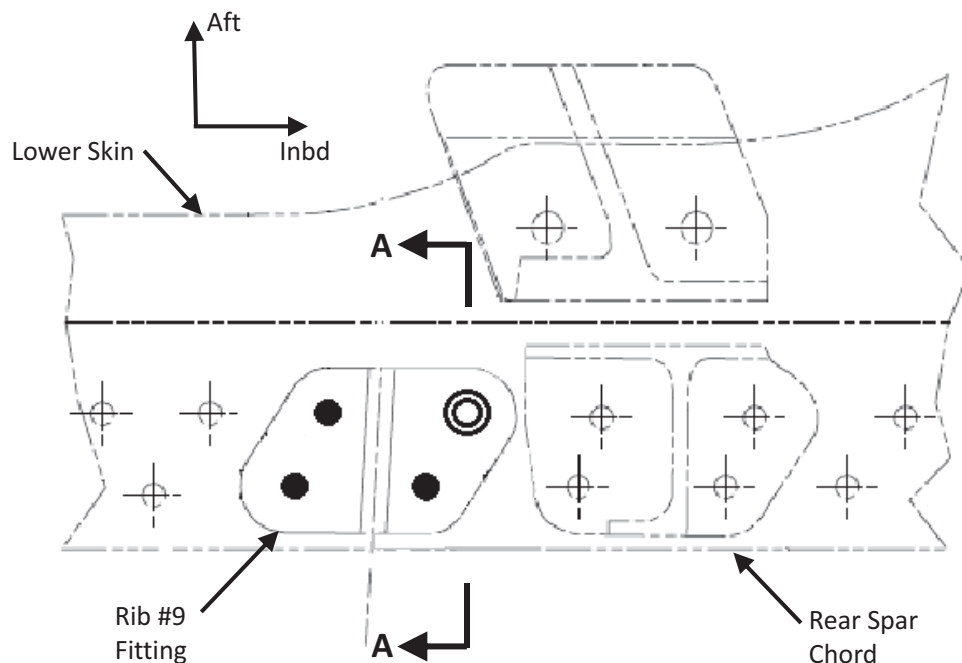
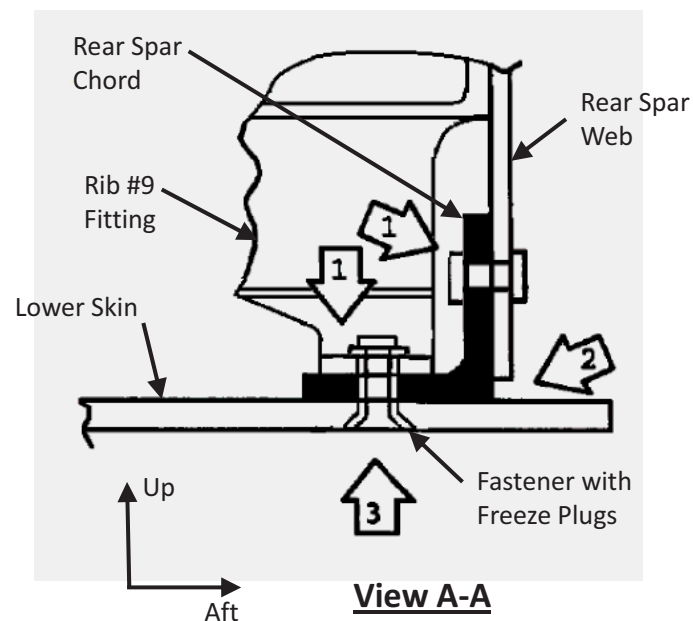
FIGURE 3. 53-80-I13-N1780061195 - Aft Pressure Bulkhead Web Rework, NCR N1780061195

Fastener with Freeze Plugs

Adjacent fasteners requiring inspection for SSI 57-20-I01G

In the reworked area, perform the following inspections:

- 1) From direction 1, HFEC inspect the rear spar lower chord per the 777 NDT Manual Part 6, 51-00-01. Use the lower chord edges, radius, Rib #9 fitting shear tie foot and fastener collars on the vertical leg as a probe guide.
- 2) From direction 2, HFEC inspect the rear spar lower chord per the 777 NDT Manual Part 6, 51-00-01. Remove sealant as required. Use the rear spar web lower edge as a probe guide.
- 3) From Direction 3, inspect the rear spar lower chord at the freeze plug fastener location per 777 NDT Manual Part 6, 57-20-01.
- 4) Inspect the remaining 3 adjacent fastener locations as required for SSI 57-20-I01G.
