DHC-8 (DASH 8)

SERVICE BULLETIN 84-26-20

Fire Protection – Fire Detection System – Nacelle Fire Detection System – Main Landing Gear (MLG) Primary Zone – Advanced Pneumatic Detectors (APD) – Special Inspection and Rectification – ModSum 4–114036

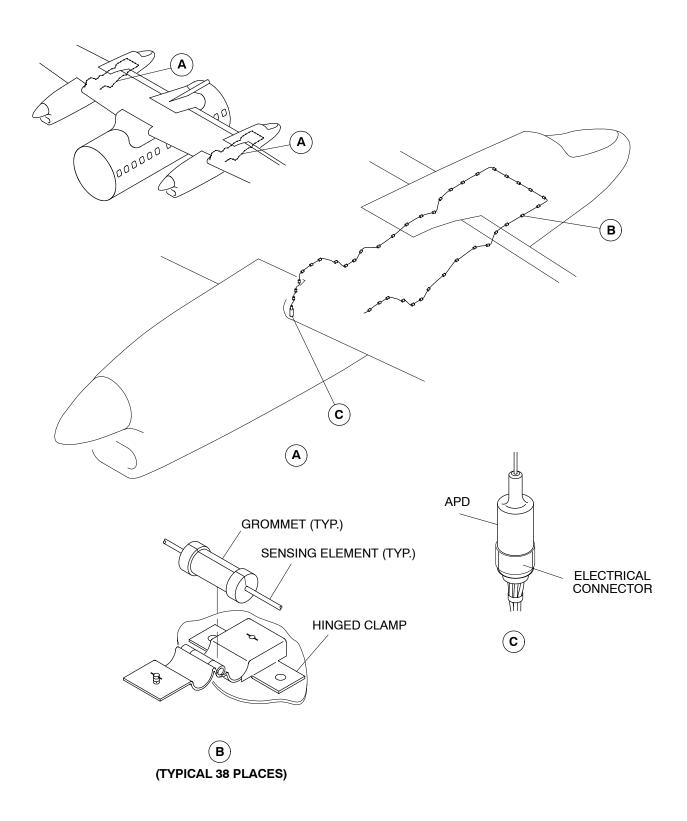
MLG Primary Zone APD Sensing Line (Element) - Location Figure 1

- (1) Chemical clean the advanced pneumatic detector. Refer to AMM TASK 26-10-00-110-801. No external damage is allowed. Some surface discolorations is allowed.
- (2) Inspect clearance between MLG primary zone APD Sensing Line (Element) and surrounding structure as well as clearance between other system components installed in vicinity of the MLG primary zone APD Sensing Line (Element) in the main landing gear bay area, in the LHS and RHS nacelles.

(3) Refer to AMM TASK 26-11-06-400-801 for minimum clearance requirements between the APD Sensing Line (Element) and surrounding structure as well as other system components installed in vicinity of the MLG primary zone APD and sensing line.

NOTE: To adjust APD Sensing Line (Element) clearance, move APD Sensing Line (Element) away from surrounding structure or other system components maintaining AMM TASK 26-10-00-110-801 APD installation requirements.

NOTE: If APD Sensing Line (Element) is damaged, it is required to remove APD per AMM TASK 26-11-06-000-801 and re-install per AMM TASK 26-11-06-400-801.

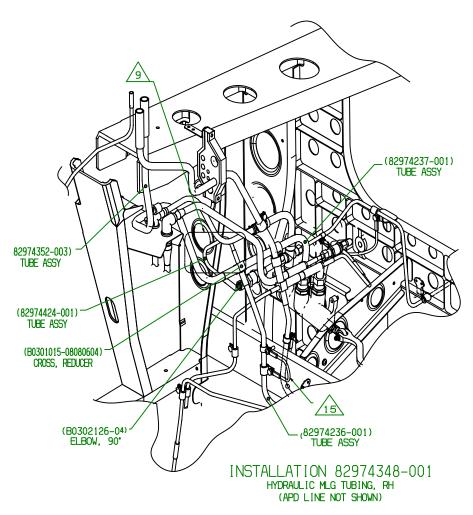
Hydraulic Tube - Location (RH Nacelle) Figure 3

A hydraulic leak was reported by flight crew during flight. Additionally, the crew received an annunciation of the Check Fire Detect light caused the aircraft to return to base. An inspection of the area of the leak revealed a leak from the Tube Assembly, Cross to Restrictor, Nacelle (P/N:82974424-001) resulting from chafing with the RH MLG primary zone Advanced Pneumatic Detector (APD) sensing line.

Installation of the APD pressure sensing lines in close proximity to hydraulic system lines in the MLG primary zone.

INSPECT CLEARANCE BETWEEN MLG PRIMARY ZONE APD SENSING LINE AND SURROUNDING STRUCTURE AS WELL AS CLEARANCE BETWEEN OTHER SYSTEM COMPONENTS INSTALLED IN VICINITY OF THE MLG PRIMARY ZONE APD SENSING LINE IN THE MAIN LANDING GEAR BAY AREA, IN THE LHS AND RHS NACELLES.

INSPECT TUBE ASSEMBLY 82974424-001 LOCATED IN THE RHS NACELLE FOR CHAFING DAMAGE. APPROXIMATE INSPECTION AREA IS LOCATED AT RHS NACELLE FRAME X201D 187.53, AS SHOWN IN THE ISO VIEW.

(4) If the tube damage is more than the allowance limits, remove the tube assembly per AMM TASK 29-00-00-000-802 and install new tube assembly 82974424-001 (RHS Nacelle) or tube assembly 82974234-() (LHS Nacelle) and elbow B0302126-04 per AMM TASK 29-00-00-400-802.

/15\ IF TUBE ASSY 82974236-001 IS RE-INSTALLED, INSTALL BONDING STRAP (B0312009BB6) AND BONDING CLAMP (AN735C6) AS SHOWN. INSTALL BONDING STRAP PER AMM TASK 51-80-00-400-801.

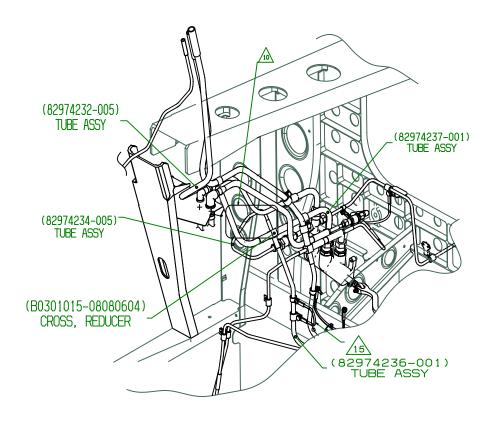
Hydraulic Tube - Location (LH Nacelle) Figure 4

INSPECT CLEARANCE BETWEEN MLG PRIMARY ZONE APD SENSING LINE AND SURROUNDING STRUCTURE AS WELL AS CLEARANCE BETWEEN OTHER SYSTEM COMPONENTS INSTALLED IN VICINITY OF THE MLG PRIMARY ZONE APD SENSING LINE IN THE MAIN LANDING GEAR BAY AREA, IN THE LHS AND RHS NACELLES.

INSPECT TUBE ASSEMBLY 82974234-() LOCATED IN THE LHS NACELLE FOR CHAFING DAMAGE. APPROXIMATE INSPECTION AREA IS LOCATED AT LHS NACELLE FRAME X201D 187.53, AS SHOWN IN THE ISO VIEW.

/15\ IF TUBE ASSY 82974236-001 IS RE-INSTALLED,
INSTALL BONDING STRAP (B0312009BB6) AND BONDING
CLAMP (AN735C6) AS SHOWN. INSTALL BONDING STRAP PER AMM TASK 51-80-00-400-801.
