**No. AS350-05.01.01**

# ALERT SERVICE BULLETIN

### TIME LIMITS - MAINTENANCE CHECKS - Main Rotor

#### Inspection of the pitch rod upper links

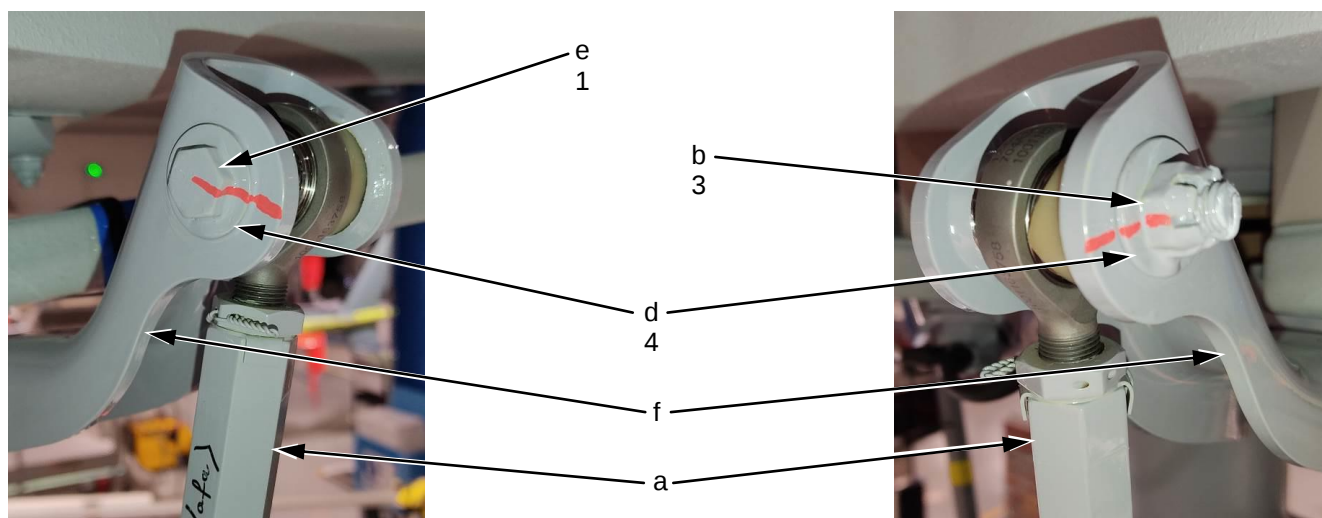
Figure 1

##### 3.B.2.a. Marking of the screw (e) and the nut (b) of the pitch rod (a) upper link, (Figure 1)

- As per the principles of Work Card 20-02-05-404 (MTC), mark the tightening of the screw (e) or (1) and nut (b) or (3), ([Figure 1](#)) by applying a line of red paint (approximately 2 mm (.078 in.)) to:

*Figure 1 is given as an indication to illustrate the lines of red paint.*

- . the screw head (e) or (1), the washer (d) or (4) and the pitch horn (f),
- . the nut (b) or (3), the washer (d) or (4) and the pitch horn (f).

##### 3.B.2.b. Visual inspection of the pitch rod (a) upper link, (Figure 1)

- Make sure that the two red lines of the pitch rod (a) upper link are aligned ([Figure 1](#)).
- If the two red lines are aligned on both sides, comply with paragraph [3.B.3.](#),
- If at least one of the two red lines is not aligned, check the tightening torque of the pitch rod upper links as per paragraph 3.B.2.c.

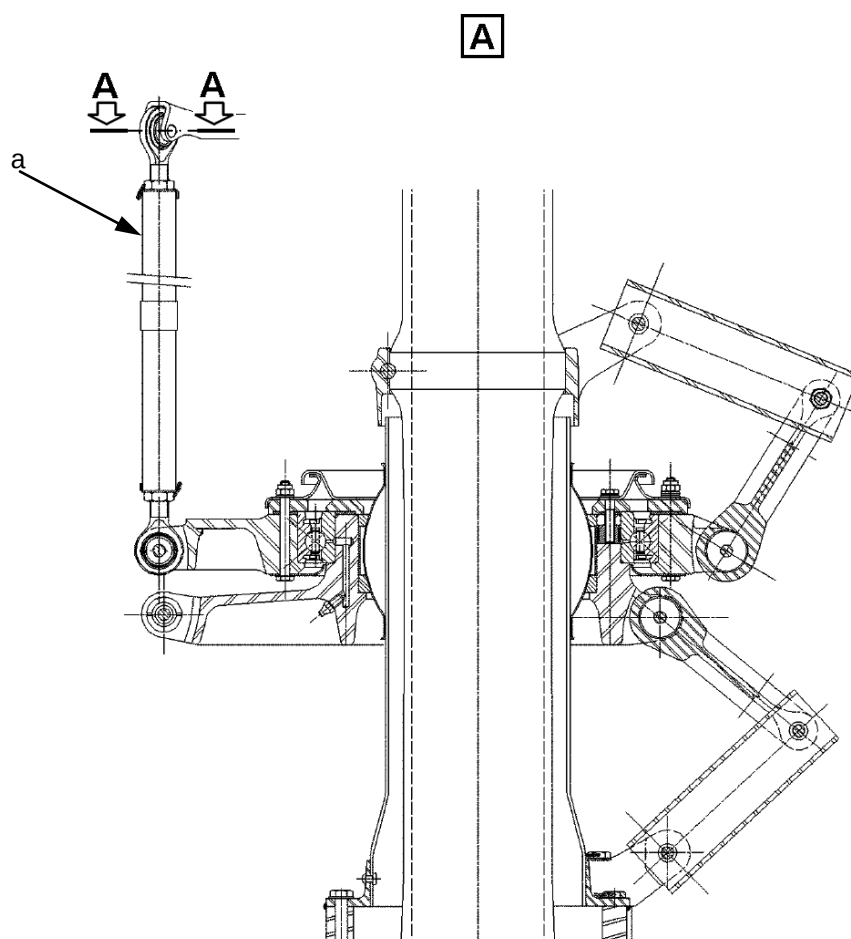
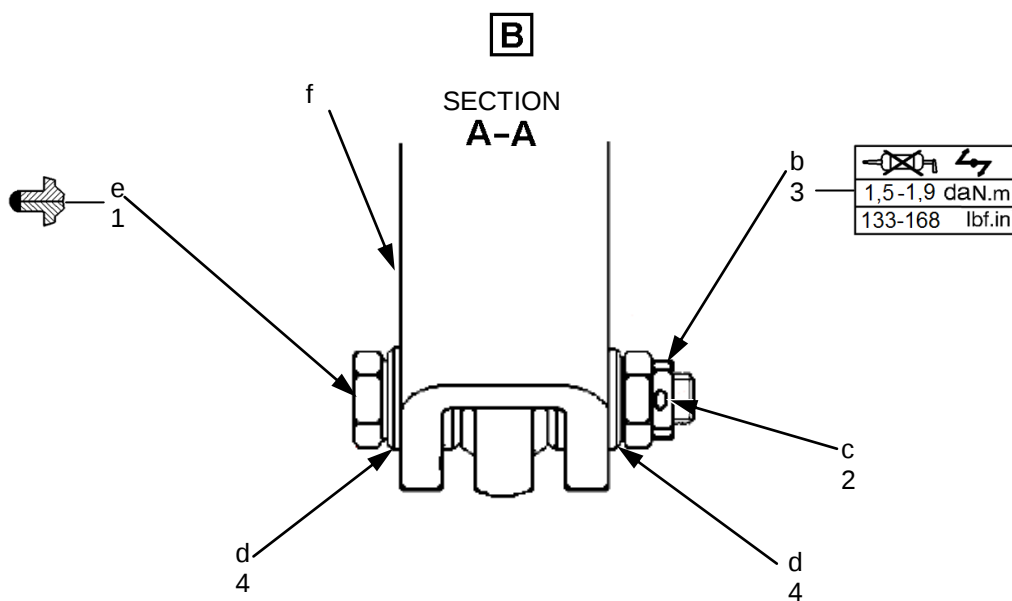
Figure 2

#### 3.B.2.c. Check of the pitch rod (a) upper link (Figure 2)

- Before removal of the pitch rod (a) upper link ([Figure 2](#)):
  - . remove and discard the split pin (c),
  - . check the tightening torque of the nut (b) as per Task 62-33-00, 6-6 (AMM) or Detail B, [Figure 2](#) and Work Card 20-02-05-404 (MTC),

- .. E-mail: [support.technical-dyncomp.ah@airbus.com](mailto:support.technical-dyncomp.ah@airbus.com)
    - .. Fax: + 33 (0) 442.85.99.66
  - . remove and discard the nut(s) (b), the washers (d) and the screw(s) (e) ([Figure 2](#)),

- . disengage the pitch rod (a) from the pitch horn (f),
  - . perform a visual inspection of the pitch rod (a) upper link as per the principles of Task 62-33-00, 6-1 (AMM) or Work Card 62-30-00-601 (MET),

- . without removal, perform a visual inspection of the pitch horn (f) ([Figure 2](#)) as per the principles of Task 62-21-00, 6-12 (AMM) or Work Card 62-20-00-605 (MET),

- . engage the pitch rod (a) in the pitch horn (f),
  - . install the screw (1), the washers (4), the nut (3) and the split pin (2) on the pitch rod (a) upper link as per the principle of Task 62-33-00, 4-1 (AMM) or Work Card 62-20-00-401 or 62-20-16-401 (MET),
