[Docket No. FAA–2022–0459; Project Identifier MCAI–2021–00266–E; Amendment 39–22102; AD 2022–13–16]

#### **Airworthiness Directives; GE Aviation Czech s.r.o. (Type Certificate Previously held by WALTER Engines a.s., Walter a.s., and MOTORLET a.s.) Turboprop Engines**

**ACTION:** Final rule.

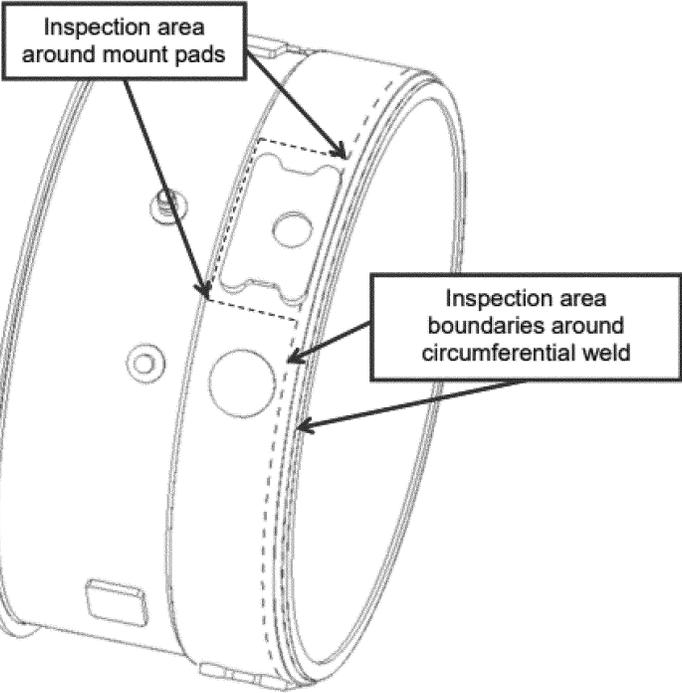
Figure 1. Centrifugal Compressor Case

This AD was prompted by the manufacturer revising the airworthiness limitations section (ALS) of the existing engine maintenance manual (EMM) to include a visual inspection of the centrifugal compressor case for cracks. The FAA is issuing this AD to prevent failure of the centrifugal compressor case. The unsafe condition, if not addressed, could result in failure of the centrifugal compressor case, engine separation, and loss of the airplane.

**Accomplishment Instruction**  
Do a visual inspection of the compressor case in the specified areas, shown in Figure 1, for every 100±10 Flight Hours. Use magnifying lens 10x for inspection. No visible cracks are allowed.

- (1) Within 90 days after the effective date of this AD, revise the ALS of the existing EMM by incorporating Figure 1 to paragraph (g)(1) of this AD.
