ENGINE - General (72-00-00) - Fuel manifolds coupling nuts re-torque for containment action

Service bulletin

DMC: PASSPORT20-A-72-00-0142-00A-930A-D
Language: sx/US
Issue No: 001
Issue Date: 11 May 2022
Title: ENGINE - General (72-00-00) - Fuel manifolds coupling nuts re-torque for containment action - Service bulletin

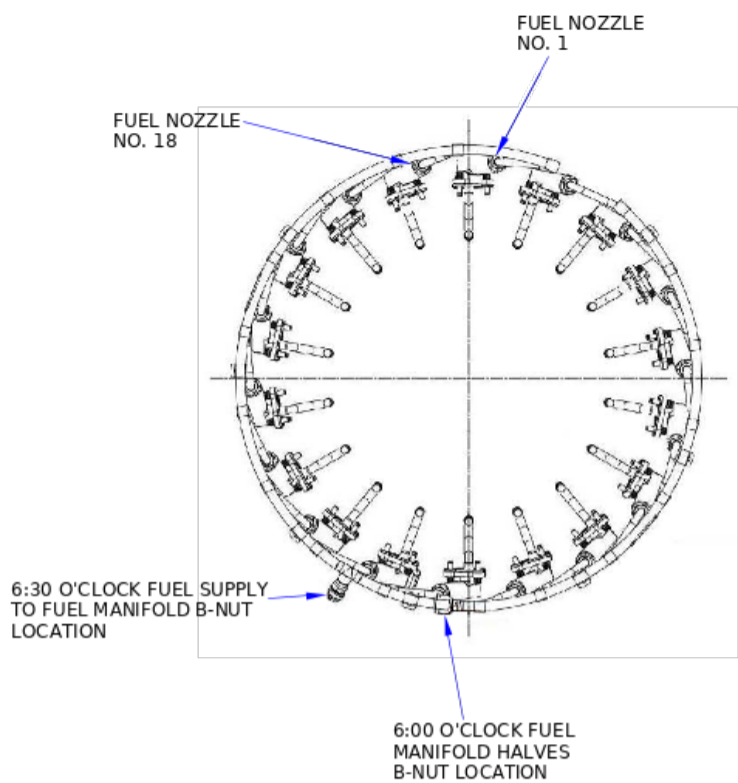
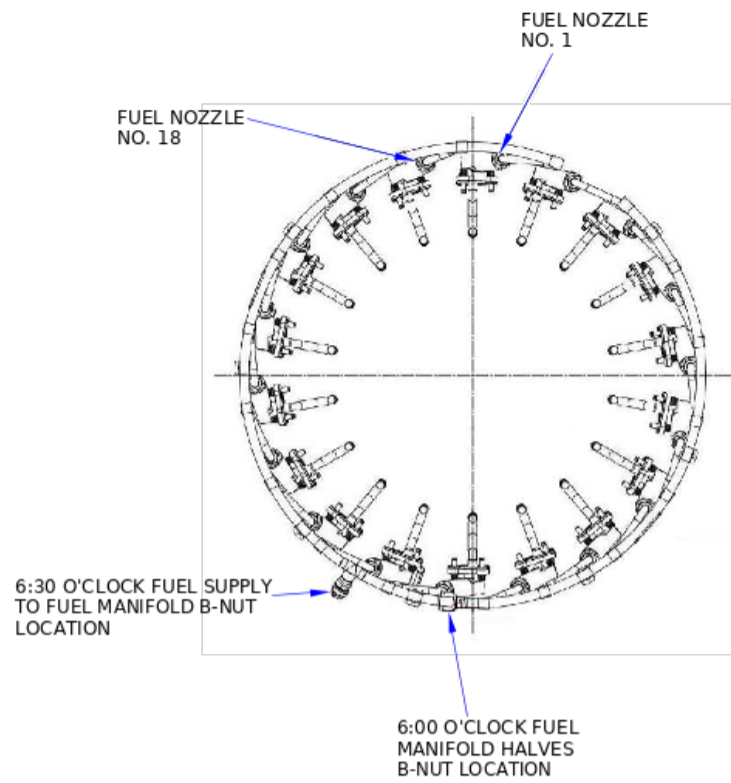
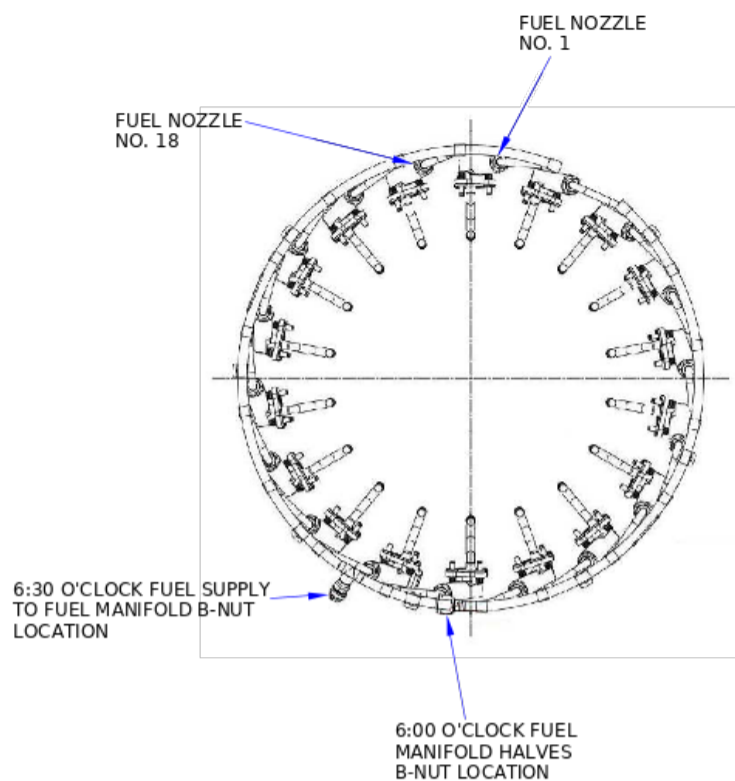
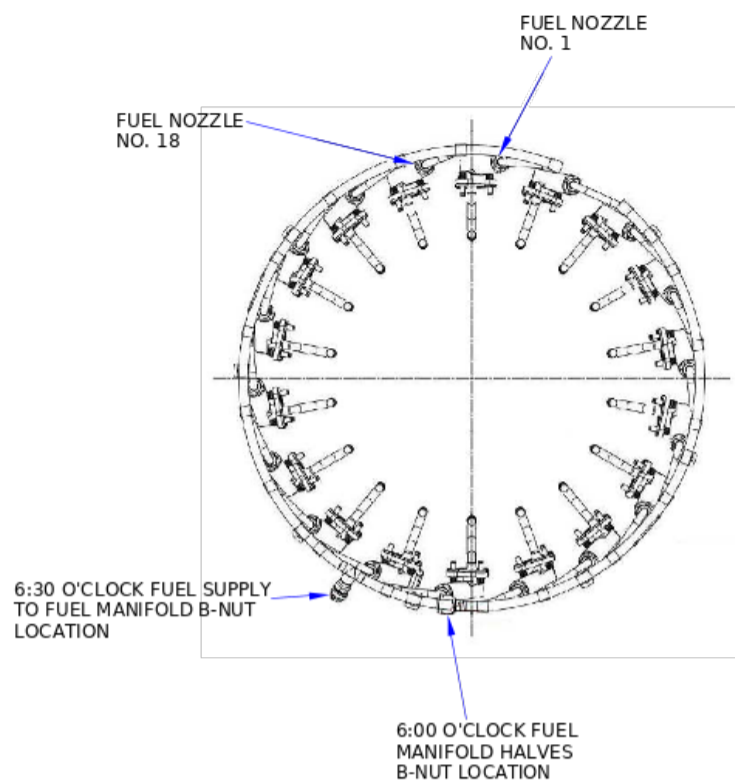
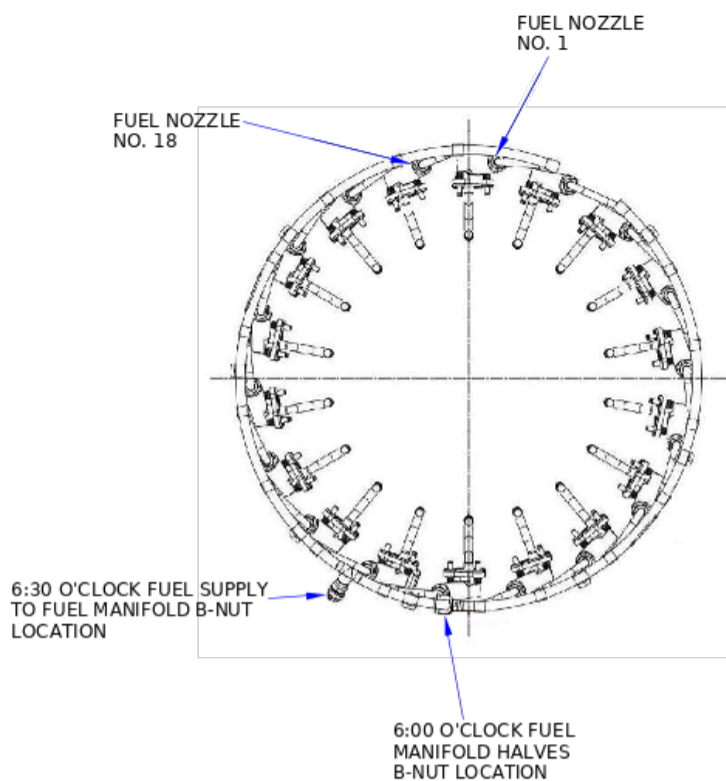
Figure 2: Fuel nozzle locations, ALF

Note: Fuel nozzle No. 1 starts on fuel nozzle located at 12 o'clock and continues in a clockwise direction ALF. Refer to [Figure 2](#)

- (10) Visually examine the fuel nozzle to fuel manifold coupling nuts at all 18 locations for evidence of fuel wetting.
- (11) If fuel indications are observed, contact your GE field service engineer or 24/7 Business Aviation Support. Refer to step (40) at the end of this document for details.
- (12) With an approved marker, draw a line across the joint to mark the coupling nut to nozzle position at all 18 locations. Align mark with the ALF counter clockwise (CCW), edge of the fuel nozzle flat. Refer to [SPM TASK 70-16-02-350-017 \(Temporary Marking\)](#). Refer to [Figure 3](#)
