# S-92<sup>®</sup> HELICOPTER

# **ALERT SERVICE**

ASB 92-62-009

SUBJECT: ROTORS – Main Rotor (MR) Swashplate Assembly – One-Time Visual Inspection of MR Stationary Swashplate Assembly for Cracks

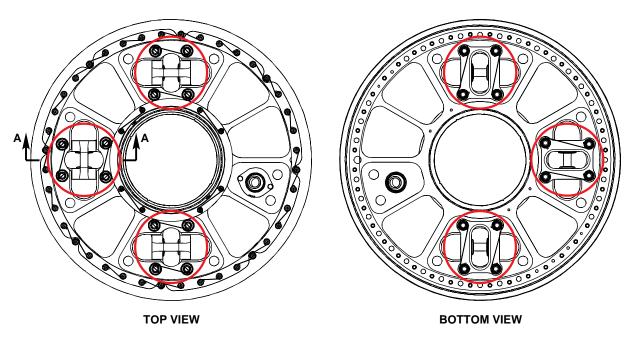
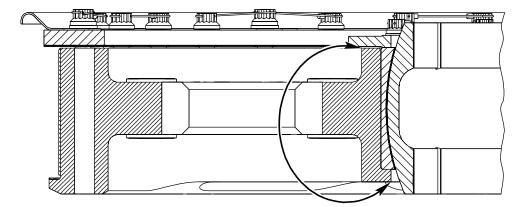
MR STATIONARY SWASHPLATE ASSEMBLY INSPECTION LOCATIONS FIGURE 1

- C. Background An occurrence of an in-service crack was reported on MR stationary swashplate assembly inner ring during a recurring inspection. An inspection has been developed to determine if cracks are present. If cracks are found, the swashplate assembly, uniball bearing, trunnions, and all attachment hardware shall be returned to Sikorsky for further investigation.

- (2) Inspect around entire circumference of upper and lower surfaces of MR stationary swashplate assembly inner ring and upper and lower surfaces of trunnion attachment areas for cracks. (Refer to Figure 1).

SECTION A-A INNER RING INSPECTION LOCATION (TRUNNION NOT SHOWN FOR CLARITY)

- (a) If cracks are found, remove swashplate assembly from service and install serviceable swashplate assembly. (Refer to Maintenance Manual SA S92A-AMM-000, Tasks 62-31-01-900-001/-002). Contact Sikorsky Customer Service Engineering at 1-800-WINGED-S or e-mail: wcs\_cust\_service\_eng.grsik@lmco.com and proceed to step C.

- (b) If nicks, dents, scratches, and/or any other damage is found, contact Sikorsky Customer Service Engineering at 1-800-WINGED-S or e-mail: wcs\_cust\_service\_eng.gr-sik@Imco.com and provide location, size (length, width, and depth) and photos of damage for disposition. After performing disposition, proceed to step C.
