S-92® HELICOPTER

ASB 92-62-010

SUBJECT: ROTORS – Main Rotor (MR) Swashplate Assembly – One-Time Inspection of MR Stationary

Swashplate Assembly to Initiate a 50-Hour Recurring Inspection

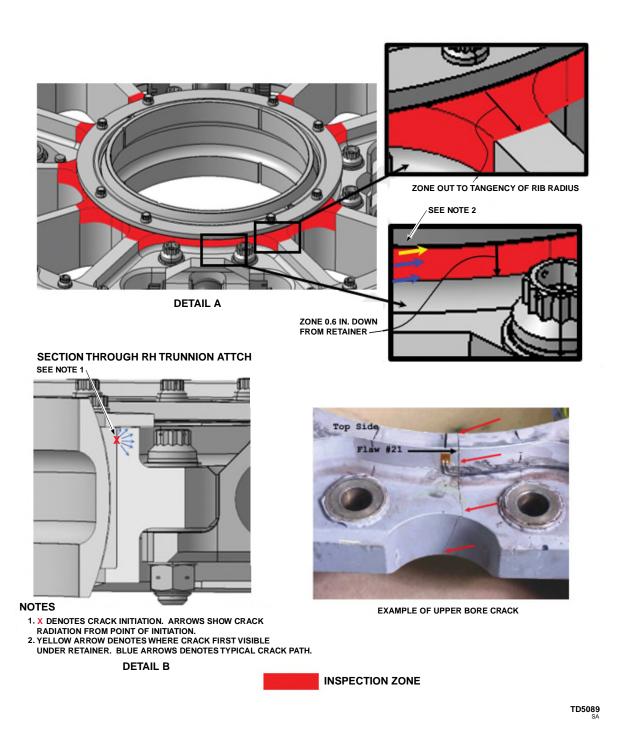
STATIONARY SWASHPLATE ASSEMBLY INSPECTION ZONES – UNIBALL UPPER BORE FIGURE 2

- (b) Uniball upper bore Breakthrough occurs on vertical wall near bearing retainer. See Figure 2, Details A and B.
 - NOTE: Cracks in the swashplate may start at the trunnion attachment under the hole bushing flange and propagate radially outward.

- NOTE: Cracks may start at upper end of inner bore and propagate outward.
 - (b) Uniball upper bore Breakthrough occurs on vertical wall near bearing retainer. See Figure 2, Details A and B.

(b) Uniball upper bore – Breakthrough occurs on vertical wall near bearing retainer. See Figure 2, Details A and B.

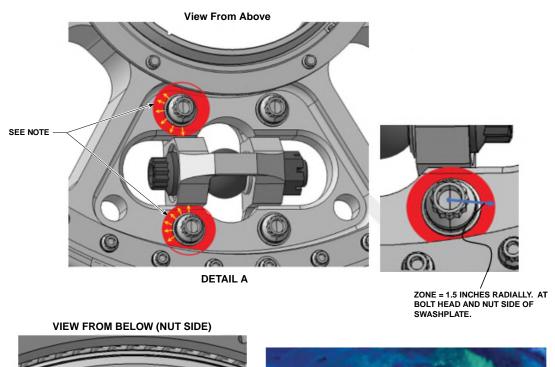
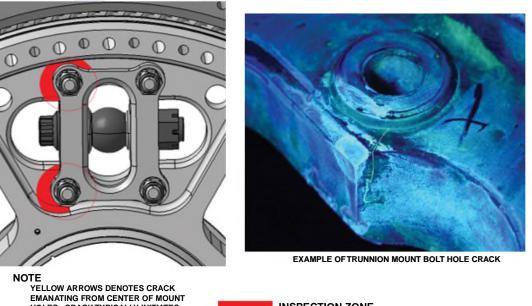
STATIONARY SWASHPLATE ASSEMBLY INSPECTION ZONE - TRUNNION MOUNT BOLT **HOLES** FIGURE 3

- (c) Trunnion mount bolt holes Inspection zone begins outside of the minimal caulking region. See Figure 3, Detail A.
- (4) During visual inspection, discontinuities in the surface may be observed that require confirmation as either (1) a detectable crack (none allowed) that would have a detectable depth or length, or (2) only a surface break defect (suspected crack) in the paint/primer that could include observable metallic base material. The process steps to confirm a detectable crack is to perform either the FPI (step D) or eddy current inspection (step C).

NOTE: Cracks in the swashplate may start at the trunnion attachment under the hole bushing flange and propagate radially outward.

EMANATING FROM CENTER OF MOUNT HOLES. CRACK TYPICALLY INITIATES UNDER BUSHING FLANGE.

- (5) If a crack is suspected at underside of swashplate assembly trunnion mount bolt holes, remove trunnion to perform FPI/ eddy current inspection. (Refer to Maintenance Manual SA S92A-AMM-000, Task 62-31-03-900-001).

- (6) If presence of crack is confirmed, contact Sikorsky Customer Service Engineering at 1-800-WINGED-S or Email; wcs_cust_service_eng.gr-sik@Imco.com. Remove main rotor swashplate assembly (92104-15011-042/-043) and trunnions and return to Sikorsky Aircraft. (Refer to Maintenance Manual SA S92A-AMM-000, Task 62-31-01-900-001).

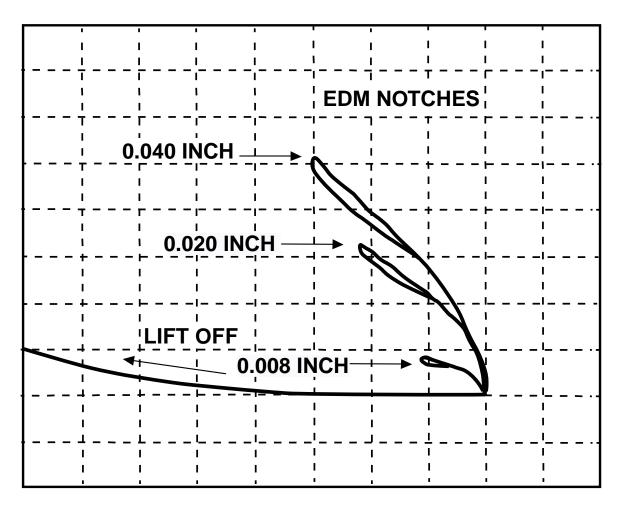
EDM NOTCHES FIGURE 4

- (5) Move probe over all three notches in the test block. Adjust gain to obtain a five-block vertical signal when probe is passed over the 0.040-inch notch in the test block (See the standard instrument display in figure 4). Separation shall be distinguishable between all notches.
