[Docket No. FAA-2023-0430; Project Identifier MCAI-2022-01092-R; Amendment 39-22378; AD 2023-05-09]

#### **Airworthiness Directives; Airbus Helicopters Deutschland GmbH (AHD) Helicopters**

#### 2023–05–09 Airbus Helicopters

39–22378; Docket No. FAA–2023–0430; Project Identifier MCAI–2022–01092–R.

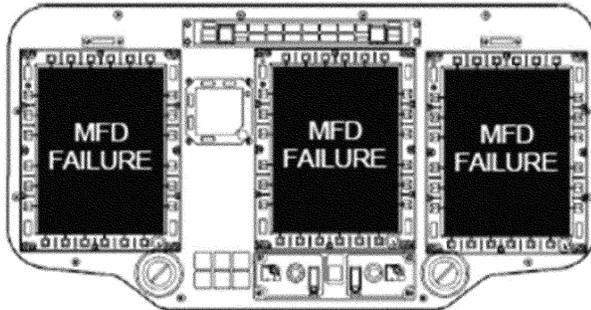
Figure 1 to Paragraph (g)(2): RFM  
Emergency Procedure—Model MBB-BK117  
Helicopters

- MFD FAILURE displayed on all MFDs
- If autopilot upper modes were coupled, they may decouple after 10 seconds (indicated by an „autopilot decouple“ voice message).

1. Double engine emergency shutdown - Perform

1. Aircraft trajectory - Maintain using IESI and stand-by compass.  
- Use AFCS "recovery" or "go-around" modes, if desired  
- Operate aircraft within the approved performance
2. MFD2 pb - OFF

3. MFD2 pb - ON

4. MFD2 - Maintain in FND format
5. LAND AS SOON AS POSSIBLE

4. VMC conditions – Establish
5. LAND AS SOON AS POSSIBLE

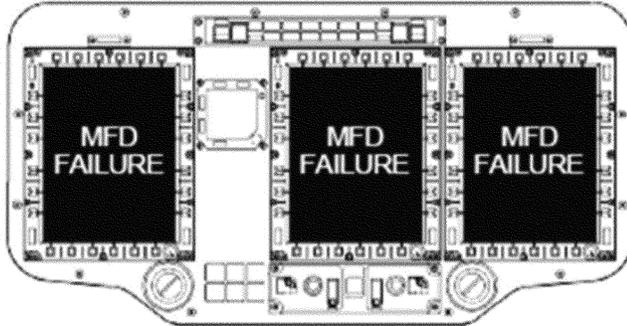
**Figure 2 to Paragraph (g)(2): RFM  
Emergency Procedure—Model EC135  
Helicopters**

- MFD FAILURE displayed on all MFDs
- If autopilot upper modes were coupled, they may decouple after 10 seconds (indicated by an „autopilot decouple“ voice message).

1. Double engine emergency shutdown - Perform

1. Aircraft trajectory
  - Maintain using IESI and stand-by compass.
  - Use AFCS "recovery" or "go-around" modes, if desired
  - Operate aircraft within the approved performance
2. MFD2 pb - OFF

3. MFD2 pb - ON

4. MFD2 - Maintain in FND format
5. LAND AS SOON AS POSSIBLE

4. VMC conditions - Establish
5. LAND AS SOON AS POSSIBLE
