Alert Requirements Bulletin B787-81205-SB780041-00 RB THRUST REVERSER SYSTEM (ROLLS-ROYCE TRENT 1000 ENGINES) - Thrust Reverser - Inner Fixed Structure Forward Upper Fire Seal and Thermal Blanket - Inspection

Federal Aviation Administration (FAA) Airworthiness Directive AD 2020-26-08 is related to Requirements bulletin B787-81205-SB780041-00 RB.

This issue is sent to add airplane variable numbers ZE018 and ZE019 to this bulletin effectivity.

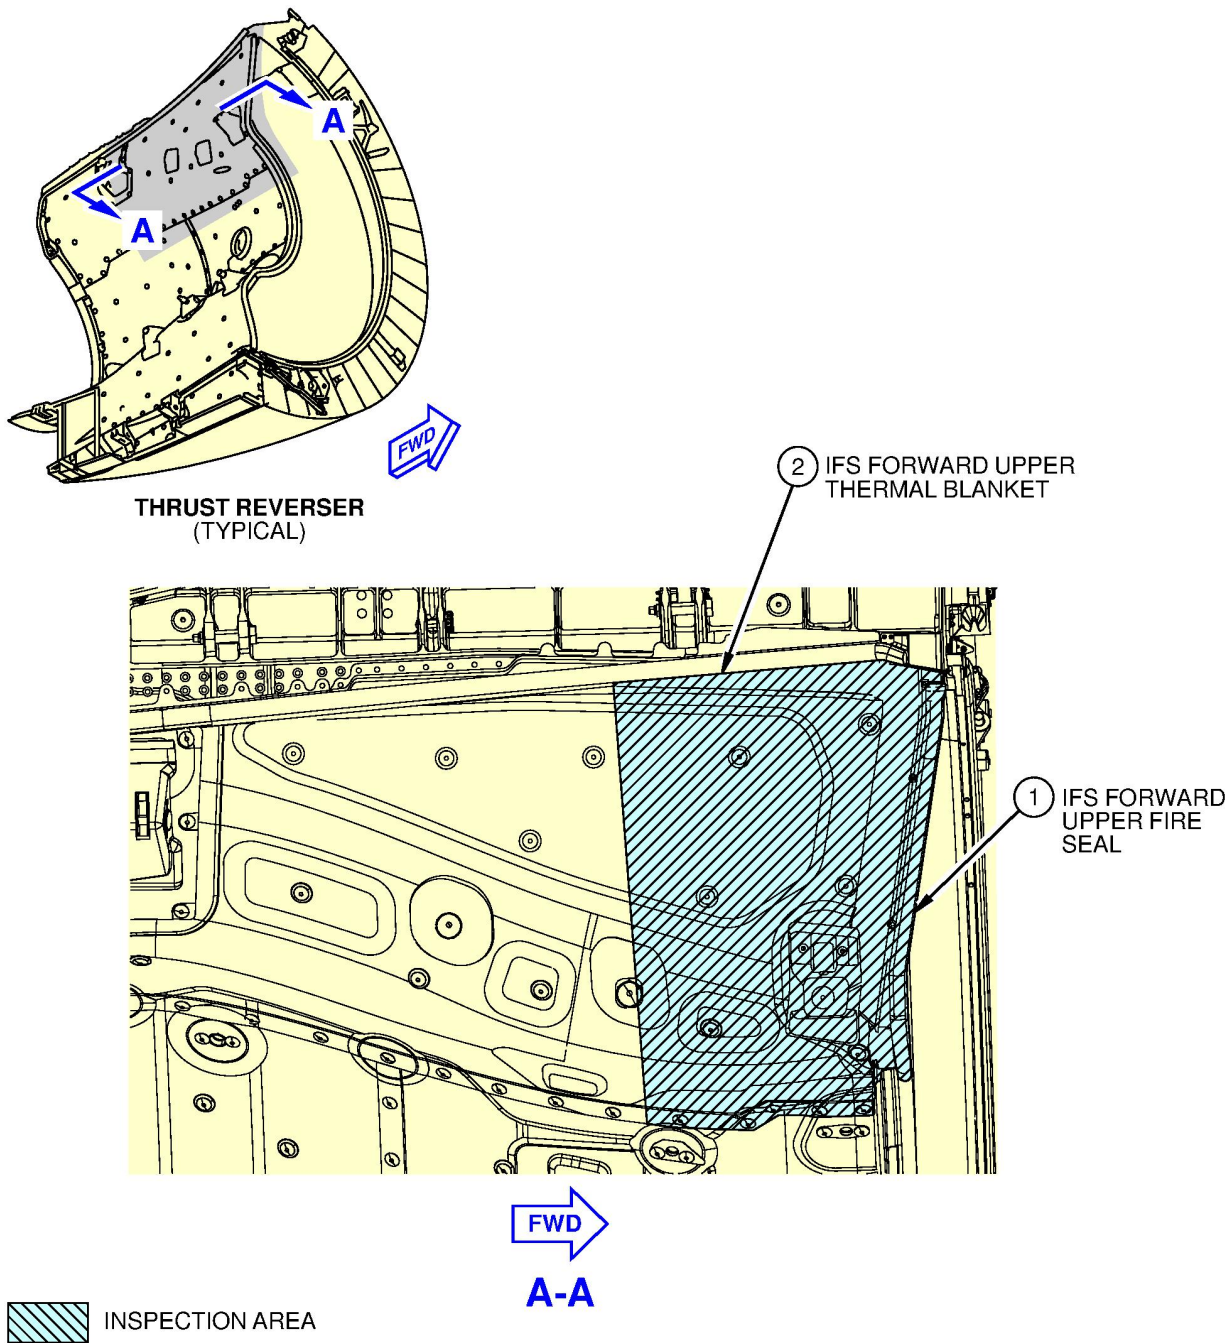
1. **Engine - Thrust Reverser - Inner Fixed Structure (IFS) Forward Upper Fire Seal and Thermal Blanket - General Visual Inspection Area (Right Opposite)**

*[1] Do a General Visual Inspection of the IFS forward upper fire seal for damage. Damage is defined as any cuts, splits, nicks, punctures, and missing sections.

*[2] Do a General Visual Inspection of the IFS forward upper thermal blanket for damage. Damage is defined as any tears, cuts, missing metal skin, missing insulation, and over-temperature conditions shown by discoloration or scorching.
