# 737

## Service Bulletin

**Number:** 737-53A1217  
**Original Issue:** August 09, 2001  
**Revision 1:** September 08, 2022  
**ATA System:** 5300

**SUBJECT:** FUSELAGE - Section 43 and Section 47 - Stringer 17 Skin Cracks at STA 360-380 and STA 888-907

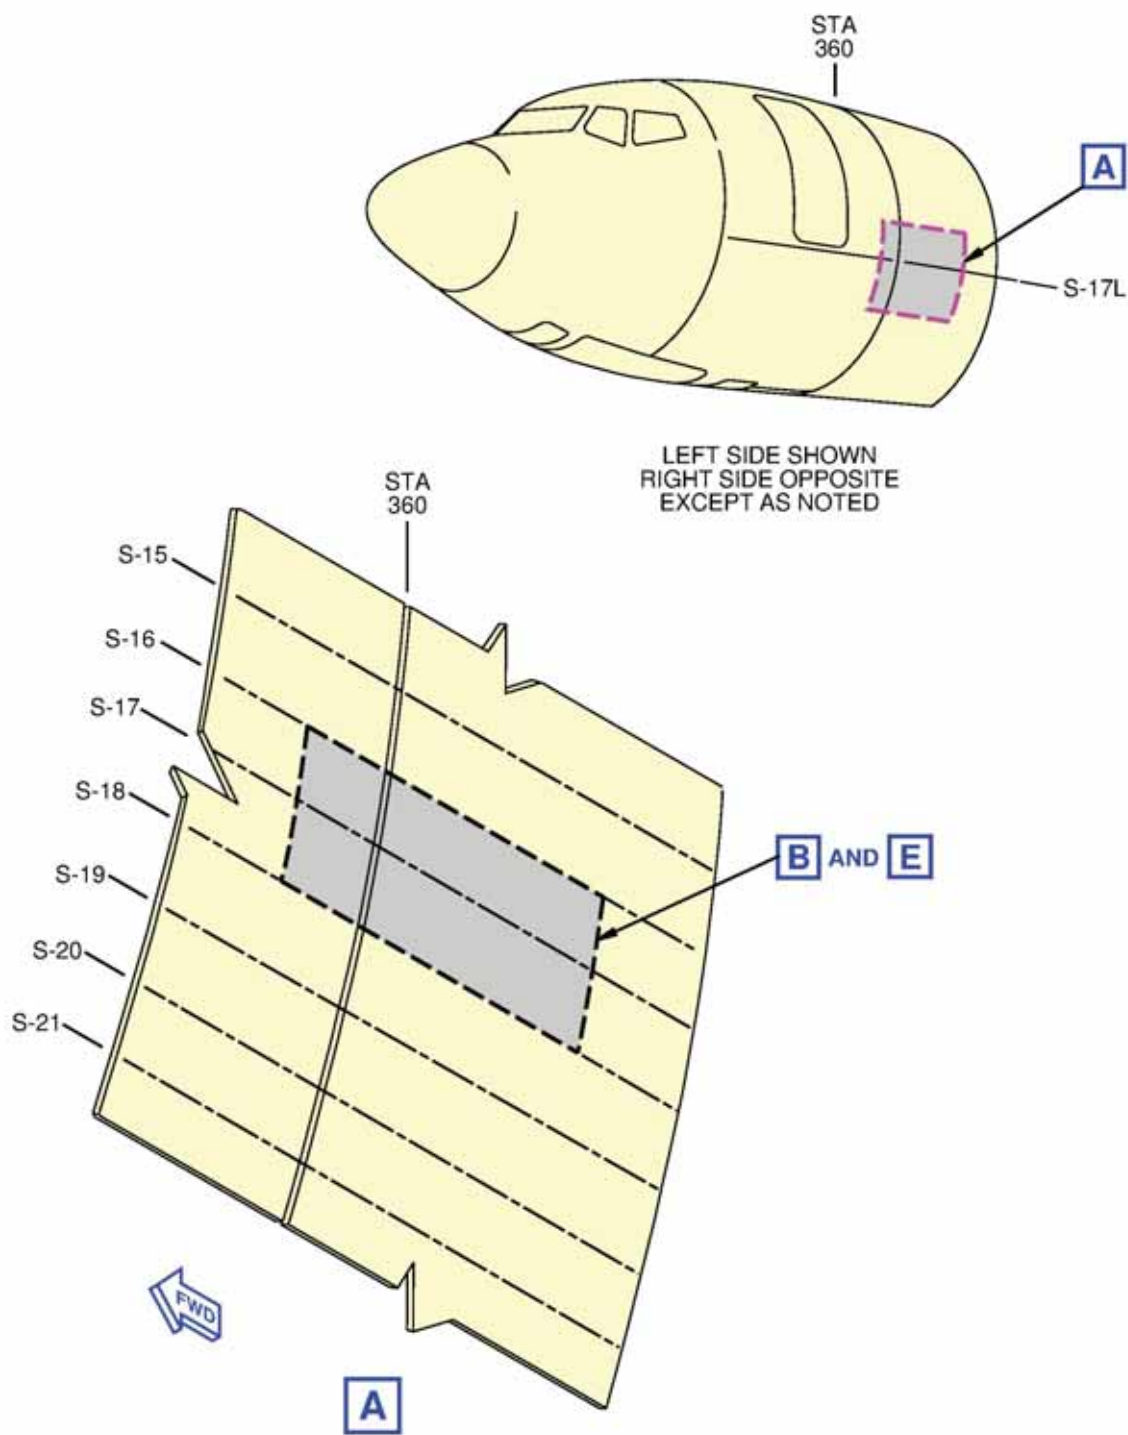
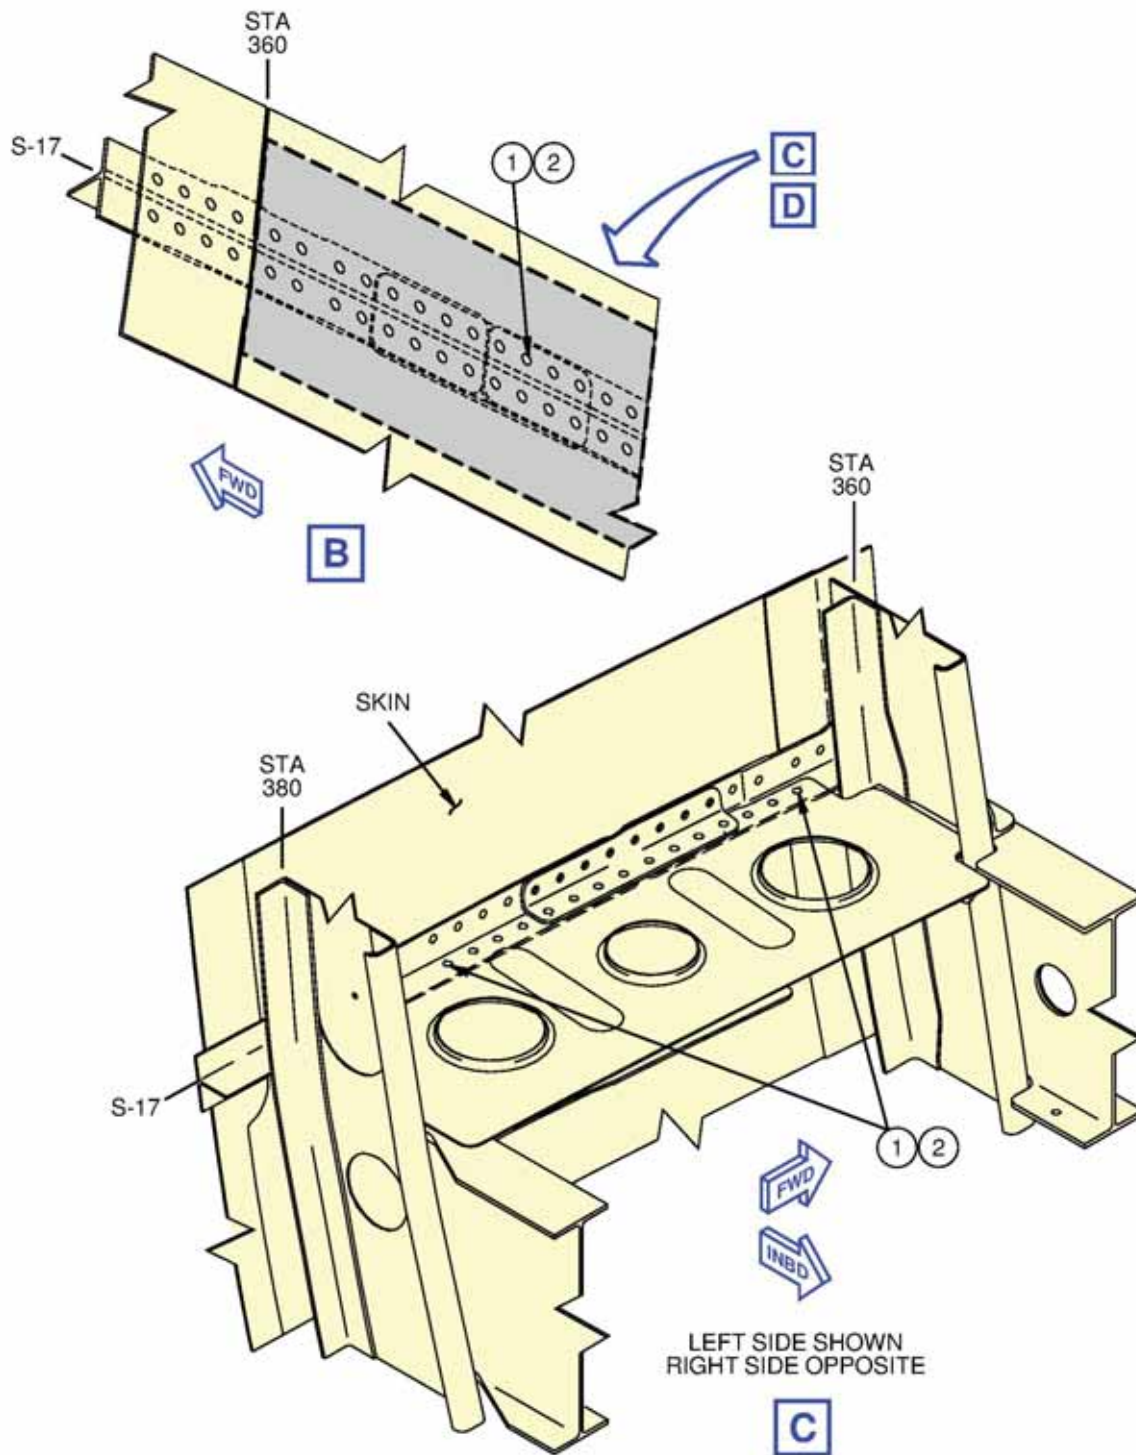
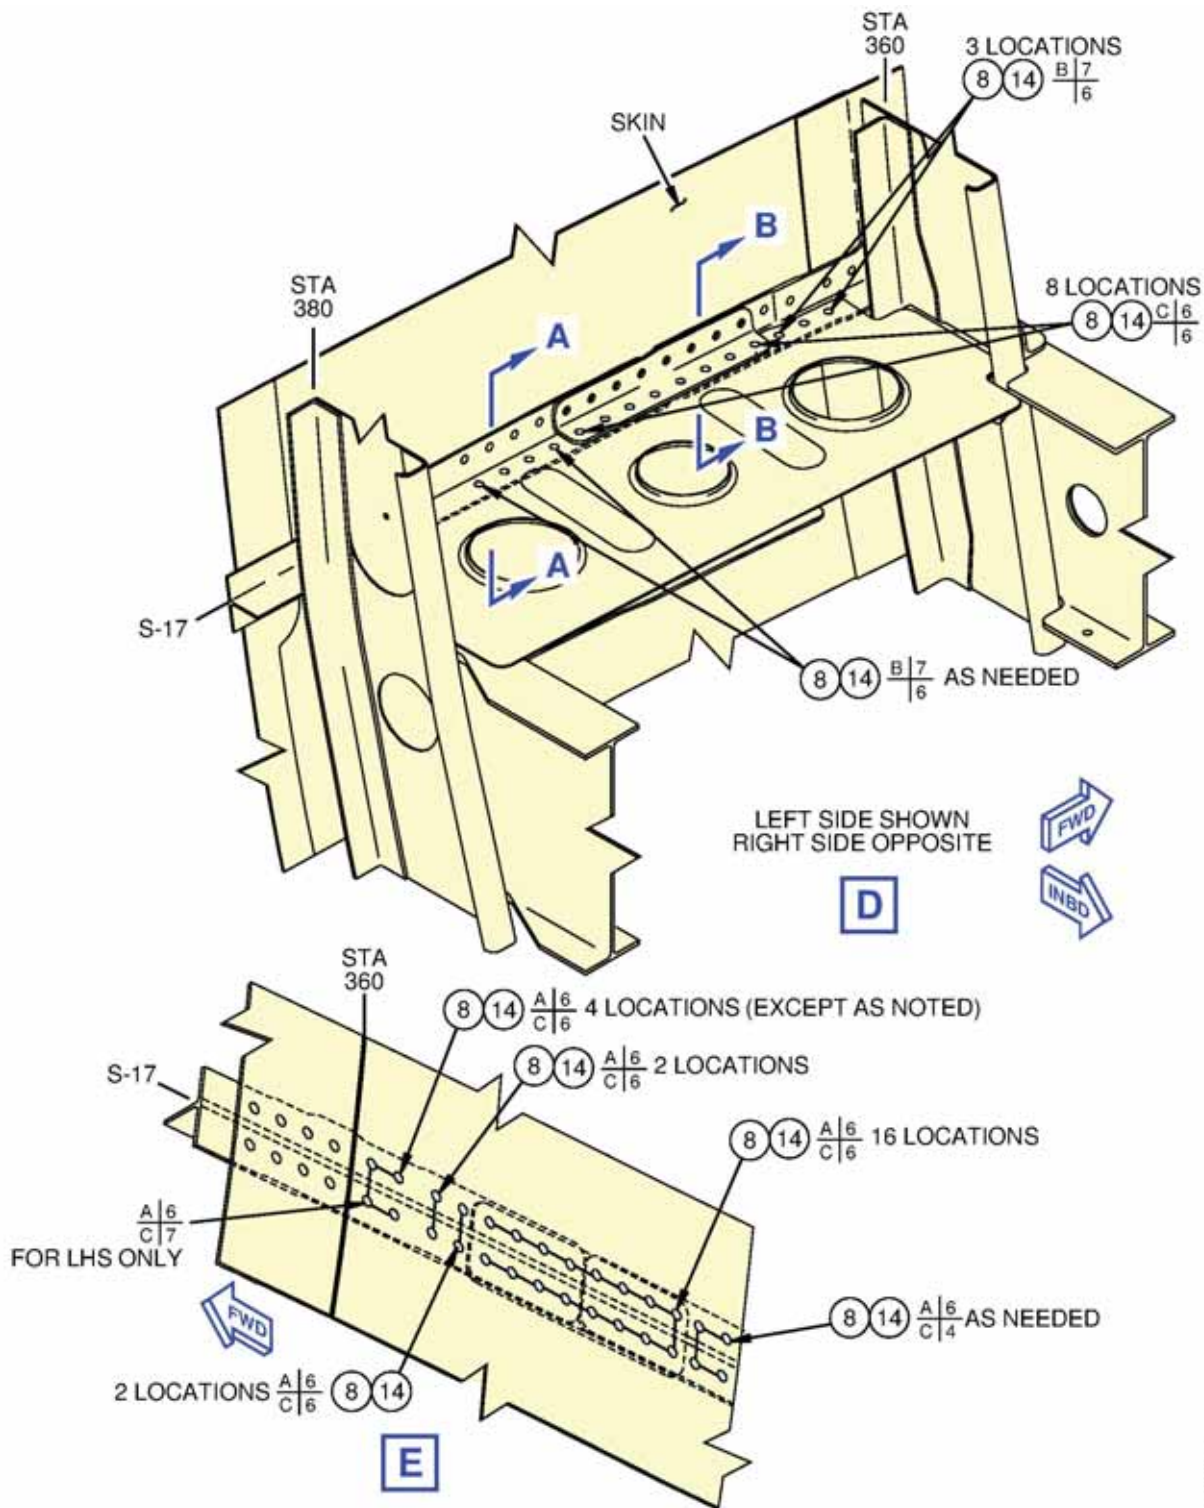
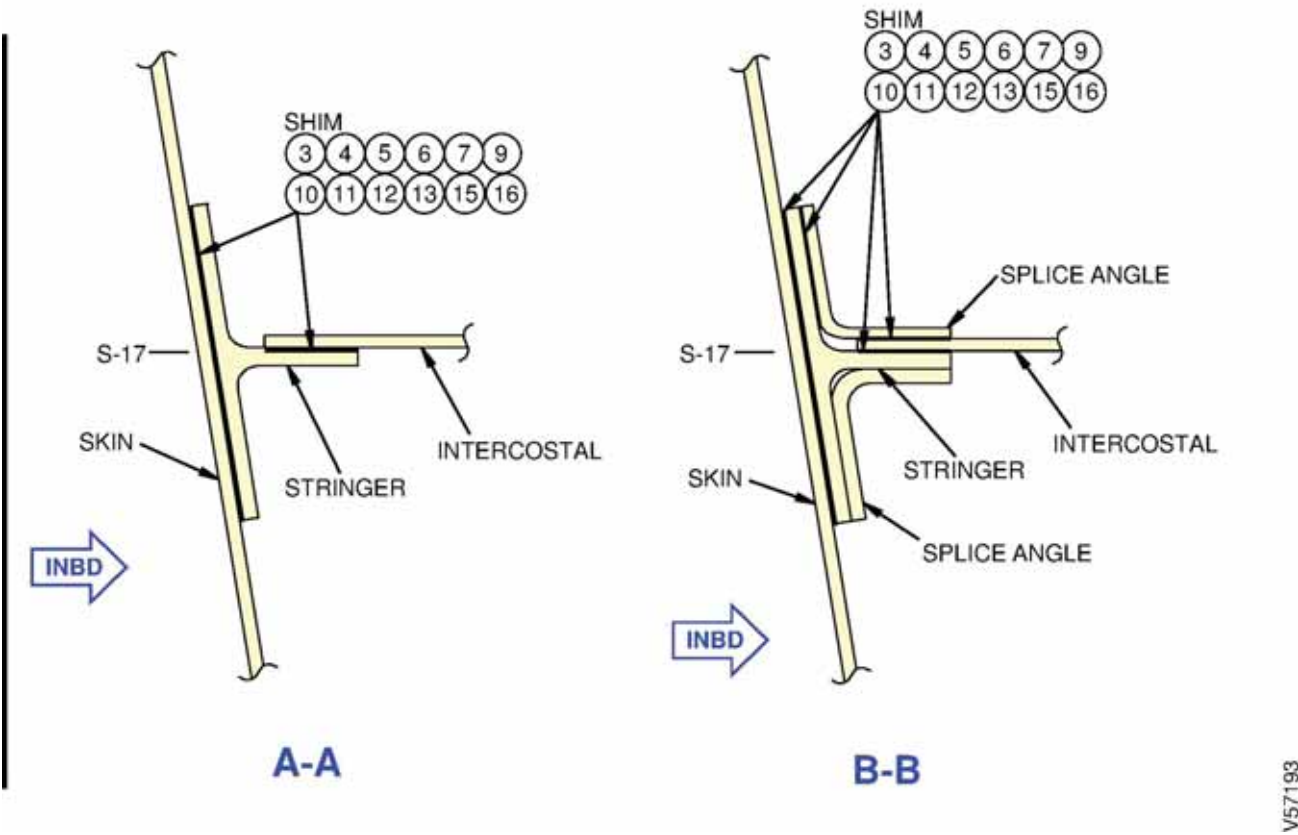
**FIGURE 4: TERMINATING ACTION AT ZONE 1 AND ZONE 2  
(SHEET 1 OF 7)**

In production, a structural preload was created in the body skin during the installation of S-17. Analysis by Boeing shows that this preload, combined with pressure cycles, can cause cracks in the skin prior to reaching the Design Service Objective (DSO).

Accomplishment of the terminating action shown in this service bulletin will ensure that cracks do not initiate. Cracks will result in unscheduled time out of service to accomplish repairs.
