[Docket No. FAA–2023–1055; Project Identifier AD–2023–00583–T; Amendment 39–22445; AD 2023–10–09]

### Airworthiness Directives; The Boeing Company Airplanes

**2023–10–09 The Boeing Company:**  
Amendment 39–22445; Docket No. FAA–2023–1055; Project Identifier AD–2023–00583–T.

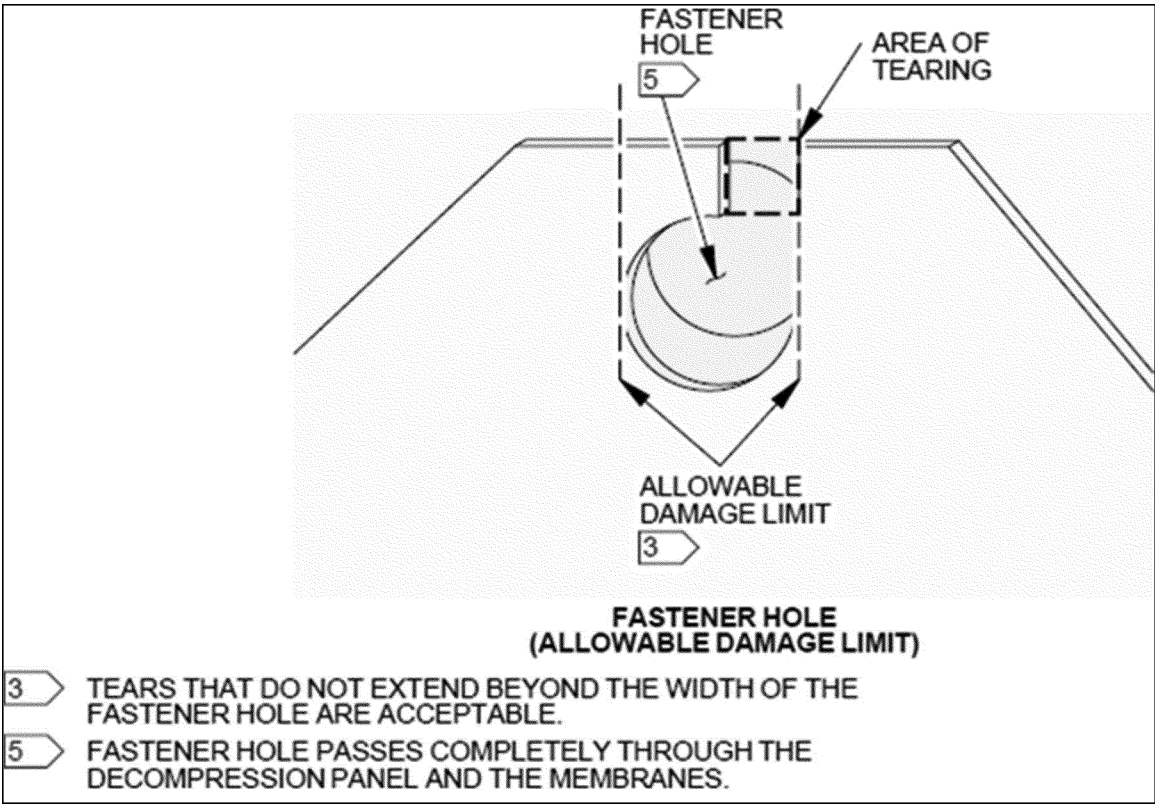
Figure 1 to paragraph (g)(3)(i)—Allowable damage not extending beyond fastener hole width

(i) If the damage is on the fastener hole, the damage must not extend beyond the width of the fastener hole. Refer to figure 1 to paragraph (g)(3)(i) of this AD. Where figure 1 to paragraph (g)(3)(i) of this AD refers to tears or tearing, this includes all types of damage as defined in paragraph (g)(2) of this AD.

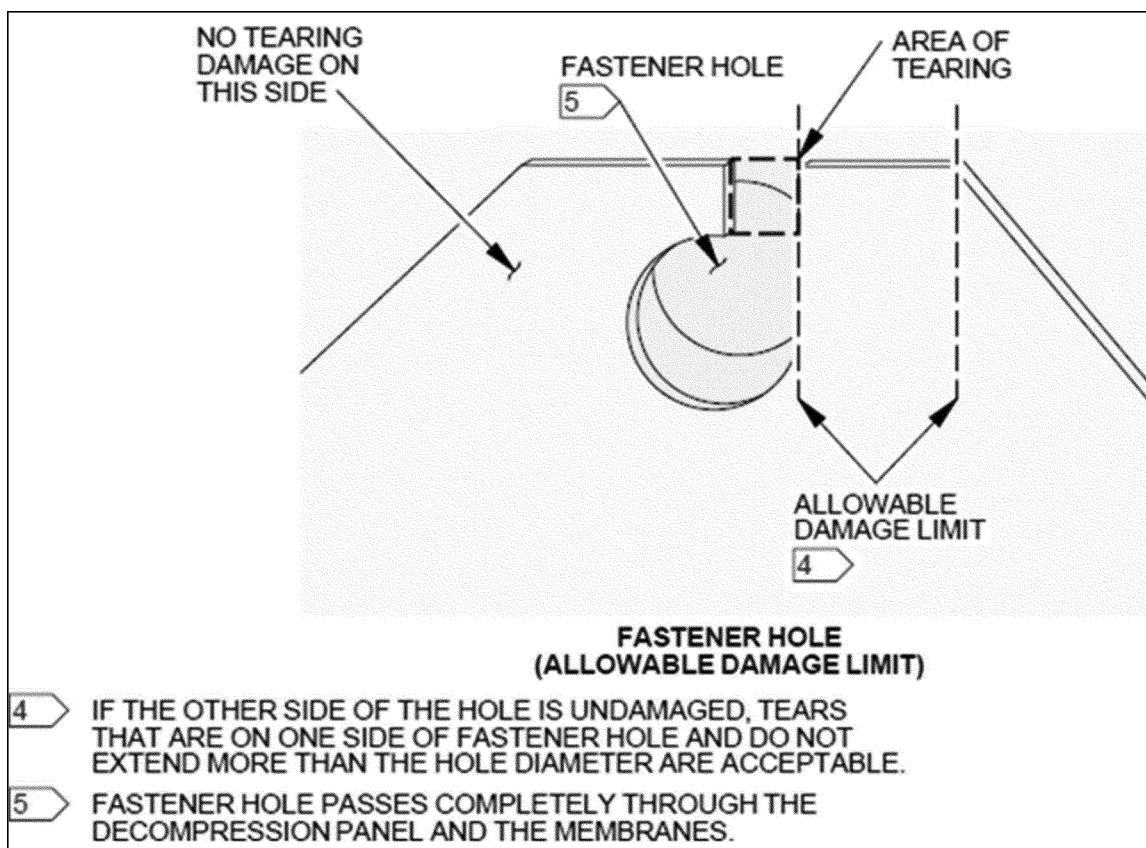
**Figure 2 to paragraph (g)(3)(ii)—Allowable damage not extending more than fastener hole diameter**

(ii) If the damage is on one side of the fastener hole and the other side of the fastener hole has no damage, the damage must not extend more than the diameter of

the fastener hole. Refer to figure 2 to paragraph (g)(3)(ii) of this AD. Where figure 2 to paragraph (g)(3)(ii) of this AD refers to tears, tearing, or tearing damage, this

includes all types of damage as defined in paragraph (g)(2) of this AD.
