MODEL BD-700-2A12 (BD-700)

Service Bulletin No. 700-24-7507

**MODIFICATION – DC POWER CONVERSION – TRANSFORMER RECTIFIER UNIT (TRU) FAN CIRCUIT, PBIT, CBIT AND TURN-ON THRESHOLD CORRECTION**

# Global 7500

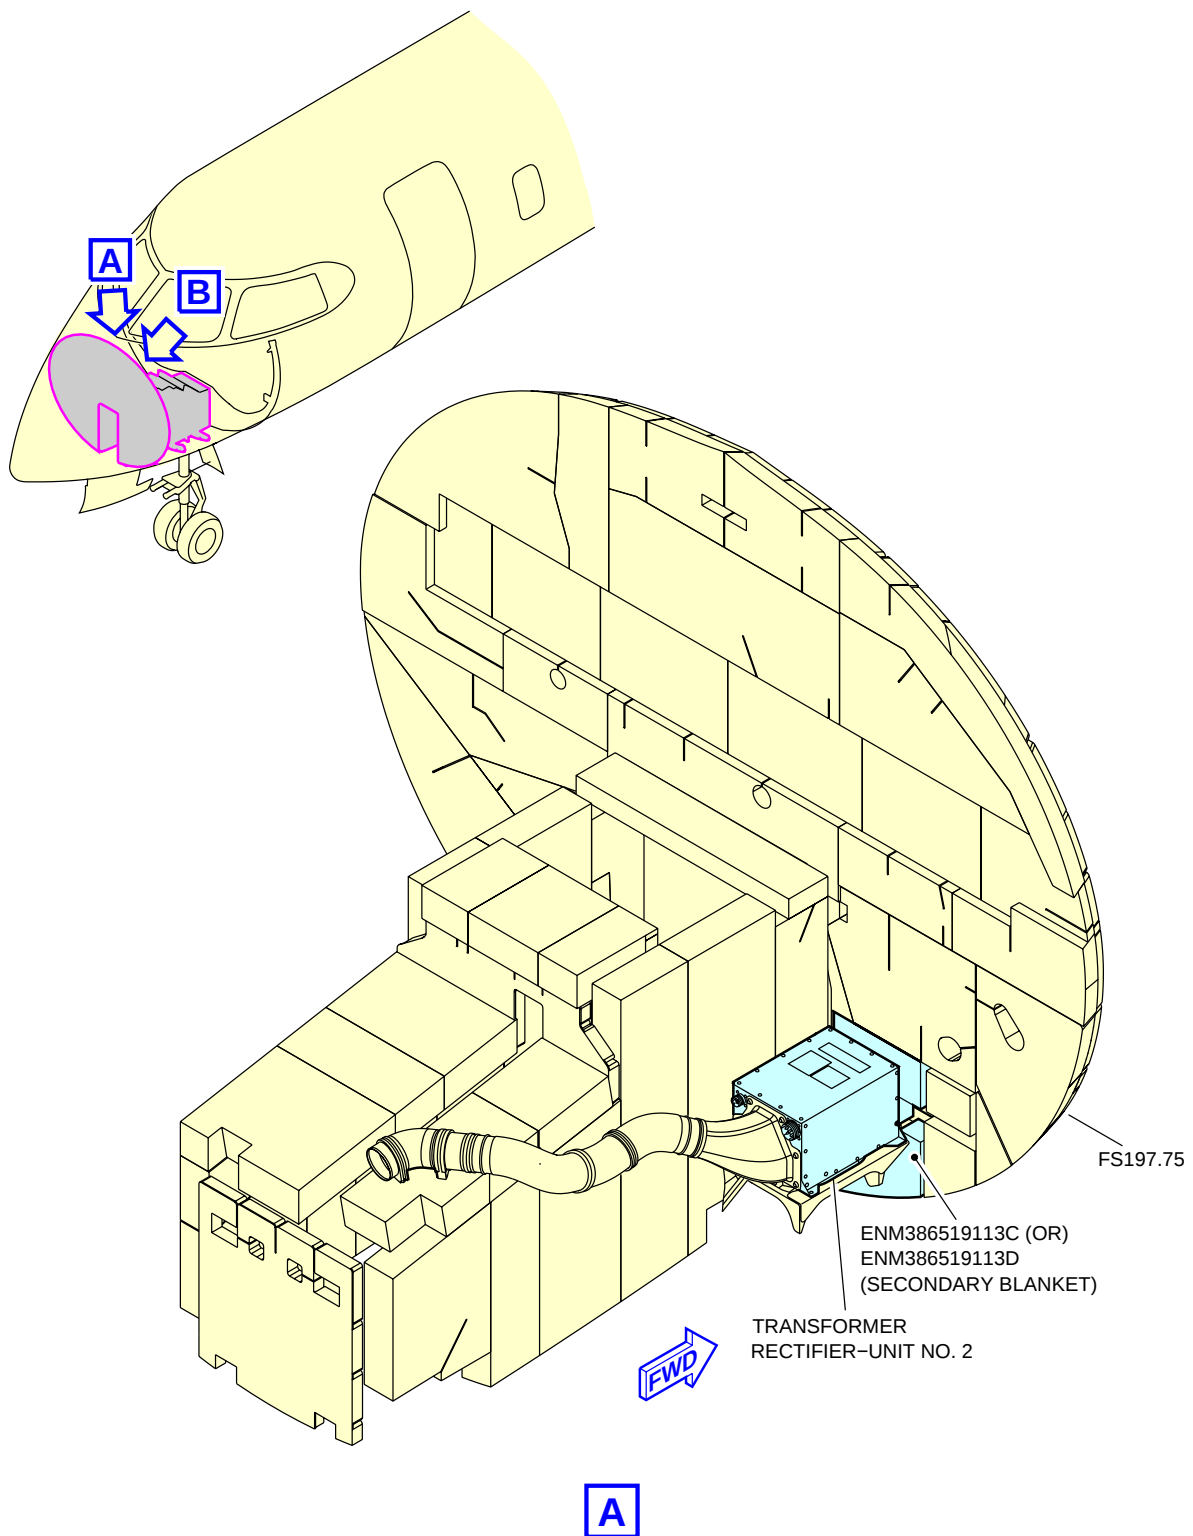
SB700-24-7507\_001

It was also identified that an insulation blanket located close to the TRU 2 fan air inlet may be leading to an eventual reduction of TRU 2 cooling efficiency.

Figure 1 – Removal and discard of the insulation blanket.  
(Sheet 1 of 2)

Remove and discard the secondary layer of insulation blanket in front of the TRU 2 fan air inlet in the cockpit underfloor RHS, as shown in Paragraph 2.B.(2).

- (1) Remove the TRU No. 2 per BD700-A-J24-31-03-00AAA-520A-A.
- (2) At FS 197.75, pressure bulkhead, remove and discard the secondary insulation blanket (part no. ENM386519113C or ENM386519113D) as shown in Figure 1.
  - (a) Re-identify the blanket installation by ink stamp per best shop practice.
- (3) Install the new TRU No. 2 Part No. G02404521-003. Refer to BD700-A-J24-31-03-00AAA-720A-A.
  - (a) Do a check of the electrical bond resistance on the TRU. Refer to BD700-AJ51-80-00-00AAA-366A-A.

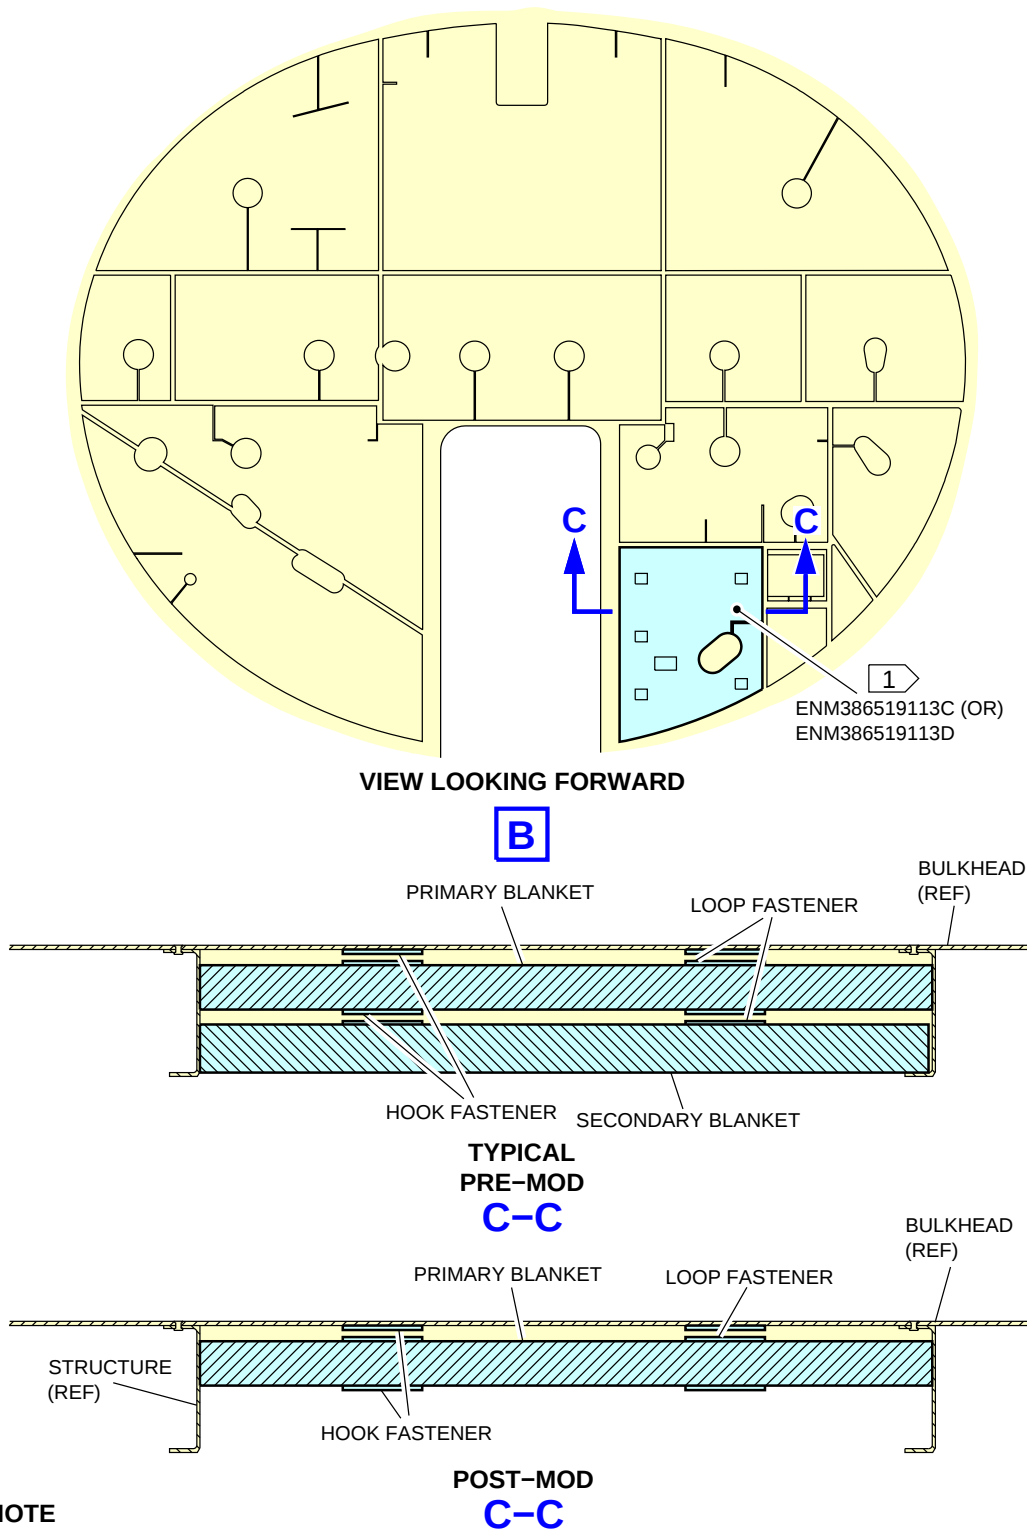
SB700-24-7507\_002

Figure 1 – Removal and discard of the insulation blanket.  
(Sheet 2 of 2)

- 1 Remove and discard the secondary blanket.
