[Docket No. FAA-2024-1896; Project Identifier MCAI-2023-00978-T]

Airworthiness Directives; MHI RJ Aviation ULC (Type Certificate Previously Held by Bombardier Inc.) Airplanes

ACTION: Notice of proposed rulemaking

MHI RJ Aviation ULC (Type Certificate Previously Held by Bombardier Inc.): Docket No. FAA–2024–1896; Project Identifier MCAI–2023–00978–T.

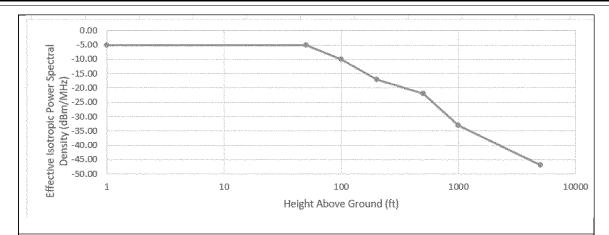
Figure 1 to Paragraph (g)(1)—Fundamental Effective Isotropic PSD at Outside Interface of Airplane Antenna

(1) Tolerance to radio altimeter interference, for the fundamental emissions (3.7–3.98 GHz), at or above the power spectral density (PSD) curve threshold specified in figure 1 to paragraph (g)(1) of this AD.

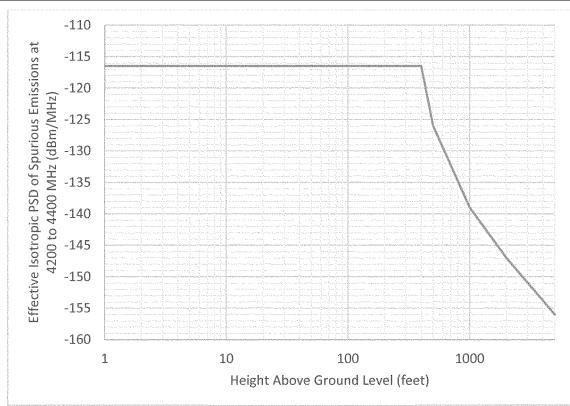
Figure 2 to Paragraph (g)(2)—Spurious Effective Isotropic PSD at Outside Interface of Airplane Antenna

(2) Tolerance to radio altimeter interference, for the spurious emissions (4.2–4.4 GHz), at or above the PSD curve threshold

specified in figure 2 to paragraph (g)(2) of this AD.
