## SERVICE BULLETIN

### No. MSB-E4-043/0

Piston borescope inspection

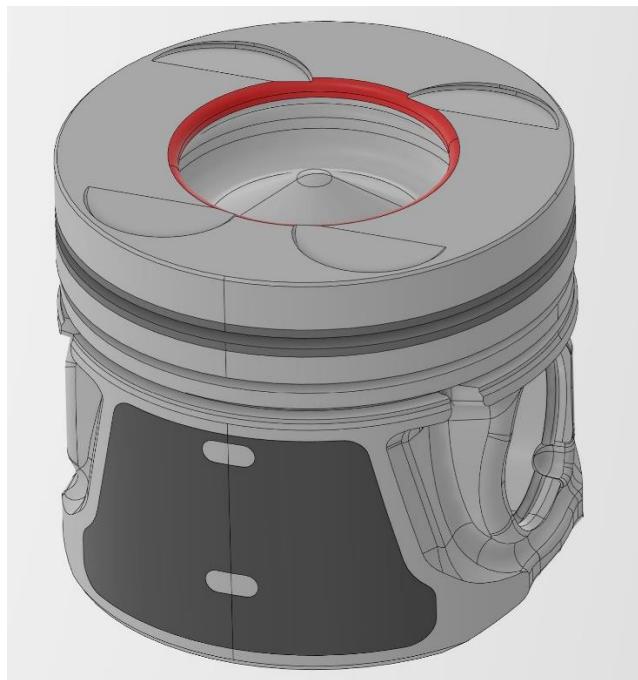
**Fig. 1**

1. Remove the injectors in accordance with MM section 73-10-01-A.
  - The compression test added with MM-TR-MDC-E4-849a is not required.
2. Use a borescope to examine the piston top for cracks, paying particular attention to the area marked in red in Fig. 1.
3. Report the inspection as “performed” on partners.diamondaircraft.com
  - Carefully handle the borescope to prevent any damage to the surface of the piston.
  - Refer to Appendix for borescope images. In case of doubt, contact Austro Engine.
  - In case of findings, proceed in accordance with paragraph 2.1.1.

### 2.1.1. Piston crack repair instructions

- If water or contaminants are not found:
- Replace the engine core with new parts in accordance with WI-MSB-E4-039-I "Core engine replacement" **or**
- Replace the piston with new parts in accordance with WI-MSB-E4-039-II "Piston replacement".

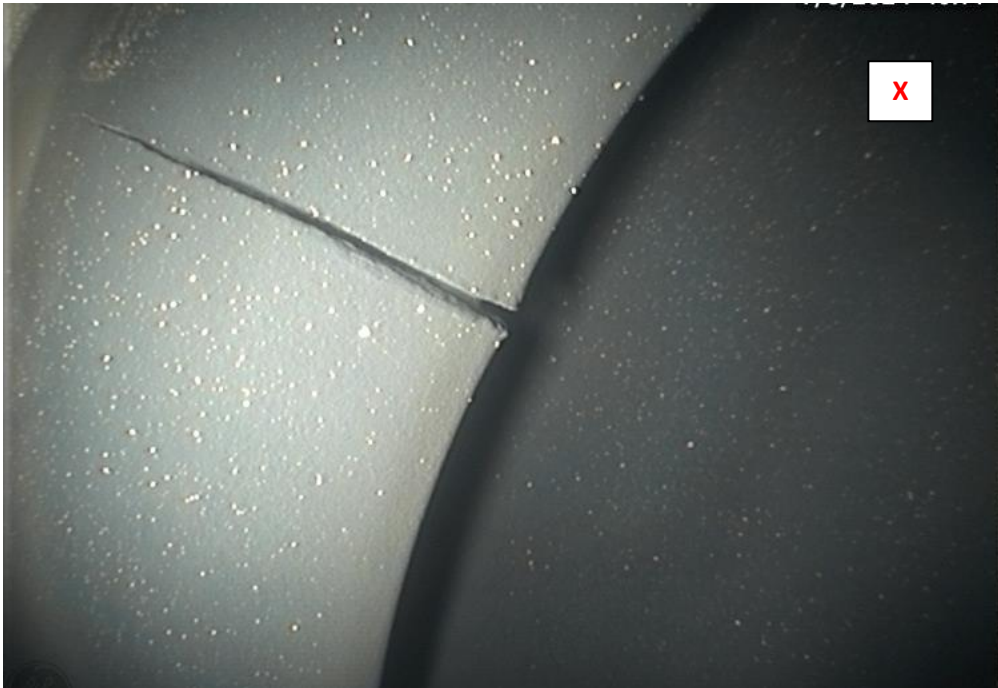
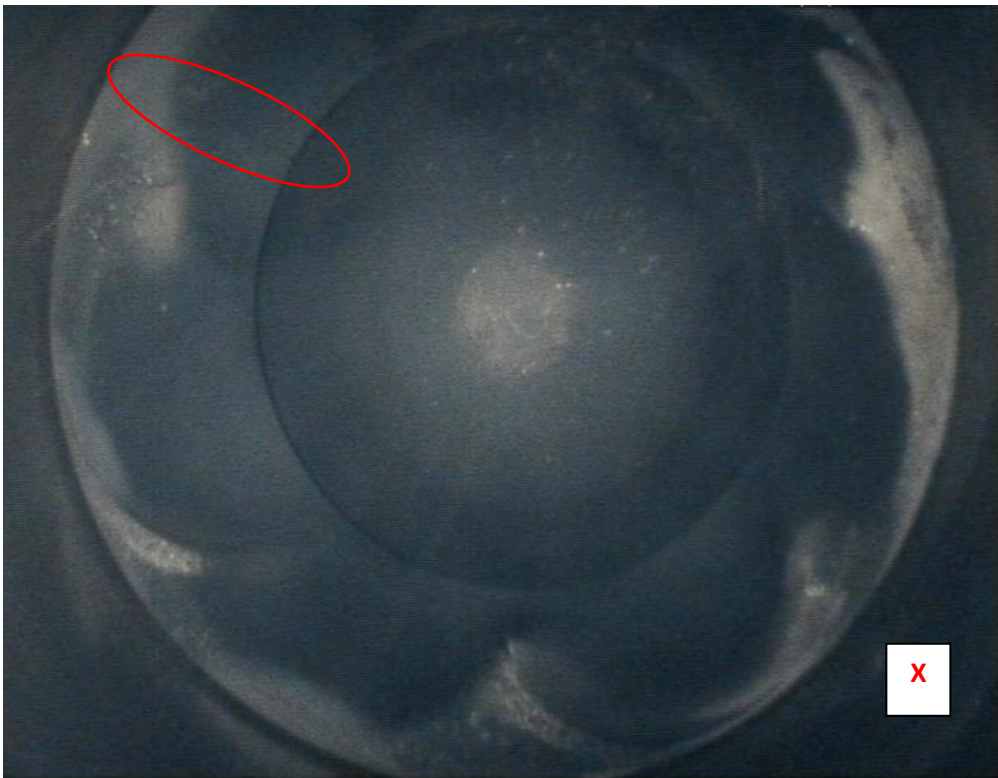
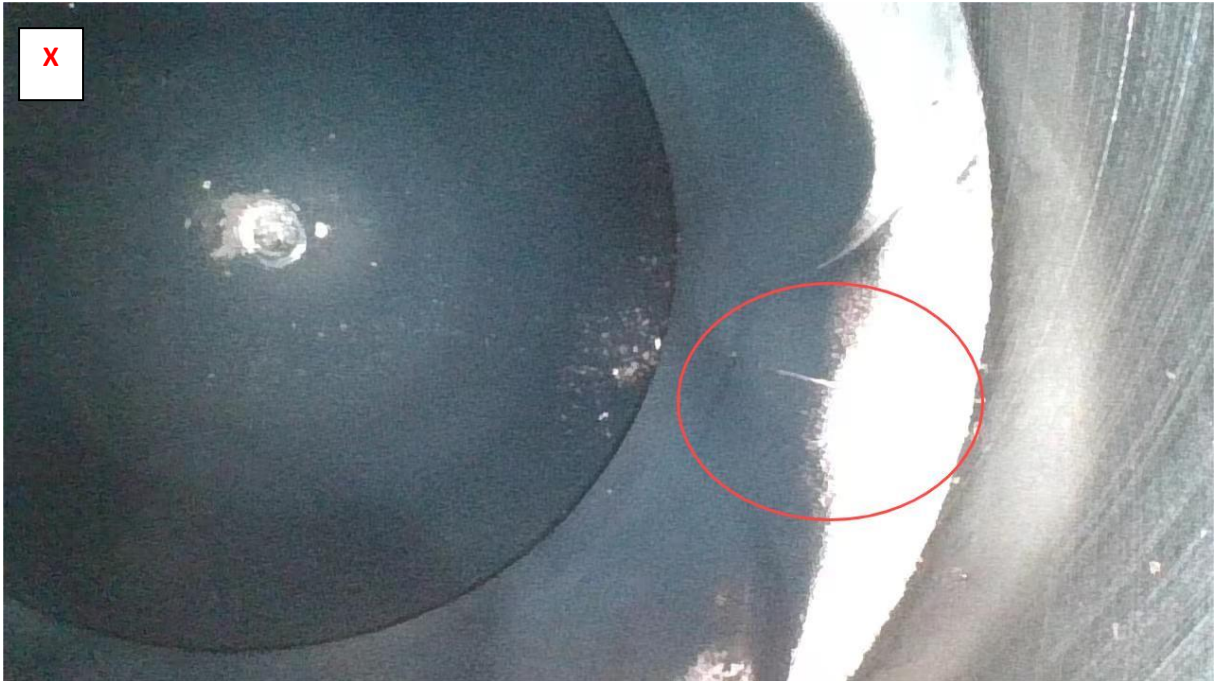
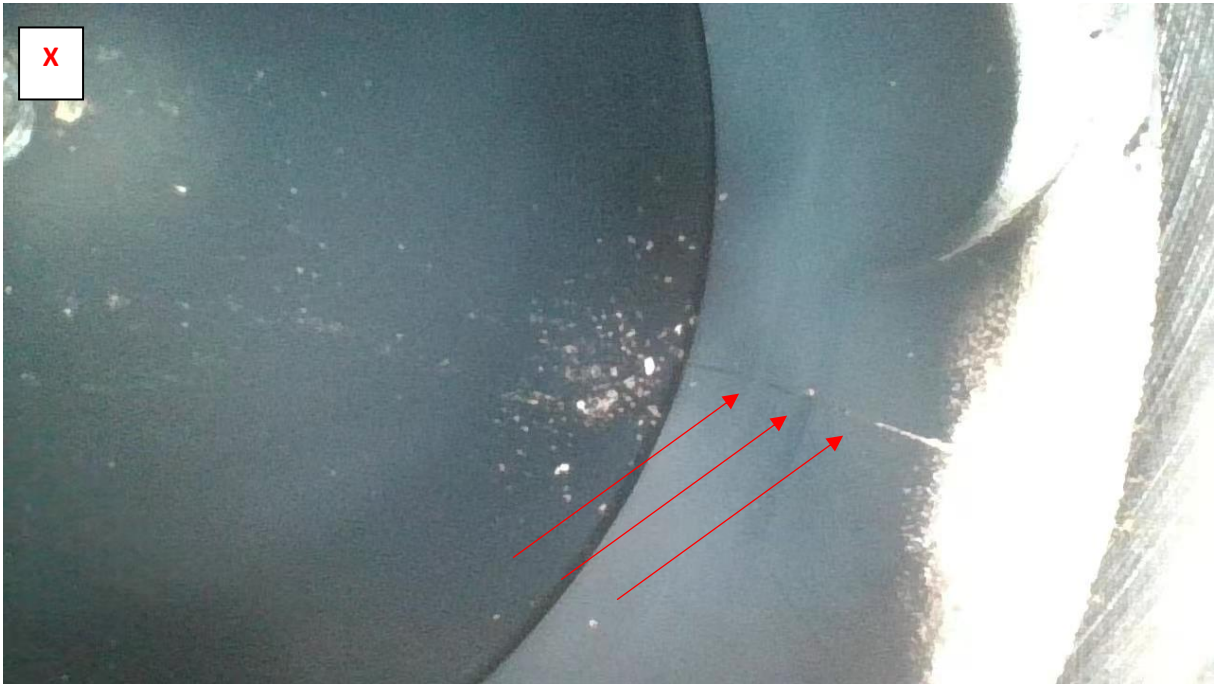
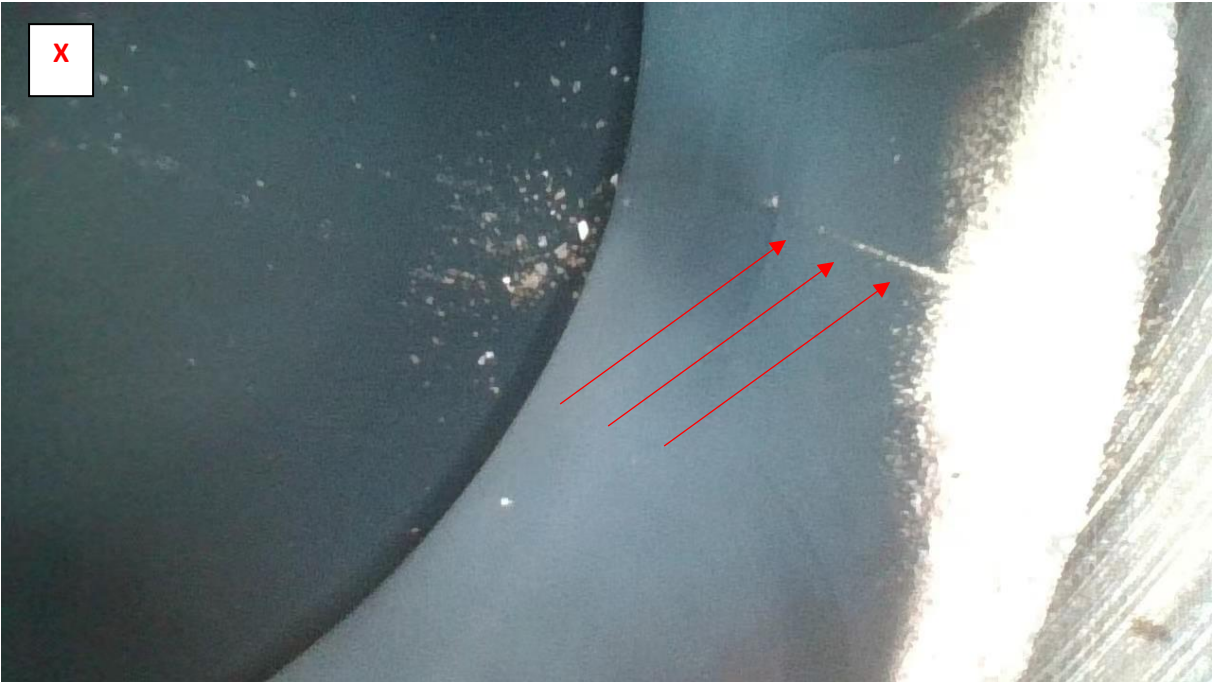
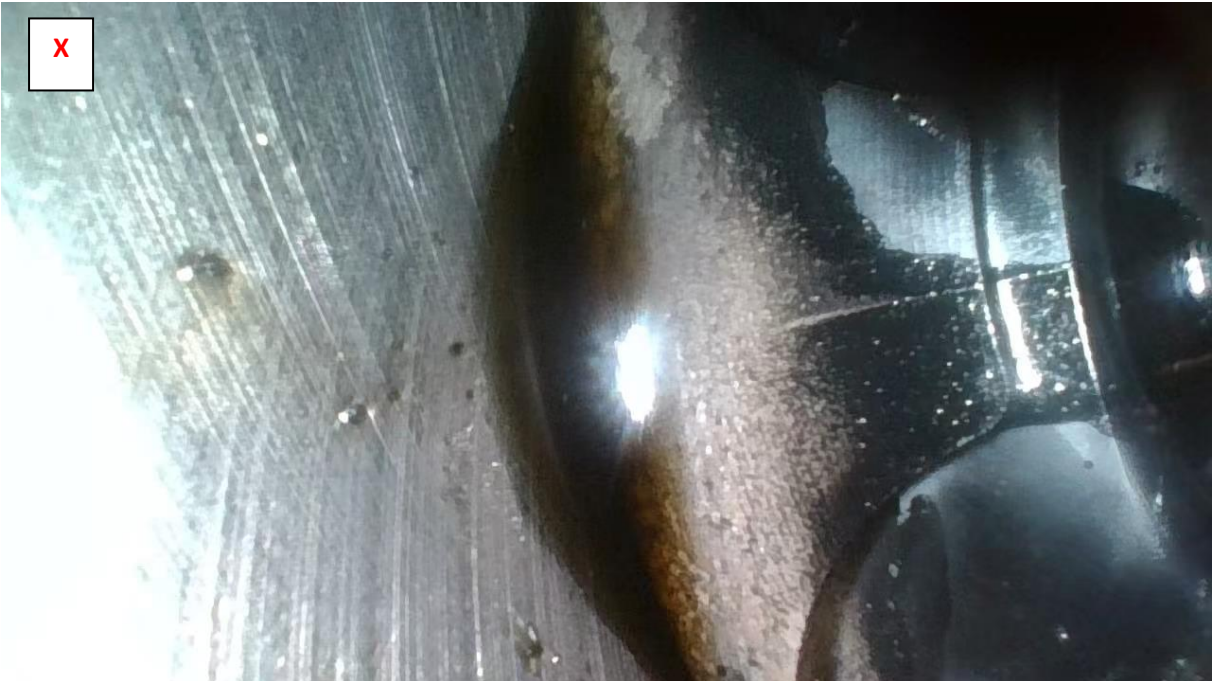
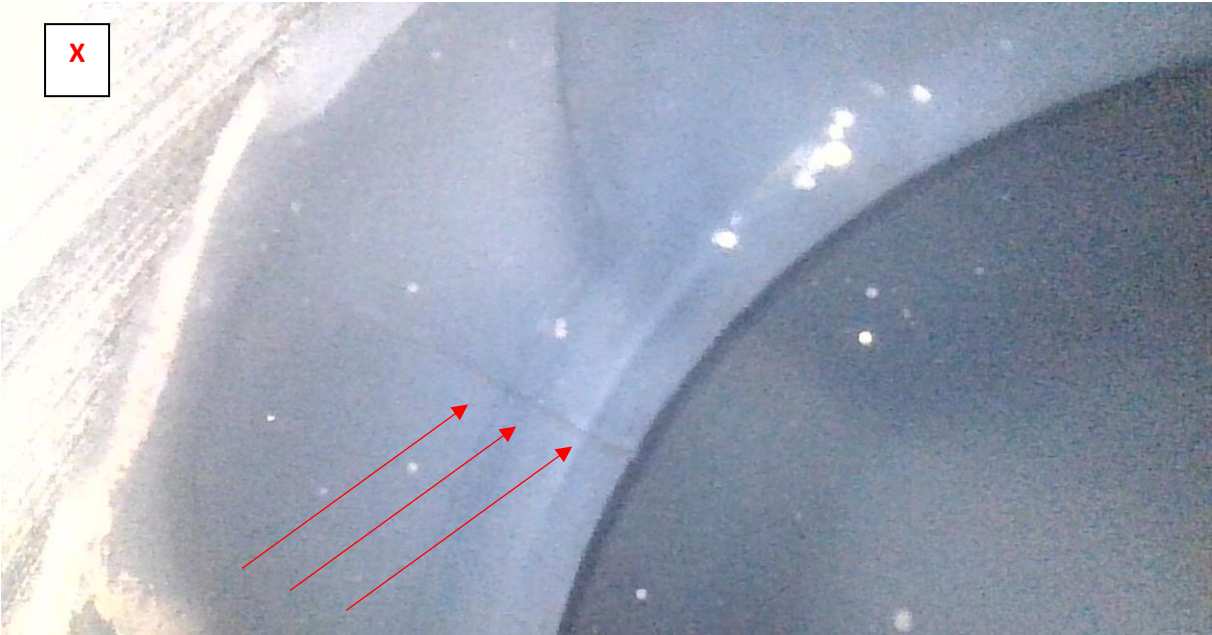
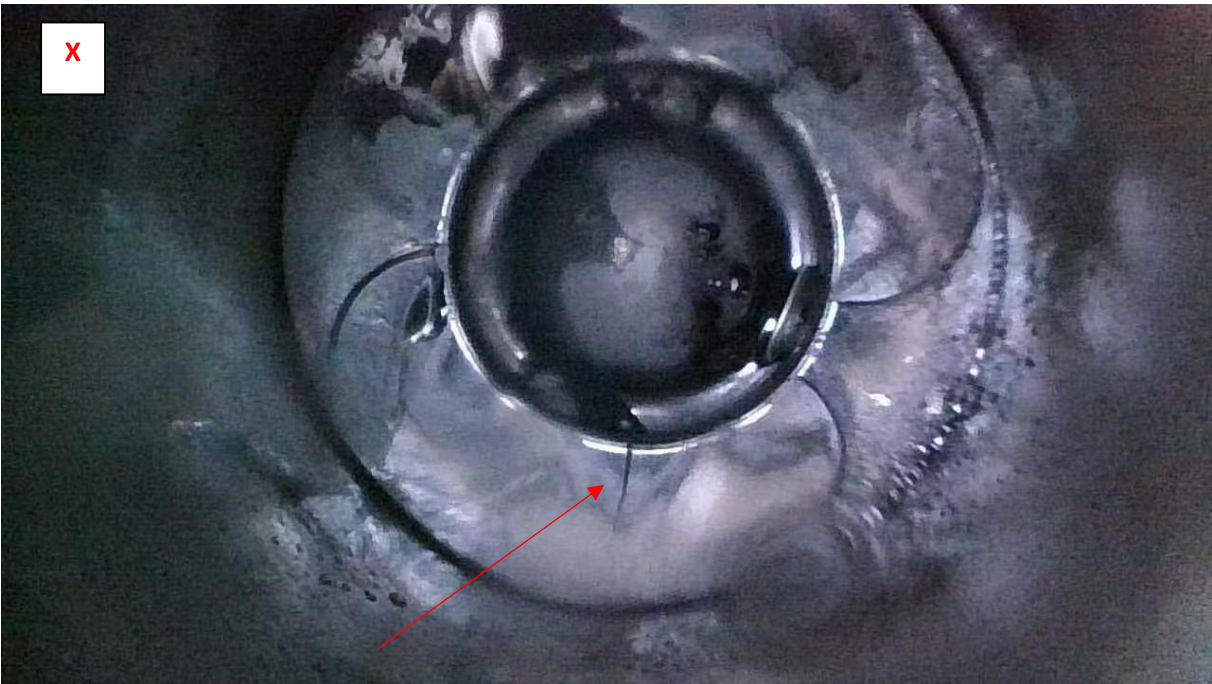
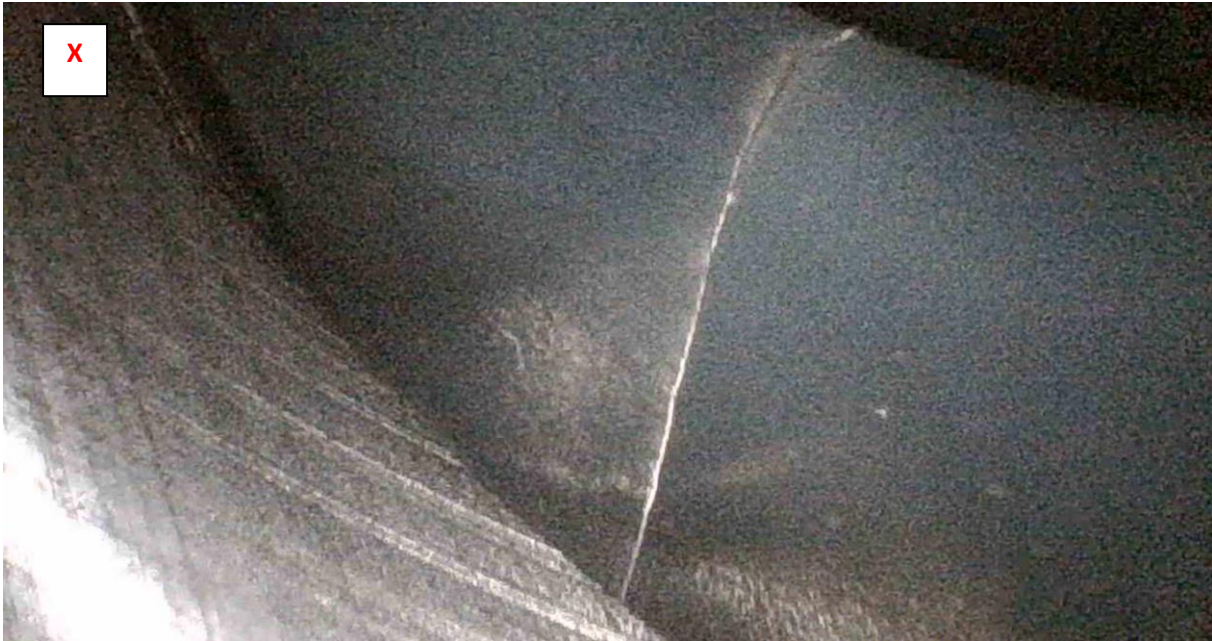
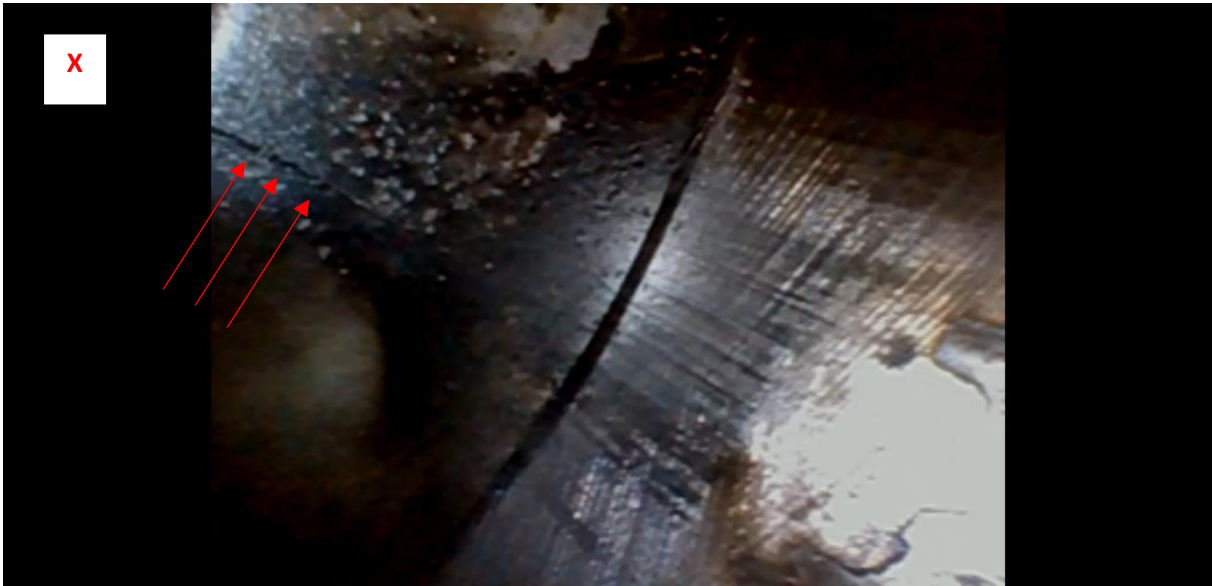
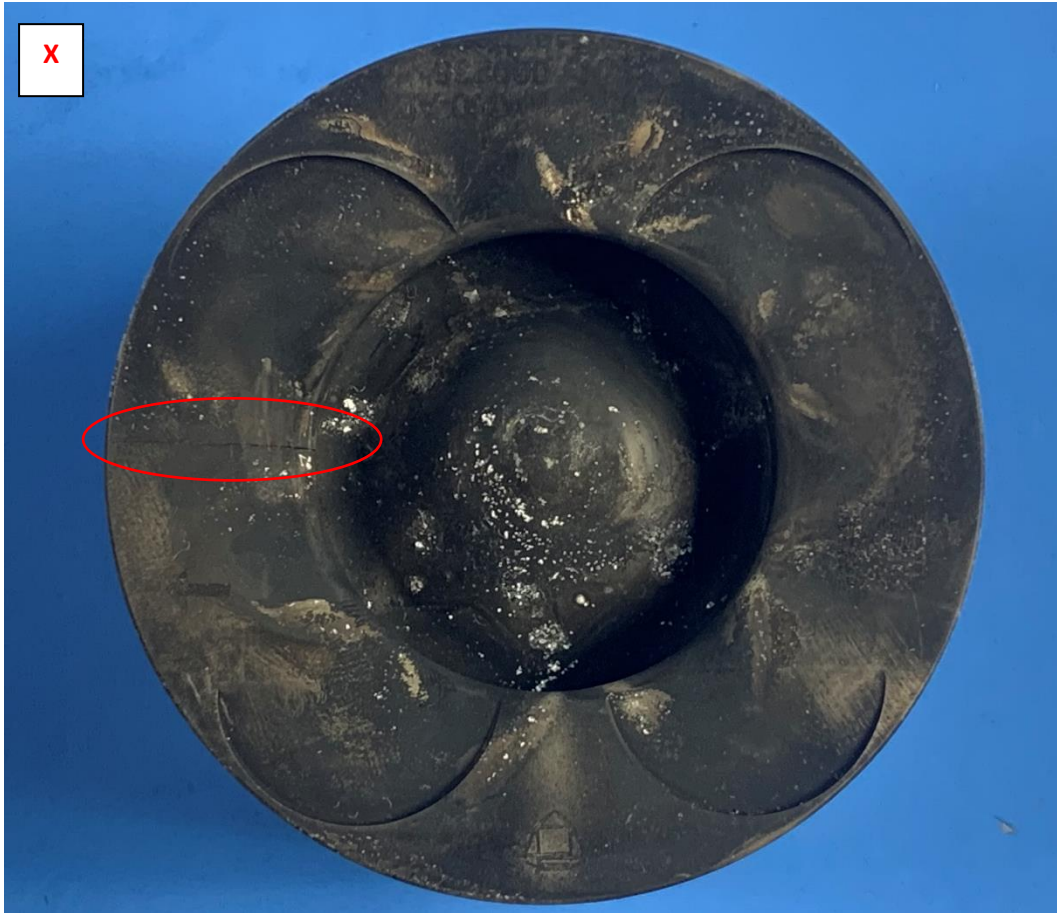
The following examples of borescope images shall assist in determining the condition of the pistons.
