[Docket No. FAA–2025–0011; Project Identifier AD–2024–00618–R; Amendment 39–23053; AD 2025–11–07]

Airworthiness Directives; Robinson Helicopter Company Helicopters

SUMMARY: The FAA is superseding Airworthiness Directive (AD) 2024–19–11 for all Robinson Helicopter Company Model R44 and R44 II helicopters. AD 2024–19–11 required visually inspecting a certain flex plate assembly (flex plate) and certain clutch shaft forward yokes (yokes), including each flex plate bolt, and depending on the results, taking corrective actions. AD 2024–19–11 also required removing certain yokes from service within a specified threshold, or as an alternative, performing in-depth inspections. Since the FAA issued AD 2024–19–11, it has been determined that clarifications regarding the alternative inspections are necessary. This AD requires the actions of AD 2024–19–11 and clarifies that the alternative inspections are repetitive and adds a particular paint remover option to use when performing those alternative inspections. The FAA is issuing this AD to address the unsafe condition on these products.

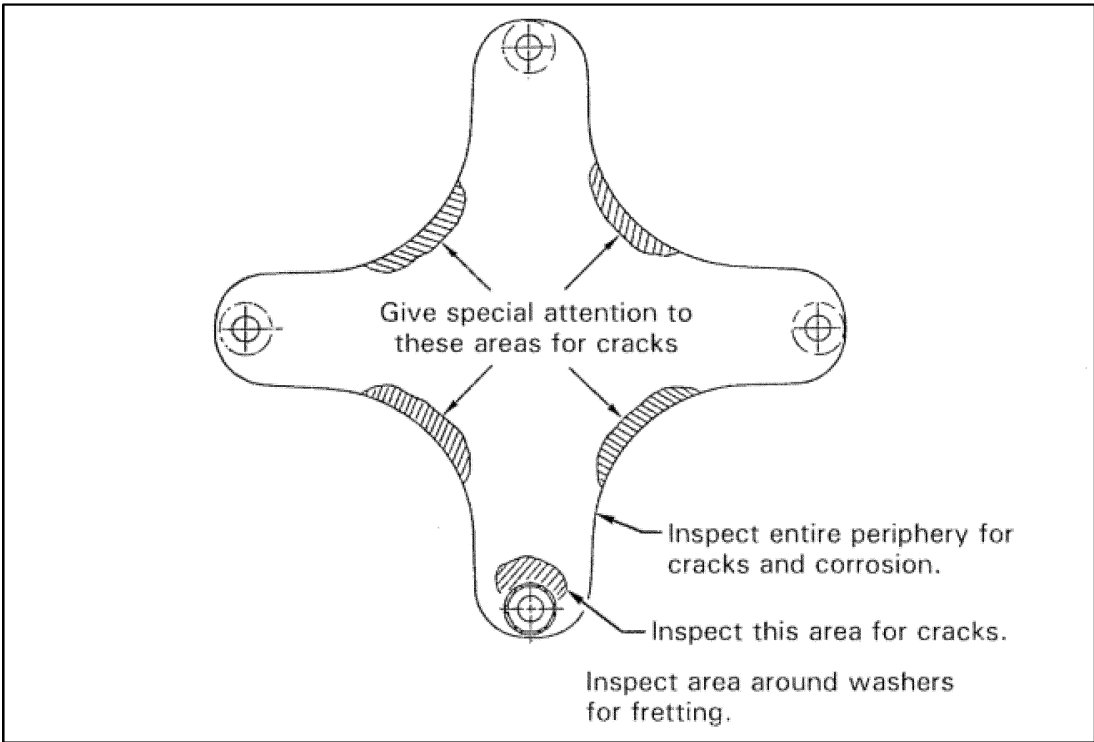
Figure 1 to Paragraph (g)(1)(i) - Flex Plate Inspection

This AD was prompted by reports of a fractured clutch shaft forward yoke (yoke) on the main rotor (M/R) drive due to fatigue cracking. The FAA is issuing this AD to detect fatigue cracking on the yoke. The unsafe condition, if not addressed, could result in loss of M/R drive and consequent loss of control of the helicopter.

(i) Visually inspect forward flex plate assembly part number (P/N) C947–1 (flex plate) for any loose fasteners, cracks, fretting, corrosion, wear, and to ensure that the washers are bonded to both sides of each flex plate arm, in the areas depicted in Figure 1 to paragraph (g)(1)(i) of this AD. If there is any loose fastener (can be moved by hand), crack, fretting, corrosion, or wear that consists of the washers not securely bonded to both sides of each flex plate arm, before further flight, remove the flex plate from service and replace it with an airworthy flex plate.
