[Docket No. FAA–2025–2546; Project Identifier AD–2025–01060–T]

#### Airworthiness Directives; The Boeing Company Airplanes

**ACTION:** Notice of proposed rulemaking (NPRM).

**The Boeing Company:** Docket No. FAA–2025–2546; Project Identifier AD–2025–01060–T.

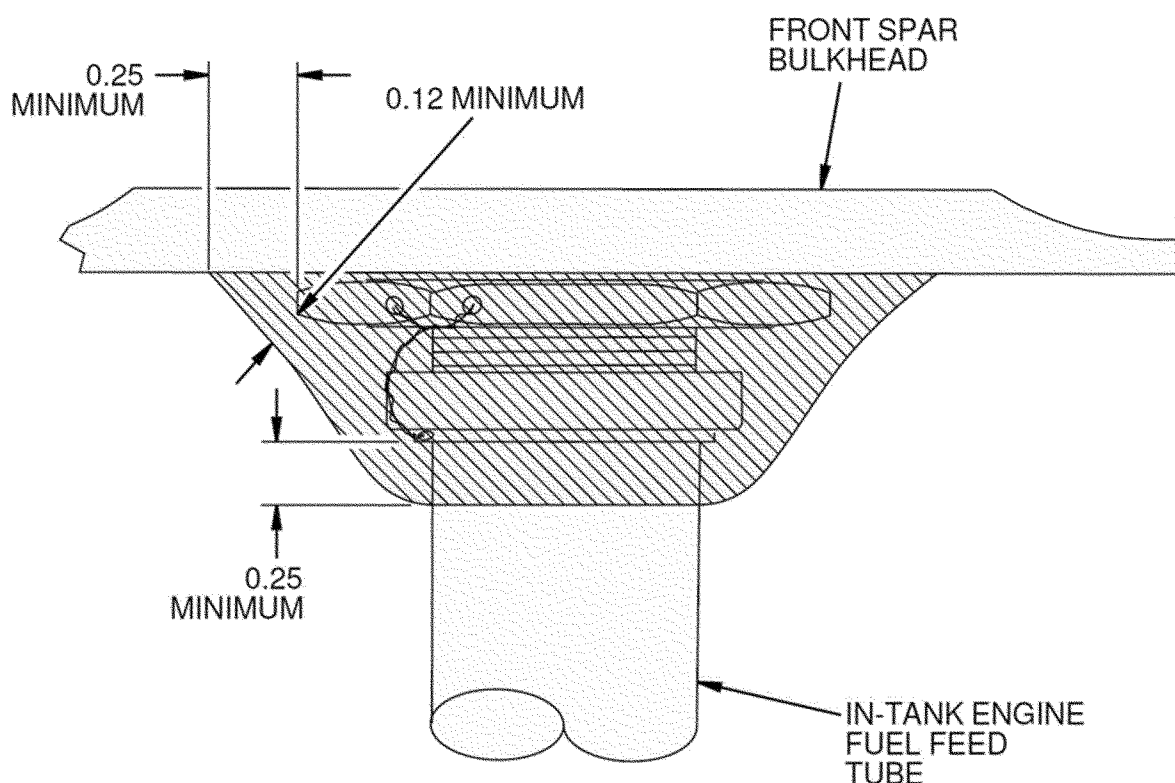
Figure 2 to Paragraph (i)—Fuel Feed Encapsulation

An additional non-electrical feature, an encapsulation seal over the side of the spar bulkhead fitting inside the fuel tank, provides additional protection from sparking at that location. The bulkhead fitting's encapsulation is designed to isolate any sparks or arcing generated at the bulkhead fitting during a lightning strike because of failed electrical bonds from flammable fuel vapors in the tank. This fitting, including the in-tank coupler connecting the fuel feed tube to the fitting, is the most probable location for sparking when electrical bonding is poor. Therefore, a failed encapsulation significantly increases the risk of a fuel tank explosion following a lightning strike to the engine nacelle on an airplane with poor electrical bonding. Analysis has shown that at least a subset of the encapsulation failures seen on Model 747 airplanes is expected on Model 777 airplanes.

The observed encapsulation failures are frequently associated with inadequate application of the encapsulation sealant. While failures are partly attributable to the design of the fitting and its associated coupler, sealant is frequently applied too thinly, does not cover the entire fitting and coupler, does not extend sufficiently onto the fuel feed tube, or the relevant surfaces are inadequately cleaned prior to application, preventing proper sealant adhesion.

The bulkhead fitting encapsulation is a unique sealant task. Most sealing tasks focus on fluid-tightness or other environmental protection between joined pieces of structure. The lightning protection function and complex shape of the bulkhead fitting encapsulation installation render it difficult to apply sealant properly using general sealing instructions. The manufacturer has communicated that it intends to publish an improved set of maintenance instructions in the Aircraft Maintenance Manual (AMM) to improve the consistency of encapsulation application. The sealant application instructions in the service information required by this proposed AD, as well as the revised Critical Design Configuration Control Limitation (CDCCL) specified in this proposed AD, are detailed and should be given special attention by maintenance personnel to ensure proper application of the bulkhead fitting encapsulation.

Finally, the FAA has determined that a new requirement in CDCCL airworthiness limitation (AWL) 28–AWL–05 is needed to address the unsafe condition. The encapsulating sealant surrounding the bulkhead fitting inside the fuel tank is a common CDCCL across many Boeing models. After reviewing the relevant Model 777 CDCCL, 28–AWL–05, it was discovered that the AWL lacks the requirement to reapply the encapsulation after disassembly of the fitting (which necessitates removal of the encapsulation). Failure to reapply the sealant after removal would result in the unsafe condition addressed by this proposed AD. The FAA is proposing an amendment to CDCCL 28–AWL–05 to address this deficiency. Additionally, the CDCCL was also discovered to not properly account for a difference in in-tank bonding jumper configurations beginning at airplane line number 830 and on. The revised CDCCL now accounts for both jumper configurations. Normally, the FAA would require the incorporation of the information contained in a revision of the relevant airworthiness limitations document from the manufacturer into the airplane maintenance or inspection program to address this requirement. However, such a document is not anticipated to be available in time to support this proposed AD.

Within 60 days after the effective date of this AD, revise the existing maintenance or

inspection program, as applicable, to incorporate the information specified in Figure 1 and Figure 2 to paragraph (i) of this AD.
