**DEPARTMENT OF TRANSPORTATION****Federal Aviation Administration****14 CFR Part 39**

**[Docket No. FAA–2021–0872; Project Identifier MCAI–2021–00312–R]**

**Airworthiness Directives; Airbus Helicopters**

**ACTION:** Notice of proposed rulemaking (NPRM).

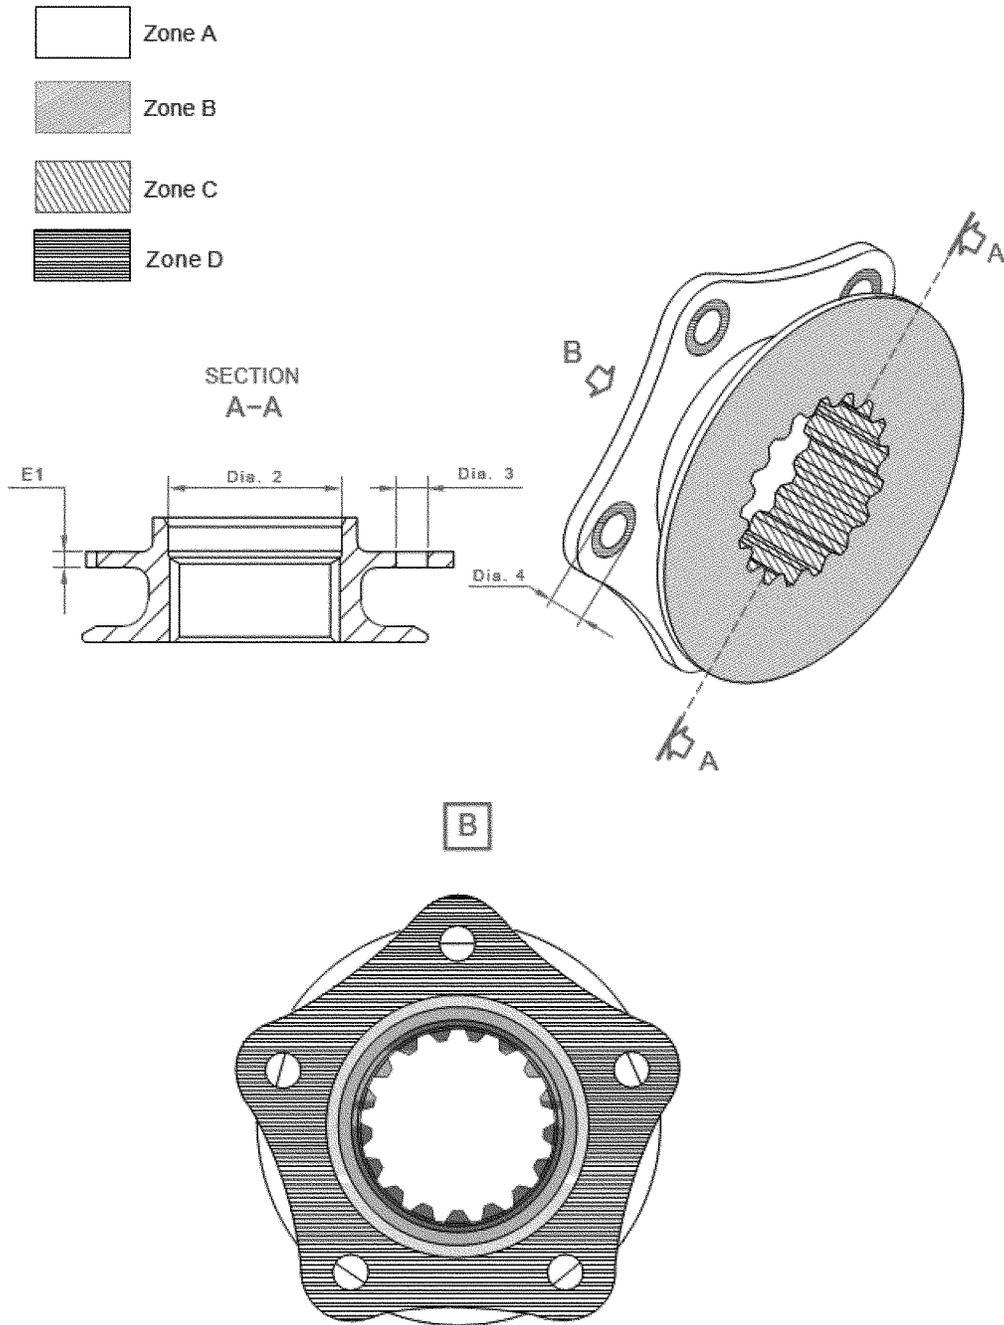
**Figure 2 to paragraph (g)(1)(ii) – Inspection Areas of Tail Rotor Splined Flange**

(ii) Inspect the TR splined flange for corrosion, impacts, fretting, wear, and a crack in the areas identified in Figure 2 of this AD. If the condition of the part (including corrosion, impacts, fretting, wear, or cracks) exceeds the criteria as specified in Figure 1 of this AD, before further flight, remove the splined flange from service and replace with an airworthy part.

<b>Location as specified in figure 2 to paragraph (g)(1)(ii) of this AD</b>	<b>Maximum damage, which causes replacement (E1, Dia. 2, Dia. 3, and Dia. 4 are shown in figure 2 to paragraph (g)(1)(ii) of this AD)</b>
Zone A	Scratch depth > 0.2 mm (0.008 in.). Crack. E1 < 2.75 mm (0.108 in.). Dia. 3 > 6.02 mm (0.2371 in.). Dia. 2 > 33.03 mm (1.3004 in.).
Zone B	Touch-up depth > 0.1 mm (0.004 in.). Crack.
Zone C	Crack. Scratch depth > 0.2 mm (0.008 in.).
Zone D [Dia. 4 = 14 mm +/- 0.1 mm (0.548; 0.555in.)]	Touch-up depth > 0.1 mm (0.004 in.). Crack. E1 < 2.75 mm (0.108 in.).
