[Docket No. FAA-2023-1993; Project Identifier AD-2023-00129-T]

## Airworthiness Directives; The Boeing Company Airplanes

**ACTION:** Notice of proposed rulemaking (NPRM).

**The Boeing Company:** Docket No. FAA–2023–1993; Project Identifier AD–2023–00129–T.

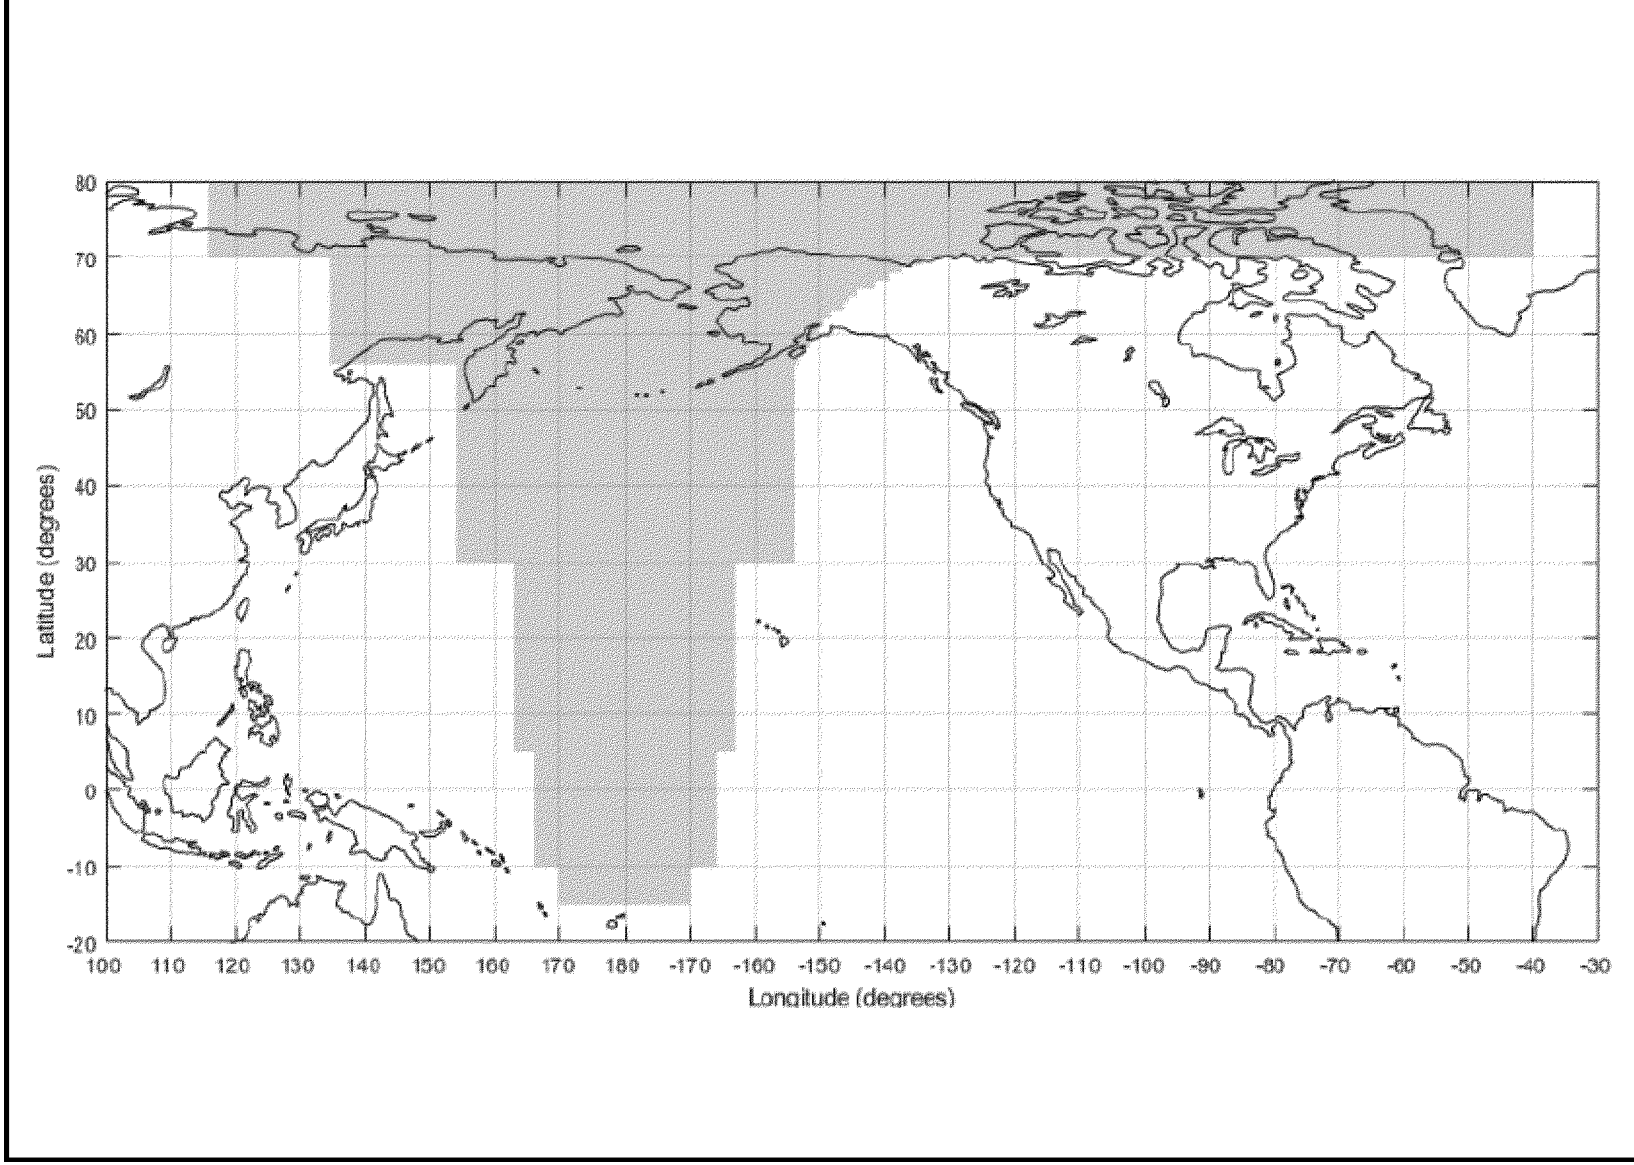
Figure 2 to Paragraph (g)—AFM—  
Limitations or Certificate Limitations  
Continued

Operations that require less than 0.3 RNP (For example, 0.1, 0.11, 0.15, etc.) in the region identified below are prohibited with GLU-2100 OPS software number COL4D-0087-0002, COL4E-0087-0001, COL48-0087-0700, or COL49-0087-0701 installed.

Exception: Anchorage (PANC) approach procedures that allow less than RNP 0.3 are authorized provided the instructions outlined in the Electronics – Global Landing Unit Section of Normal Procedures Chapter are followed.

Note: Currently, Fairbanks (PAFA) and Anchorage (PANC) are the only airports in the region with an RNP approach that requires better than 0.3 nmi performance.

Region bounded by the following coordinates:
