[Docket No. **FAA–2025–0922**; Project Identifier **MCAI–2024–00650–R**]

Airworthiness Directives; Airbus Helicopters

ACTION: Notice of proposed rulemaking (NPRM).

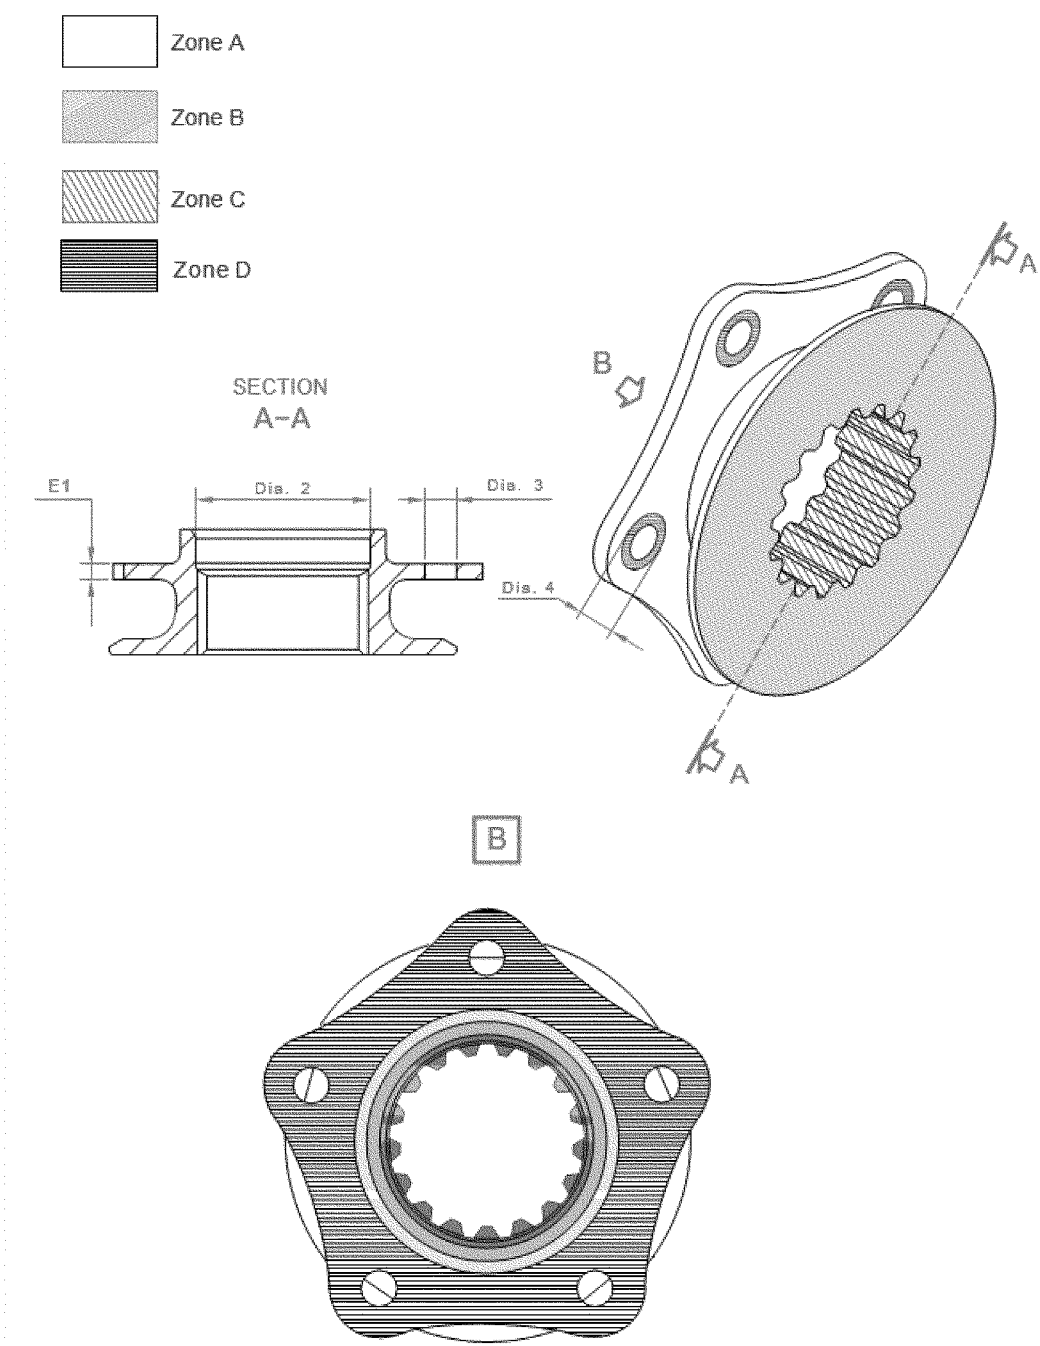
Figure 2 to Paragraph (g)(1)(ii)—Inspection Areas of Tail Rotor Splined Flange

(ii) Inspect the TR splined flange for corrosion, impacts, fretting, wear, and a crack in the areas identified in Figure 2 to paragraph (g)(1)(ii) of this AD. If the condition of the part (including corrosion, impacts, fretting, wear, or cracks) exceeds the criteria as specified in Figure 1 to paragraph (g)(1)(ii) of this AD, before further flight, remove the splined flange from service and replace with an airworthy part.

Location as specified in Figure 2 to paragraph (g)(1)(ii) of this AD	Maximum damage, which causes replacement (E1, Dia. 2, Dia. 3, and Dia. 4 are shown in Figure 2 to paragraph (g)(1)(ii) of this AD)
Zone A	Scratch depth >0.2 mm (0.008 in.). Crack. E1 <2.75 mm (0.108 in.). Dia. 3 >6.02 mm (0.2371 in.). Dia. 2 >33.03 mm (1.3004 in.).

Location as specified in Figure 2 to paragraph (g)(1)(ii) of this AD	Maximum damage, which causes replacement (E1, Dia. 2, Dia. 3, and Dia. 4 are shown in Figure 2 to paragraph (g)(1)(ii) of this AD)
Zone B	Touch-up depth >0.1 mm (0.004 in.). Crack.
Zone C	Crack. Scratch depth >0.2 mm (0.008 in.).
Zone D [Dia. 4 = 14 mm ±0.1 mm (0.548; 0.555in.)]	Touch-up depth >0.1 mm (0.004 in.). Crack. E1 <2.75 mm (0.108 in.).

(i) Remove the TR hub body and each bolt, washer, and nut installed on the TR hub body from service and replace with airworthy parts.
