# **Applying Ergonomics to Bathing Safety: Including adoption of unorthodox practices for slip-resistant underfoot surfaces of bathtubs plus showers and provision of effective points of control**

Jake L. Pauls<sup>1</sup> and Daniel A. Johnson<sup>2</sup>

**Abstract.** Of four key factors in bathing safety, related to fall prevention and mitigation, slip resistance is relatively easily addressed. However, in the field of underfoot slip resistance, water is not typically considered as a “friend.” Surprisingly, when applied to an underfoot terry cloth towel, water dramatically improves slip resistance in otherwise slippery dedicated showers and in bathtubs used for standup showers. This is now empirically established but, as it defies convention and occurs in a relative research vacuum, there is reticence about adopting the practice of simply having a wet—*or even better*—damp towel underfoot while entering, using and exiting a shower facility. This paper presents what is known and what remains to be learned about the extent to which—*plus why*—water and terry cloth are a potent slip-resistance combination that, qualitatively, solves one-quarter of the shower safety problem with co

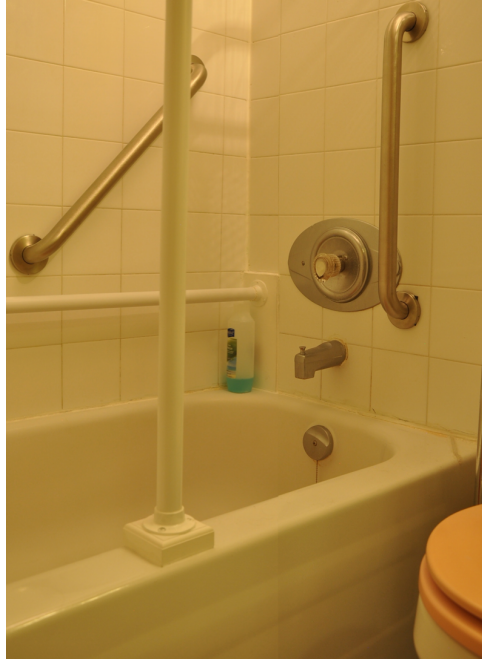
**Fig. 1.** Two options, one with stanchions (informally referred to as “poles,” usually straight lengths of graspable tubing) and the other employing conventional grab bars providing two points of control.

See Fig. 1 for a two-option, demonstration installation in a traditional, small (2.1-meter by 1.5-meter) bathroom with bathtub-shower combination, a toilet and a lavatory (off the right side of the photo).

Unlike the conventional grab bars, wall-to-wall horizontal and tub-to-ceiling vertical stanchions do not require screws into the structure behind the ceiling, tiled walls or tub wall. They are not cantilevered out from walls but are held *between* wall, ceiling and other surfaces including, as in Fig. 1, the bathtub rim. Stanchions are typically seen on buses and trains, especially those used for commuting, and are typically within easy reach of most passengers, whether seated, standing or moving from one position to the other. The innovation here is to use stanchions in bathrooms.

In a typical small bathroom, the stanchion (the vertical one, with its bottom fixing on the bathtub rim, in Fig. 1) serves toilet plus shower and immersion bathing users. Either of options would meet the new NFPA requirements for locations of grab bar for new bathtub-shower combinations.

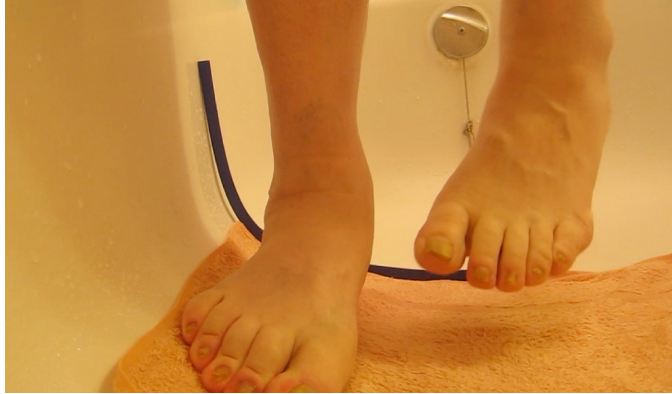
**Fig. 4.** Foot carrying all of bather's weight on the curved portion of the bathtub, where the slope ranges from 5 to 45 degrees with a damp terry cloth towel interface. Note that the towel has only shifted less than a centimeter.

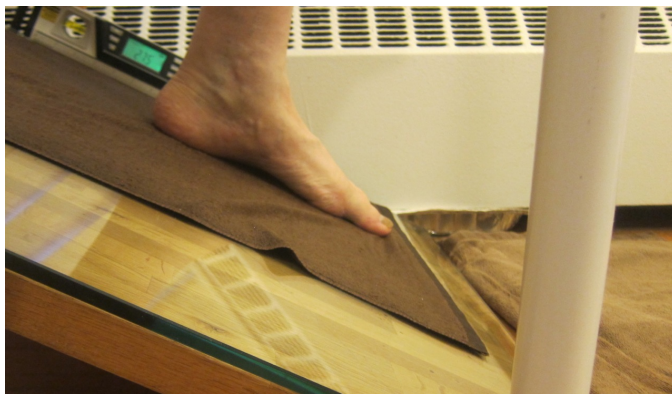
**Fig. 5.** 27.5-degree (tan 0.52) slope glass ramp surface with damp terry cloth towel showing slow creep just beginning.

**Testing with Variably-inclined Surfaces.** Subsequent, systematic testing of wet towels on a polished glass ramp surface of variable inclination confirmed that the wet towel, underfoot, is stable to nearly a 30-degree inclination. (See Fig. 5) At such high slopes the towel moves slowly, in a creep fashion (at about one cm per second), not precipitously. Note, unlike in the European Ramp Test (discussed by Di Pilla, 2003), subjects here do not walk on the sloping surfaces; they stand in place. Effective SR up to about 0.5 can be tested with the adjustable slope available to the lead author.
