**SERVICE BULLETIN 10015804-35-01  
REVISION NO. 03 DATED JUN 07/2021**

<b>SUBJECT: OXYGEN – CYLINDER – POSSIBLE MISSING COMPONENT ON OXYGEN CYLINDER VALVE ASSEMBLY</b>
--

# SERVICE BULLETIN

**SUBJECT: OXYGEN – CYLINDER – POSSIBLE MISSING COMPONENT ON OXYGEN  
CYLINDER VALVE ASSEMBLY**

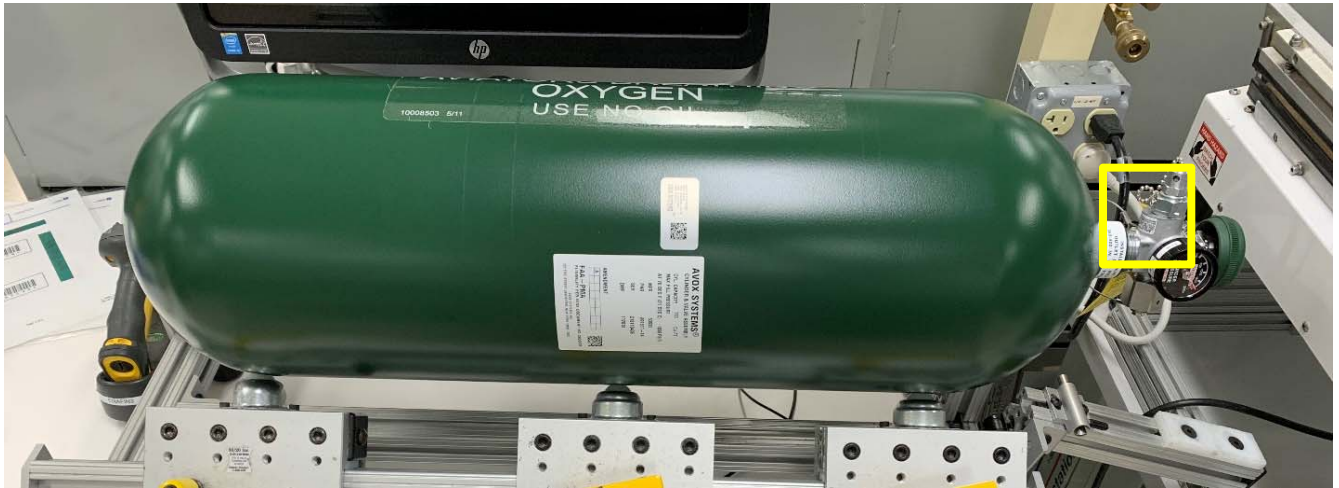
FIGURE 1  
OVERVIEW OF CYLINDER AND VALVE ASSEMBLY

- (a) Check if unit is marked with a blue paint dot. If the unit is marked with a blue paint dot, the unit has already been inspected per this SB. (Refer to Figure 7 for blue paint dot location.)
  - (b) If the unit is not marked with a blue paint dot, or, if a doubt exists that the inspection was performed on the unit, proceed with step (2).
- (2) Gain access to the cylinder & valve assembly.  
Figures 1 through 6 show the inspection location on the cylinder & valve assembly

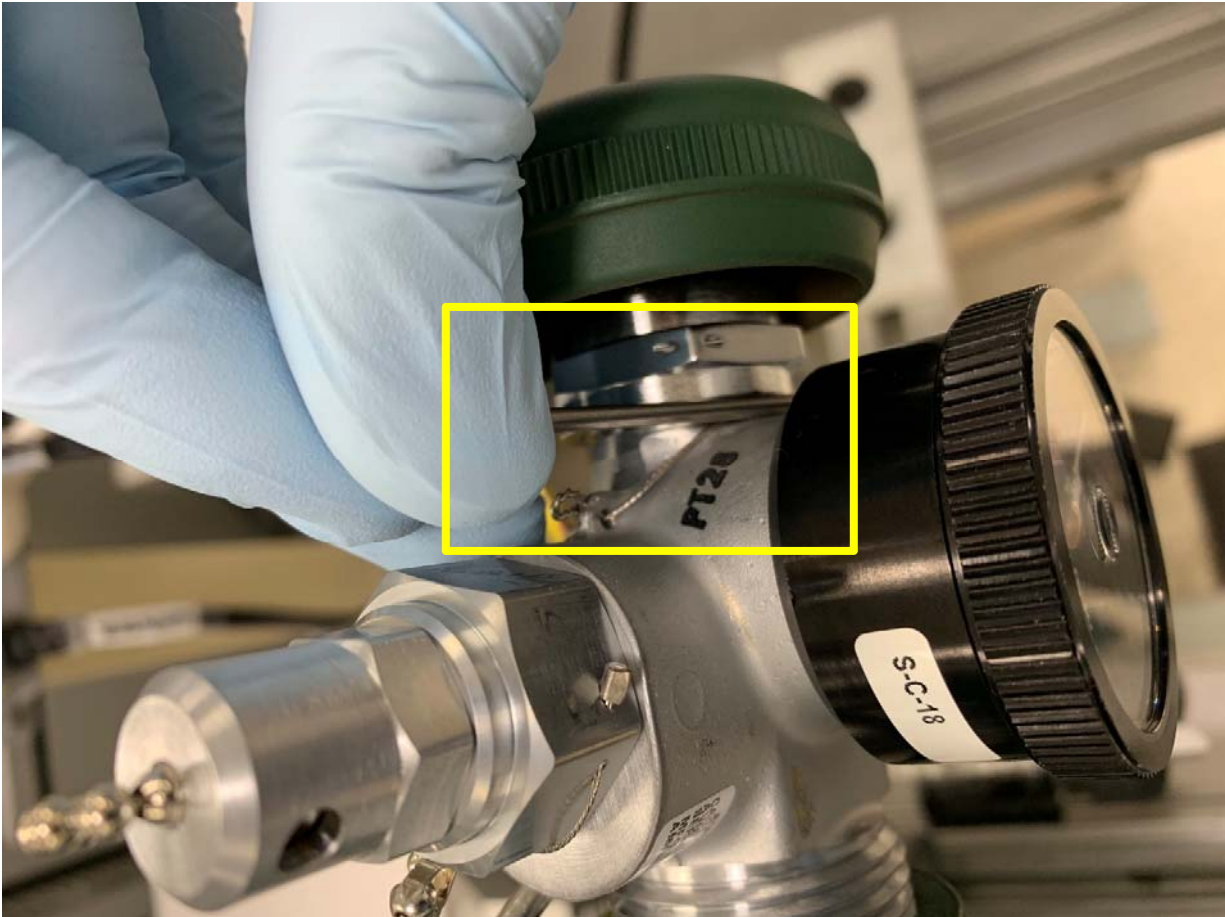
FIGURE 4  
CLOSE-UP OF INSPECTION PROCEDURE LOCATION ON VALVE ASSEMBLY

- (3) Perform the following inspection procedure on the cylinder and valve assembly.
- (a) Use a pin gauge, 0.079" or 2mm Ø, to determine if the cylinder and valve assembly meets the criteria for an acceptable unit.
- NOTE: The inspection criteria is applicable for all valve assembly configurations
- NOTE: It may be necessary to move safety cable to facilitate inspection
- (b) Slide the pin gauge between the bottom of the packing retainer and the top of the valve body above where the pressure gauge is mounted.
- NOTE: Failure to perform the inspection in exactly the location depicted may result in rejection of conforming product.
- (c) Perform visual inspection comparing the "Acceptable" or "Unacceptable" of the pin gauge.
- (Refer to Figure 5 for identification of acceptable cylinder and valve assembly)  
(Refer to Figure 6 for identification of unacceptable cylinder and valve assembly)

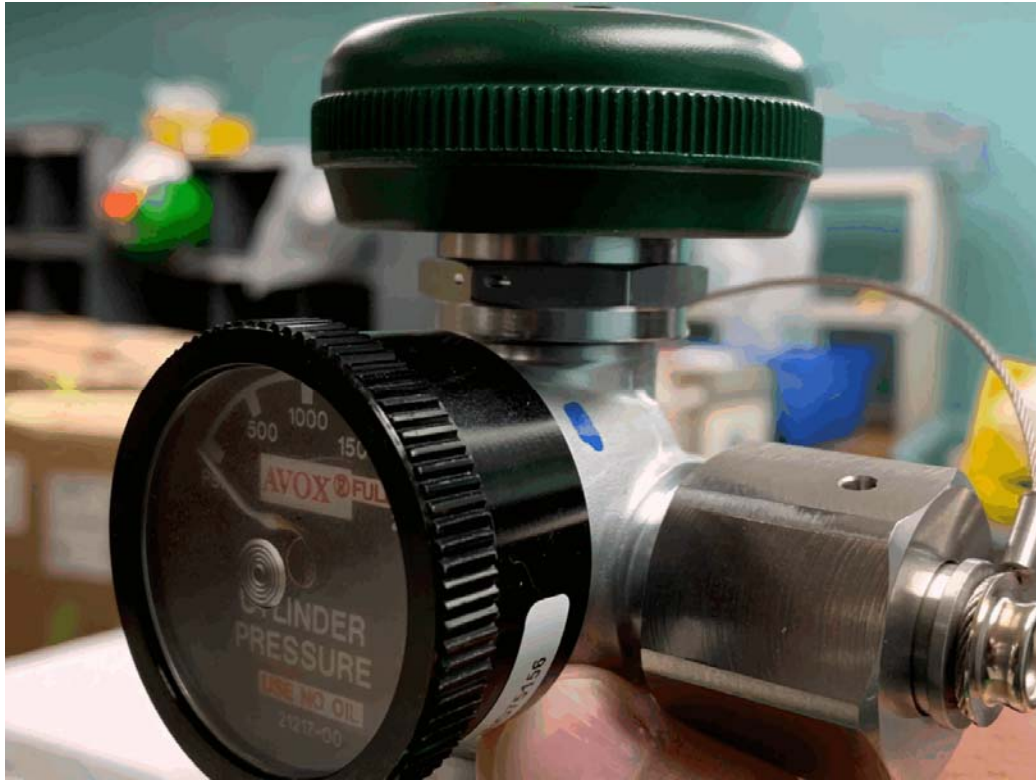
FIGURE 7  
MARK ACCEPTABLE CVA WITH A BLUE PAINT DOT

If the cylinder & valve assembly passes the inspection, it should be identified by a blue paint dot on the valve assembly to show the SB has been accomplished. (Refer to Figure 7)

- (4) If cylinder and valve assembly is identified as “Acceptable”, the cylinder and valve assembly may remain or can be used in service.
- D. Re-identification of equipment
- (1) Physically identify the acceptable cylinders after inspection by using an oil-based, blue paint permanent marker of local supply, to mark the valve with a blue paint dot as shown in Figure 7.

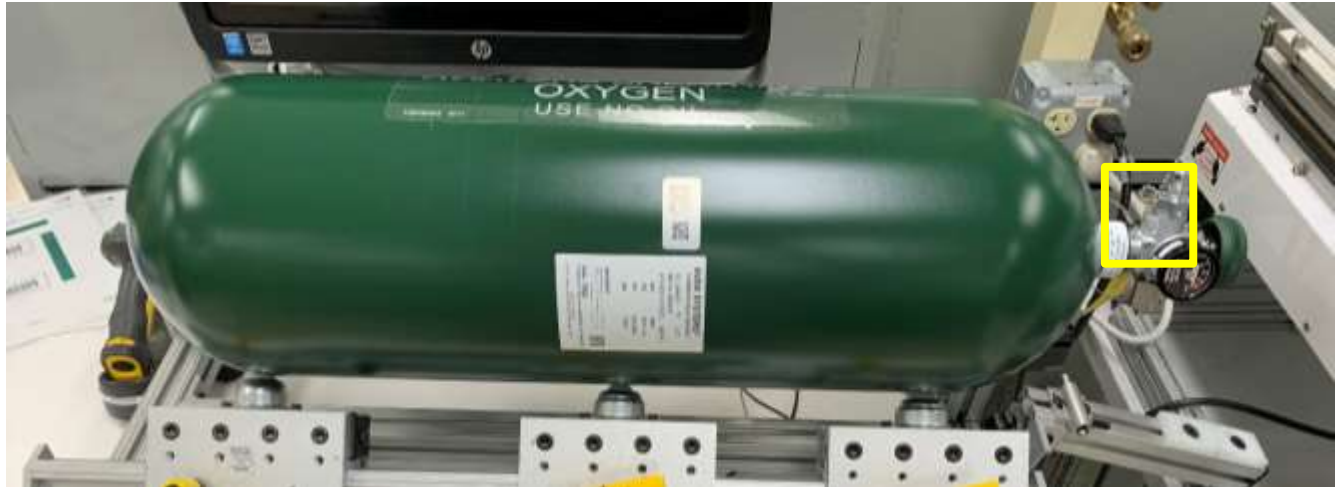
FIGURE 1  
OVERVIEW OF CYLINDER AND VALVE ASSEMBLY

- (2) Gain access to the cylinder & valve assembly.  
Figures 1 through 6 show the inspection location on the cylinder & valve assembly

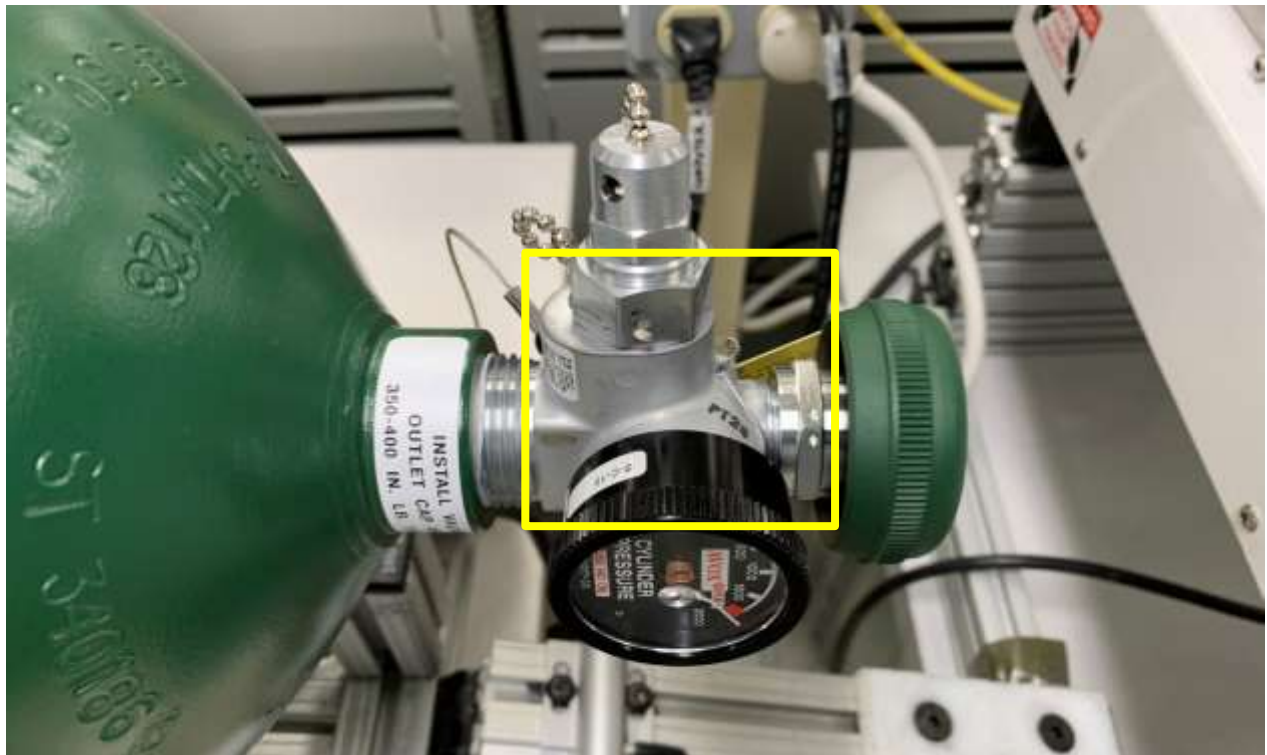
FIGURE 2  
CLOSE-UP OF VALVE ASSEMBLY

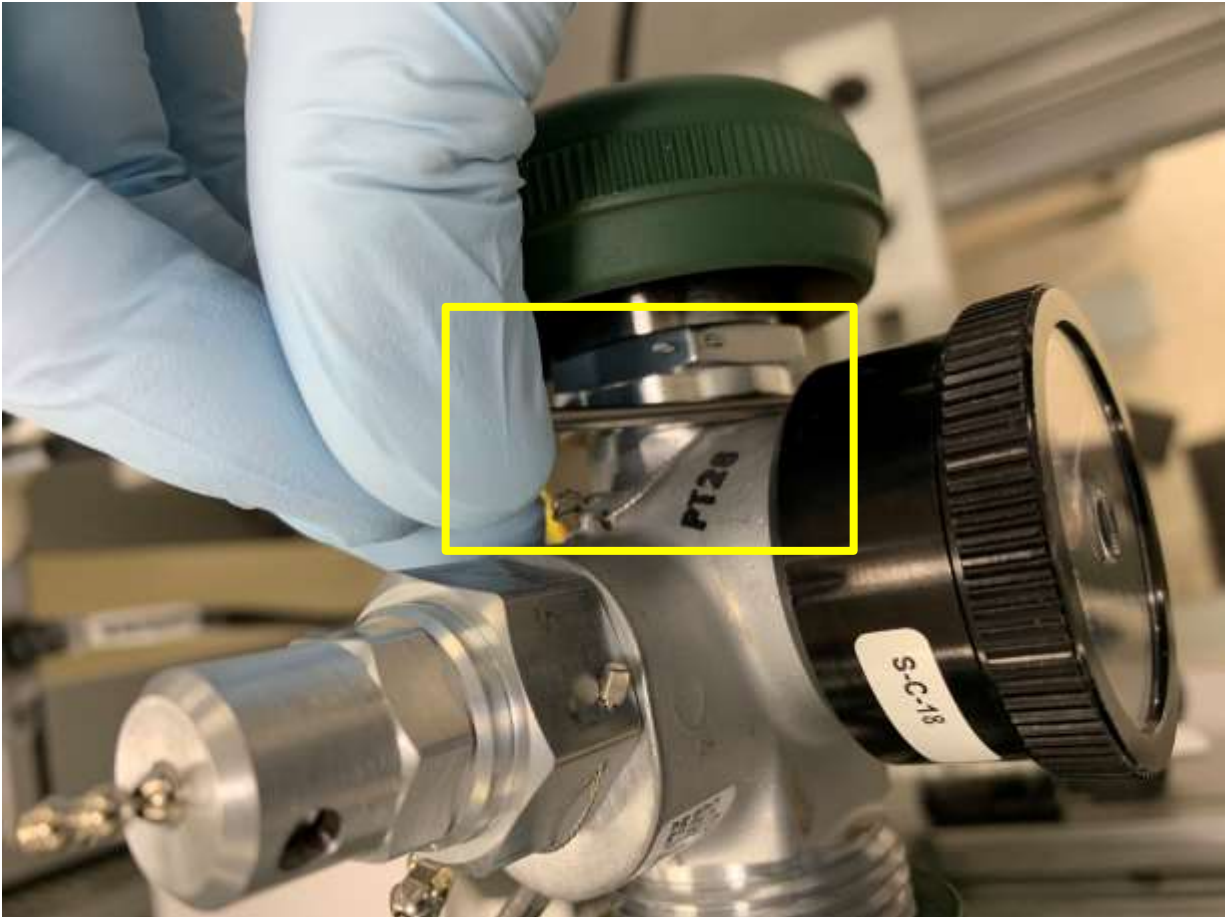
FIGURE 4  
CLOSE-UP OF INSPECTION PROCEDURE LOCATION ON VALVE ASSEMBLY

- (b) Slide the pin gauge between the bottom of the packing retainer and the top of the valve body above where the pressure gauge is mounted.
    - NOTE: Failure to perform the inspection in exactly the location depicted may result in rejection of conforming product.

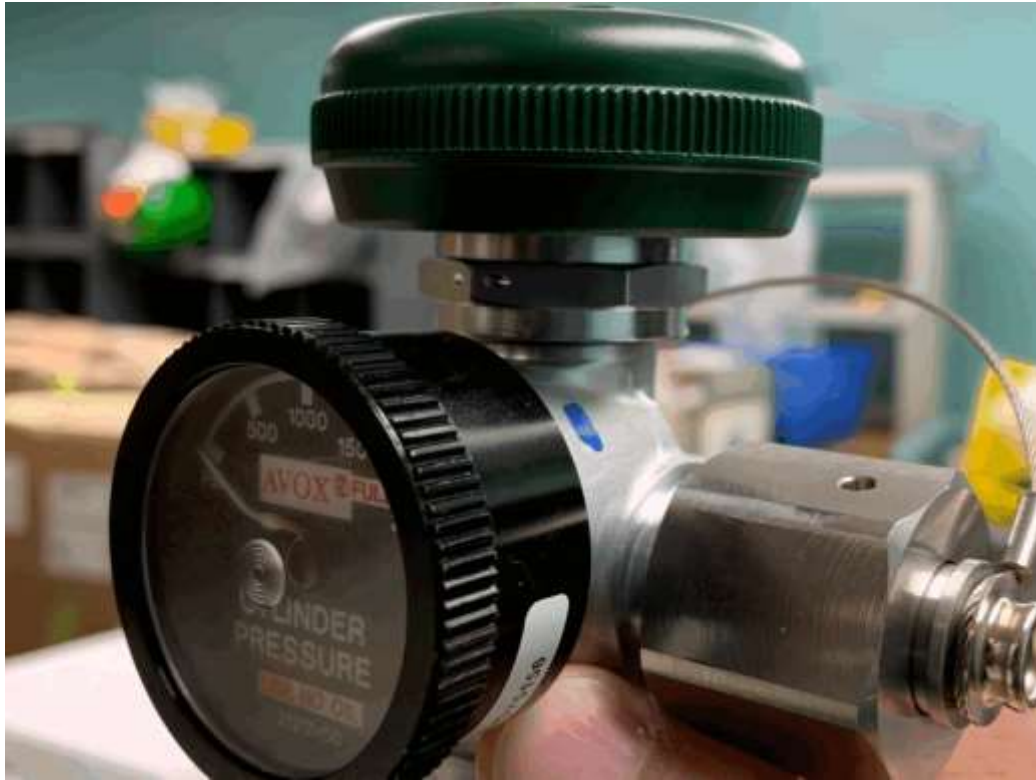
FIGURE 7  
MARK ACCEPTABLE CVA WITH A BLUE PAINT DOT
