14 CFR Part 39

[Docket No. FAA–2021–0189; Project Identifier AD–2020–00645–R; Amendment 39–21875; AD 2021–26–16]

Airworthiness Directives; Various Restricted Category Helicopters

2021–26–16 Various Restricted Category Helicopters: Amendment 39–21875; Docket No. FAA–2021–0189; Project Identifier AD–2020–00645–R.

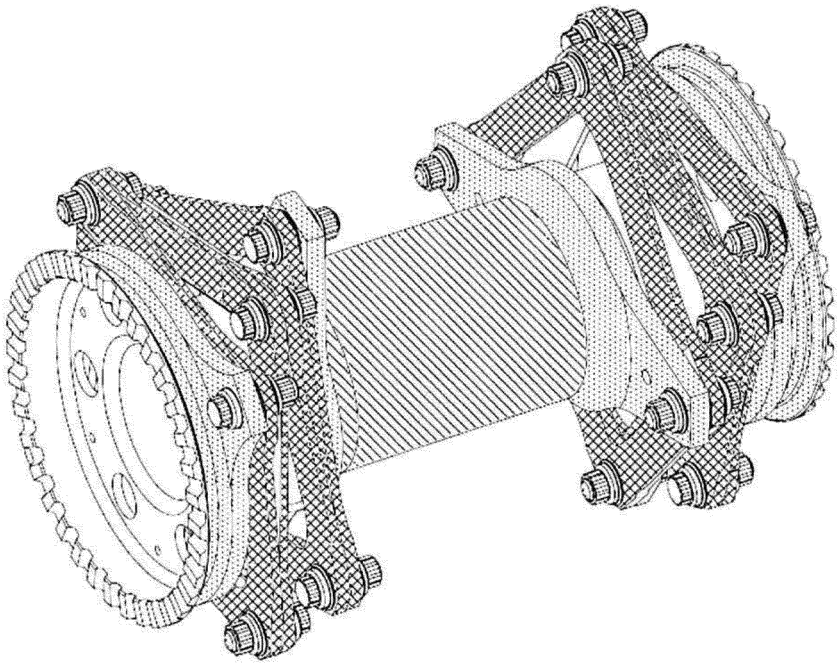
Figure 3 to Paragraph (g)(3)(iv) – Damage Limits

(iv) Inspect the main driveshaft for mechanical damage, corrosion, an edge dent, and nick as shown in Figure 3 to paragraph (g)(3)(iv) of this AD. For the purposes of this inspection, mechanical damage may be indicated by a crack, scratch, or wear; and corrosion may be indicated by corrosion or pitting. If there is a scratch, wear, corrosion, pitting, an edge dent, or a nick within allowable limits, before further flight, repair the main driveshaft in accordance with FAA-approved procedures. If there is a crack, or a scratch, wear, corrosion, pitting, an edge dent, or a nick that exceeds allowable limits,

Type of Damage	Maximum Damage and Repair Depth			
MECHANICAL	0.001" before and after repair	0.005" before and after repair	0.005" before and after repair	0.015" before and after repair
CORROSION	Surface, no pits	0.005" before and after repair	0.005" before and after repair	0.010" before and after repair
MAXIMUM AREA PER FULL DEPTH REPAIR	0.05 in^2	0.10 in^2	0.25 in^2	0.25 in^2
NUMBER OF REPAIRS	One per leg			
EDGE DENTS, NICKS	0.001 in	0.010 in	0.010 in	0.025 in

before further flight, replace the main driveshaft. The main drive shaft may be overhauled in accordance with FAA-approved procedures to accomplish the replacement required by this paragraph.
