**Number:** 777-57A0118 RB  
Original Issue: June 23, 2020  
ATA System: 5725

**SUBJECT:** WINGS - Wing Lower Skin - Fuel Tank / Dry Bay Access Door Cutouts - Inspection and Repair.

## Requirements Bulletin

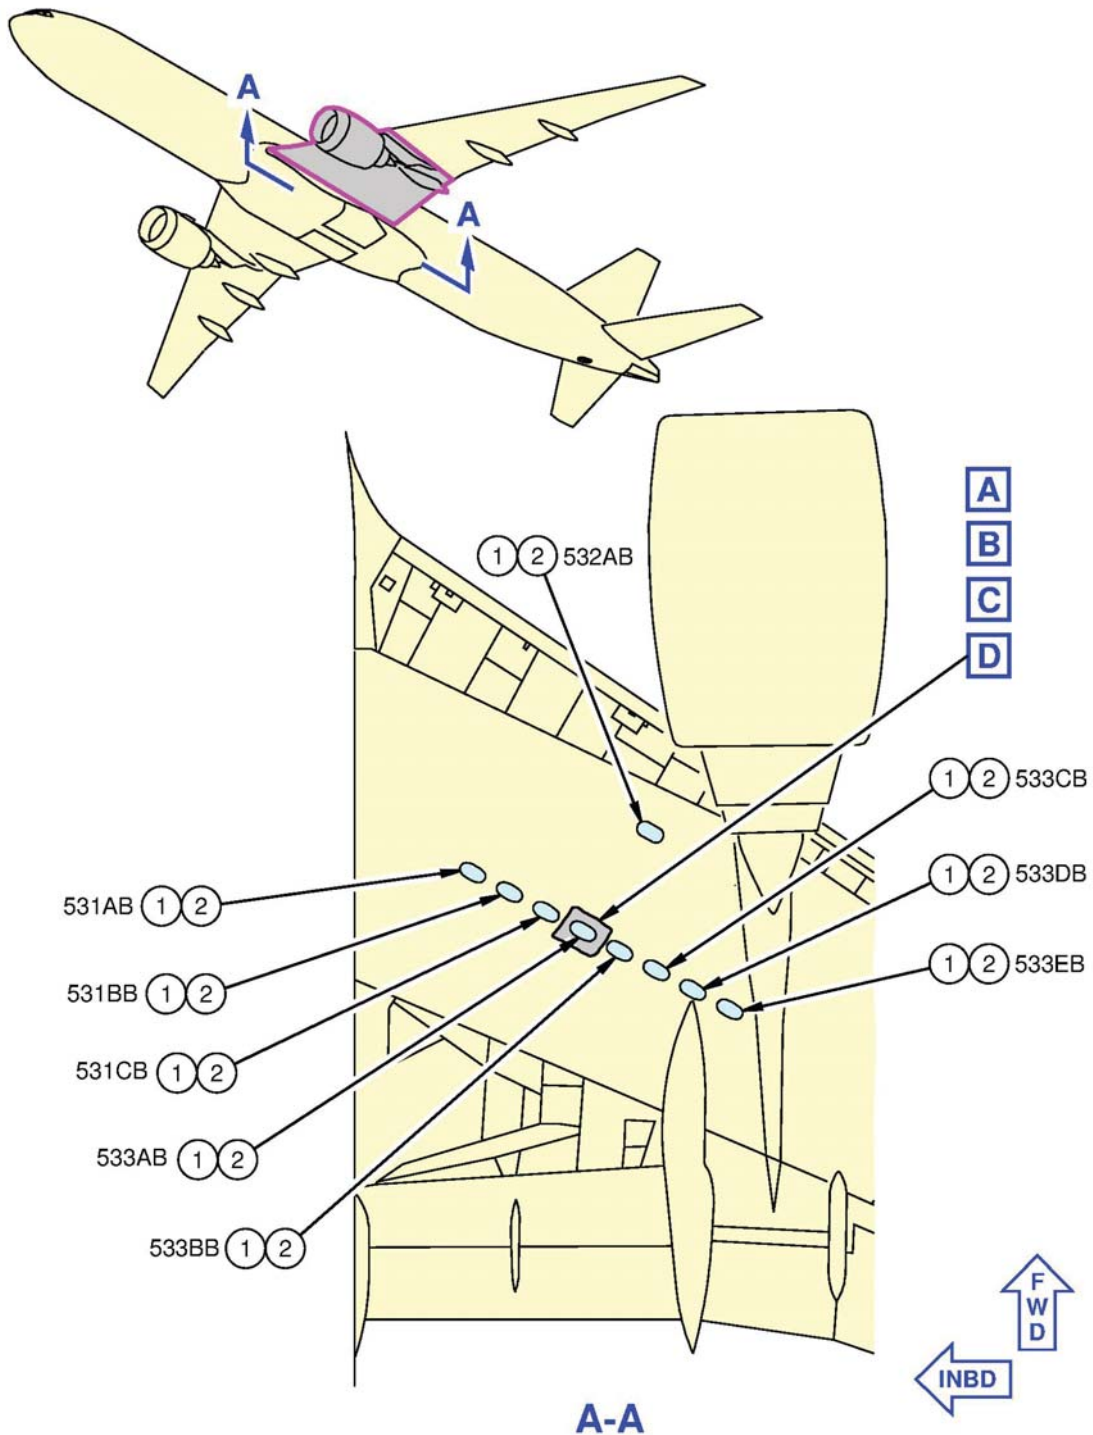
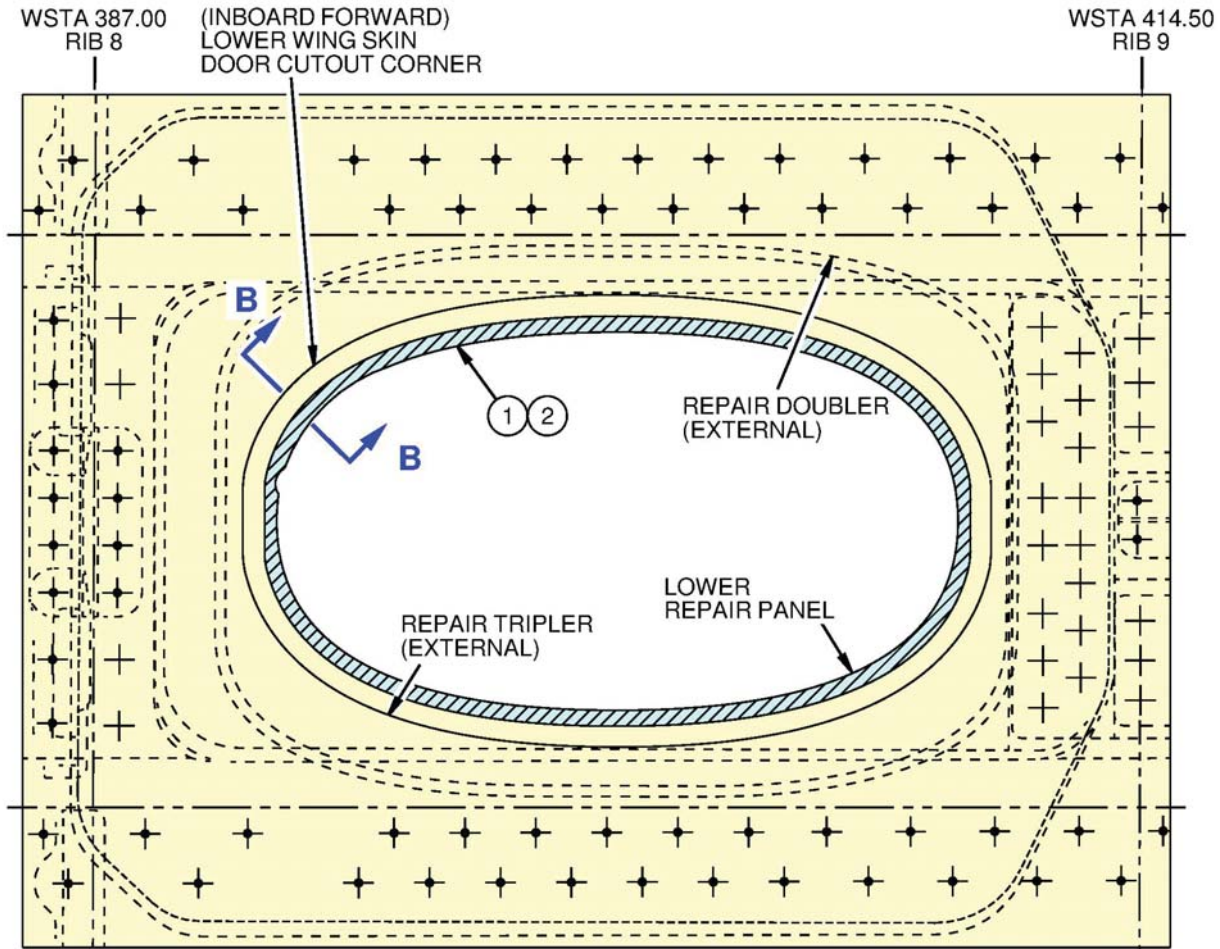
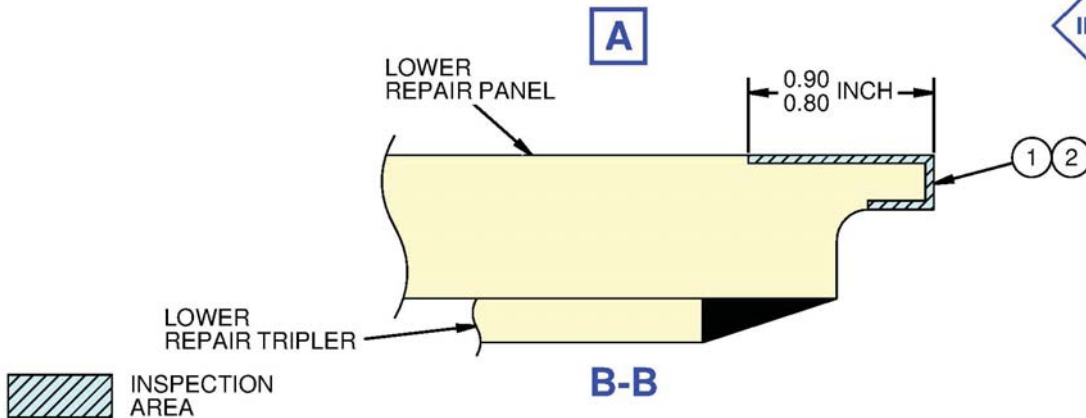
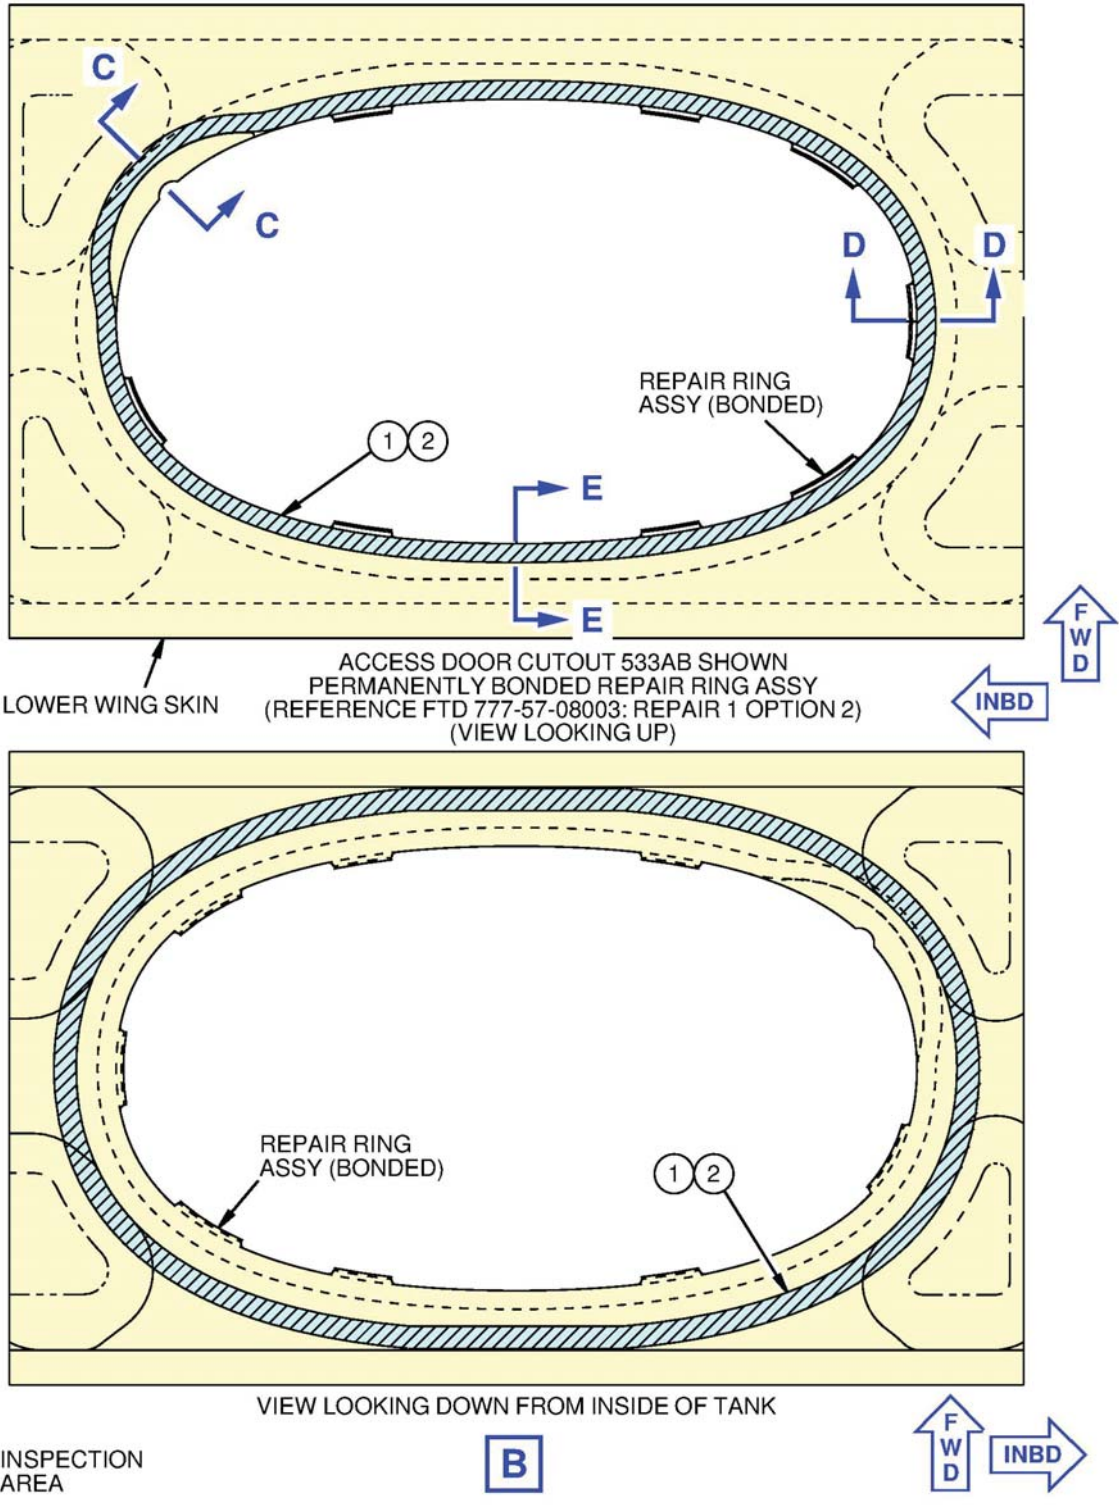
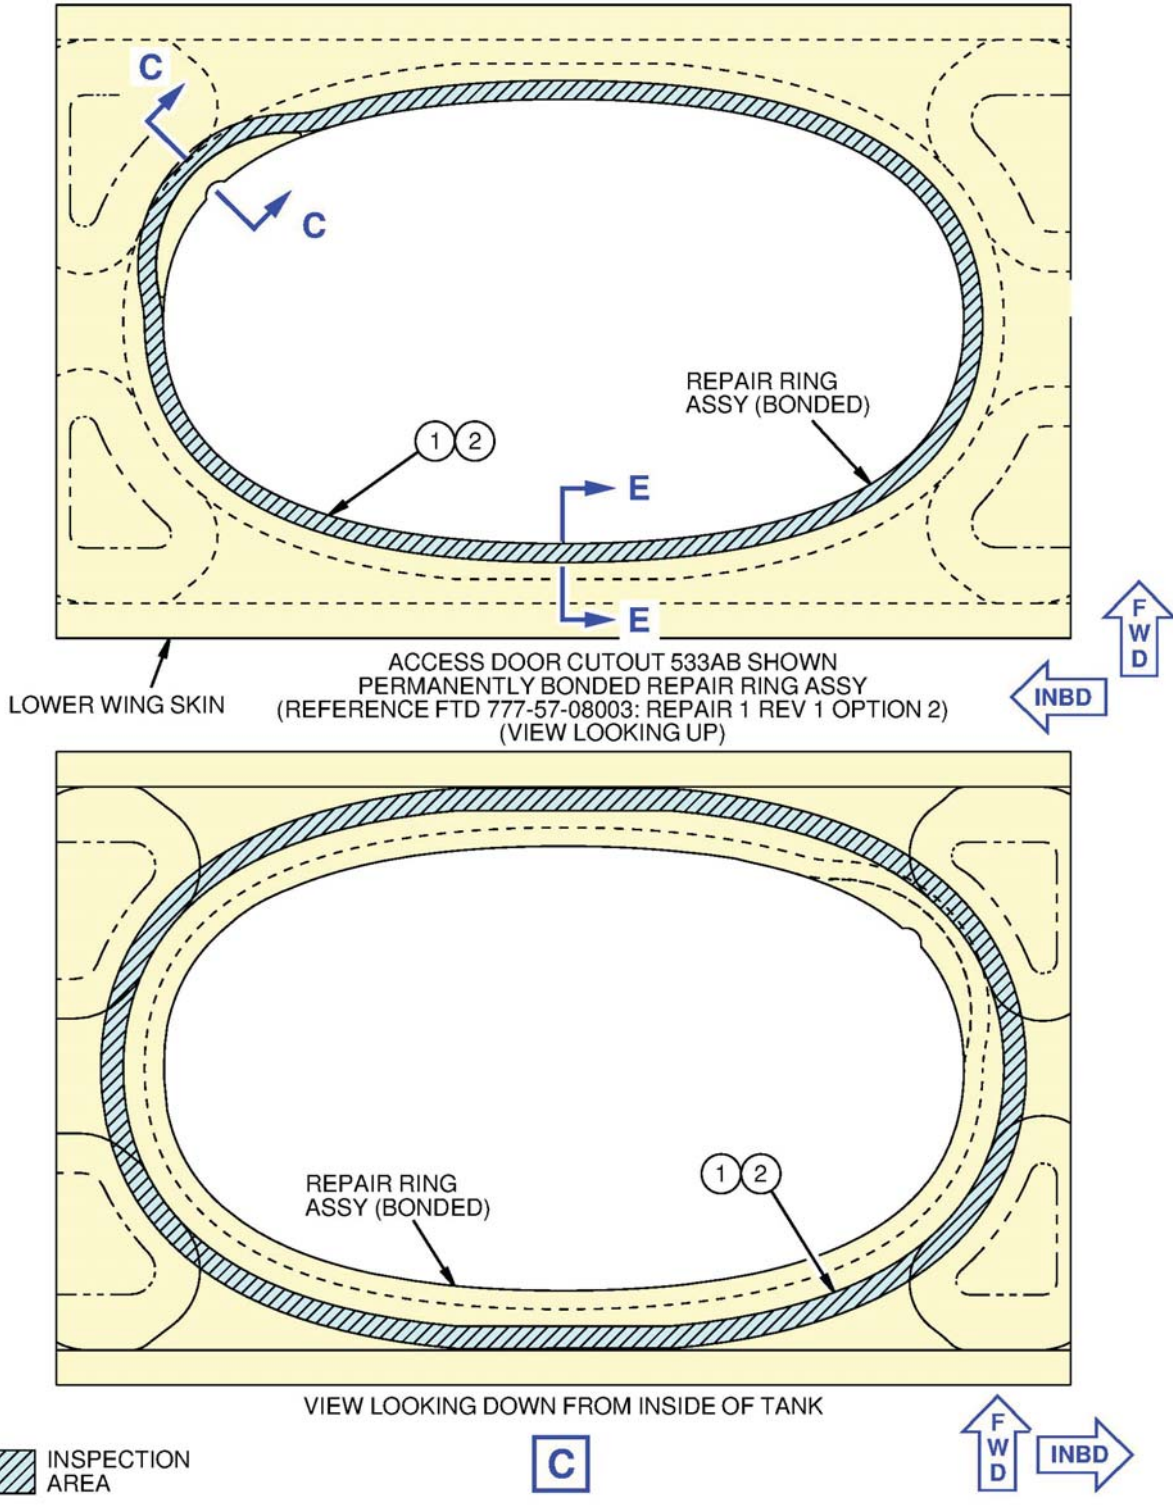
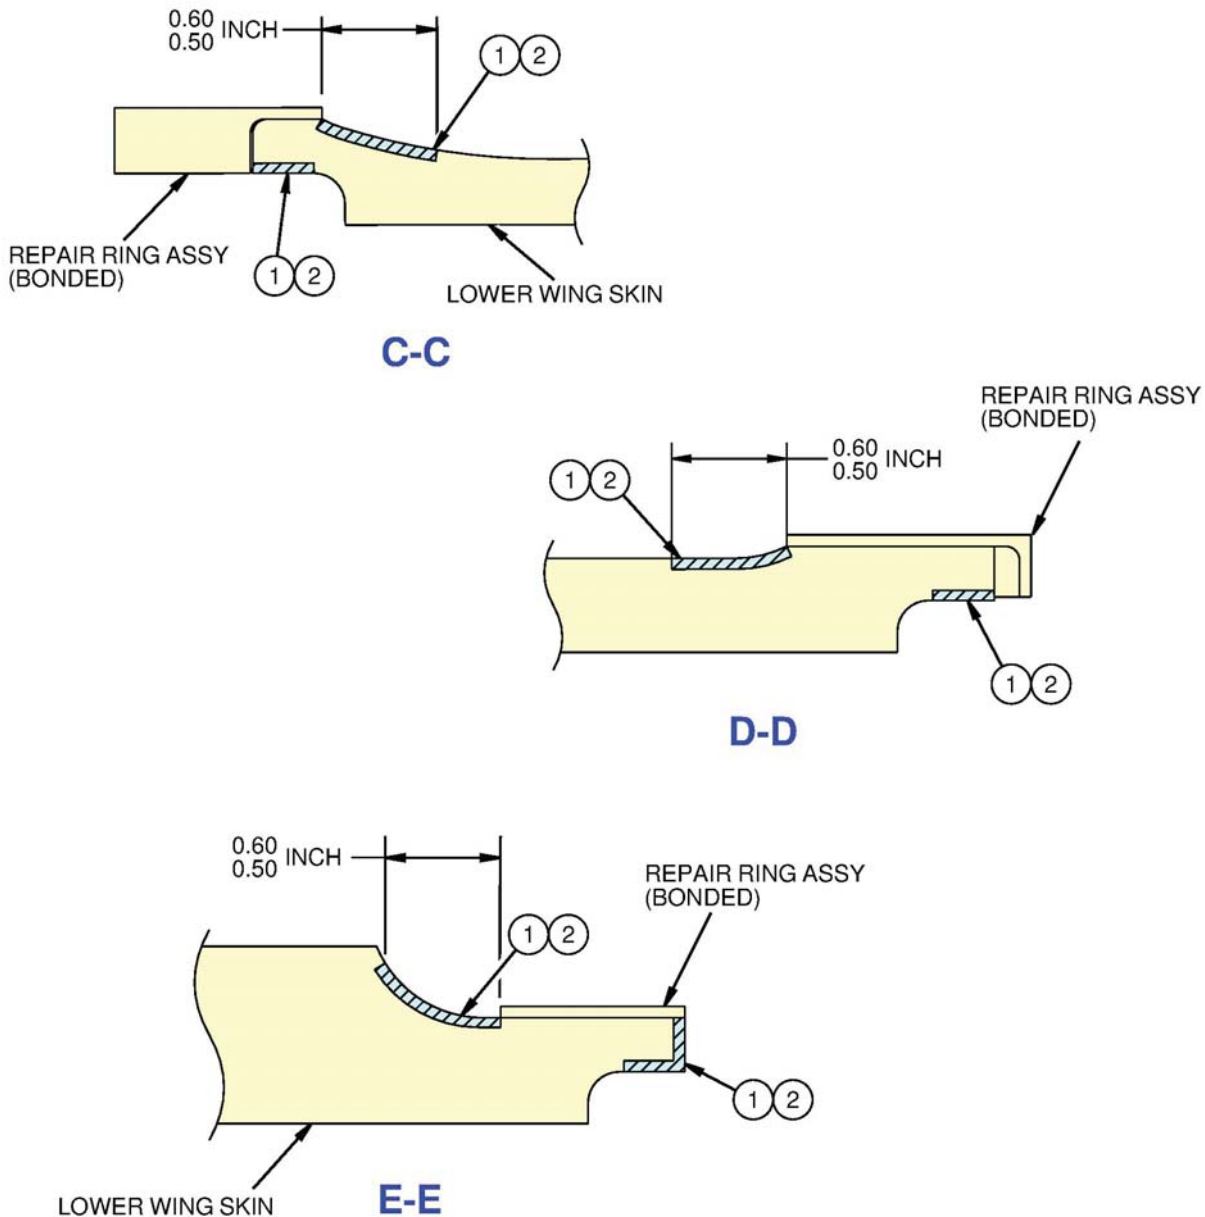
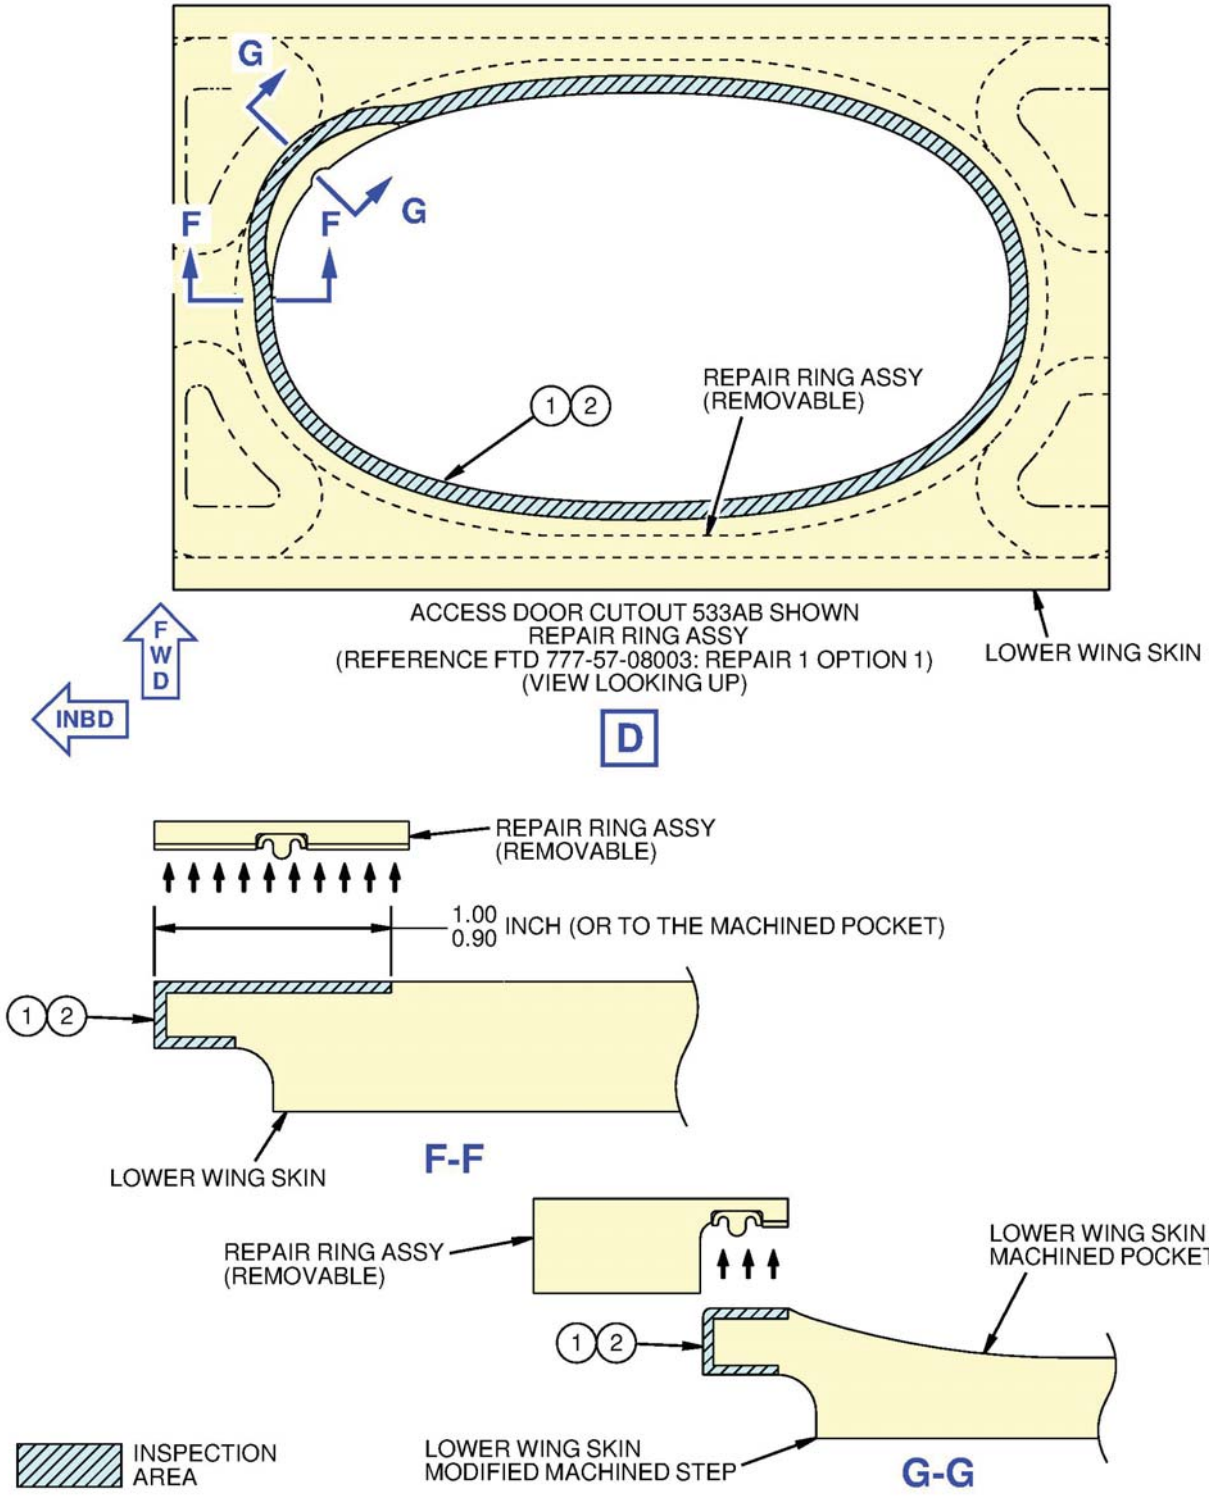
**FIGURE 2: LEFT WING - LOWER WING SKIN - FUEL TANK AND DRY BAY ACCESS DOOR CUTOUTS BETWEEN WING STATION (WS) 306.00 AND WS 520.50 WITH ANY APPROVED EXISTING REPAIR FOUND - DETAILED INSPECTION AND HIGH FREQUENCY EDDY CURRENT (HFEC) INSPECTION (SHEET 1 OF 7)**

ACCESS DOOR CUTOUT 533AB SHOWN  
REPAIRED PER SB 777-57-0098  
(VIEW LOOKING UP)

<b>Step</b>	<b>Task</b>	<b>Name</b>	<b>Identification</b>	<b>Qty</b>	<b>More Data</b>
1	Inspect	Wing Skin	-	-	(a)
2	Inspect	Wing Skin	-	-	(b)
(a) Do a Detailed Inspection of the lower wing skin fuel tank and dry bay access door cutouts between WS 306.00 and WS 520.50 for any corrosion, fretting or crack.					
(b) Do a HFEC inspection of the wing lower skin fuel tank and dry bay access door cutouts between WS 306.00 and WS 520.50 for any crack. Refer to 777 NDT Manual Part 6, 51-00-01 as an accepted procedure.

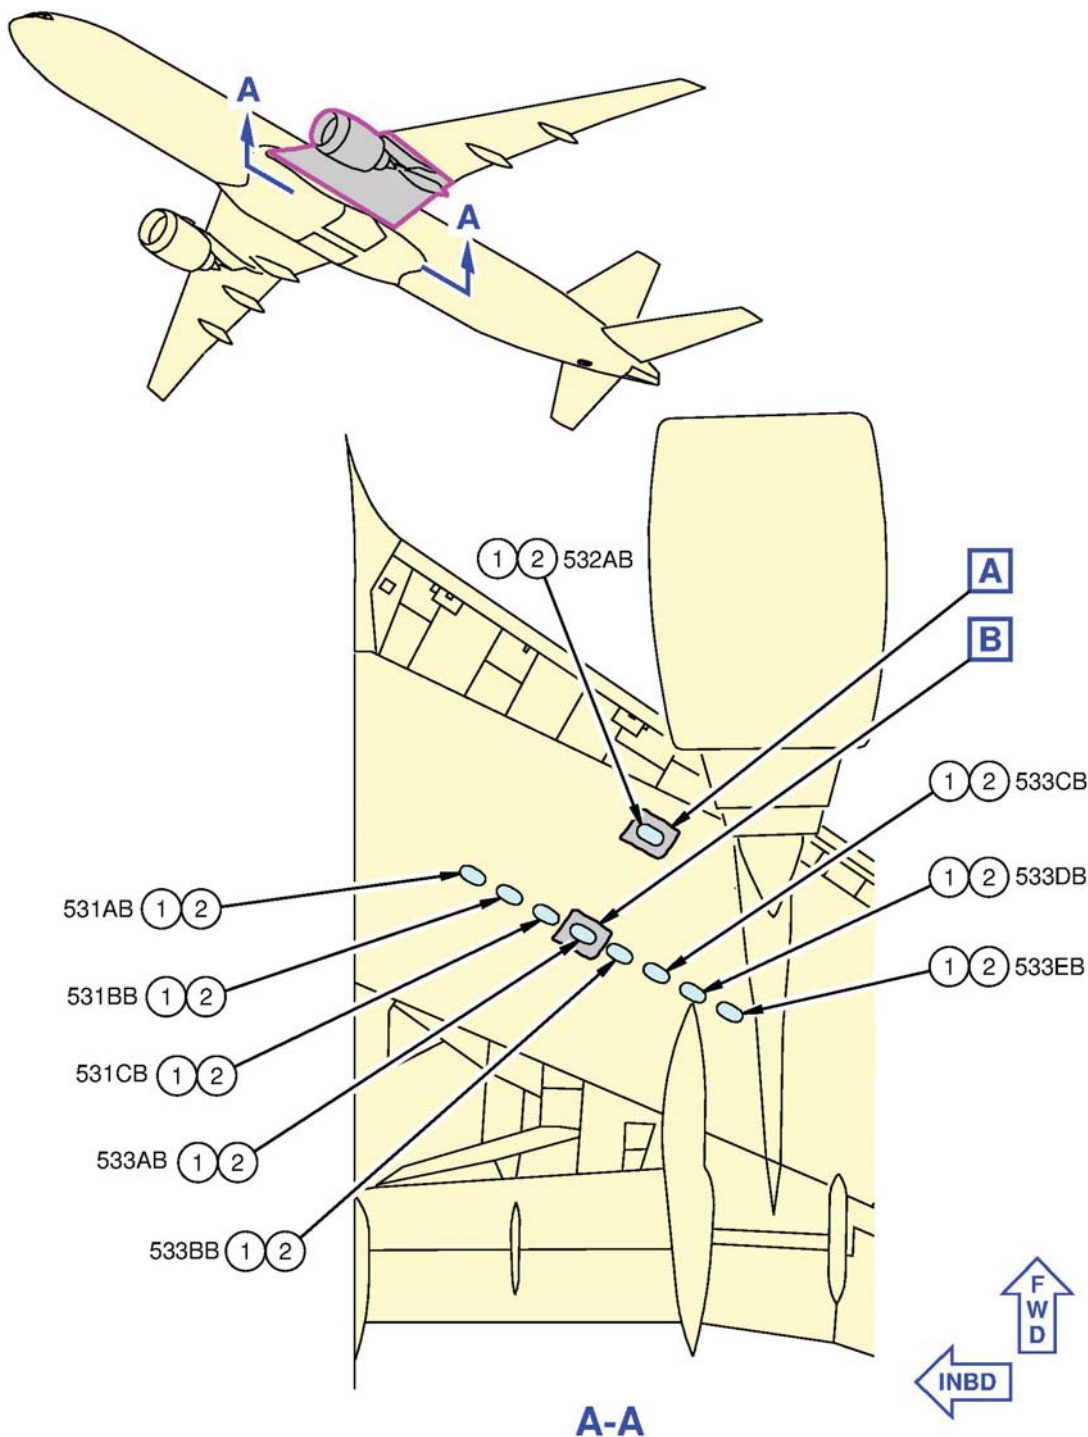
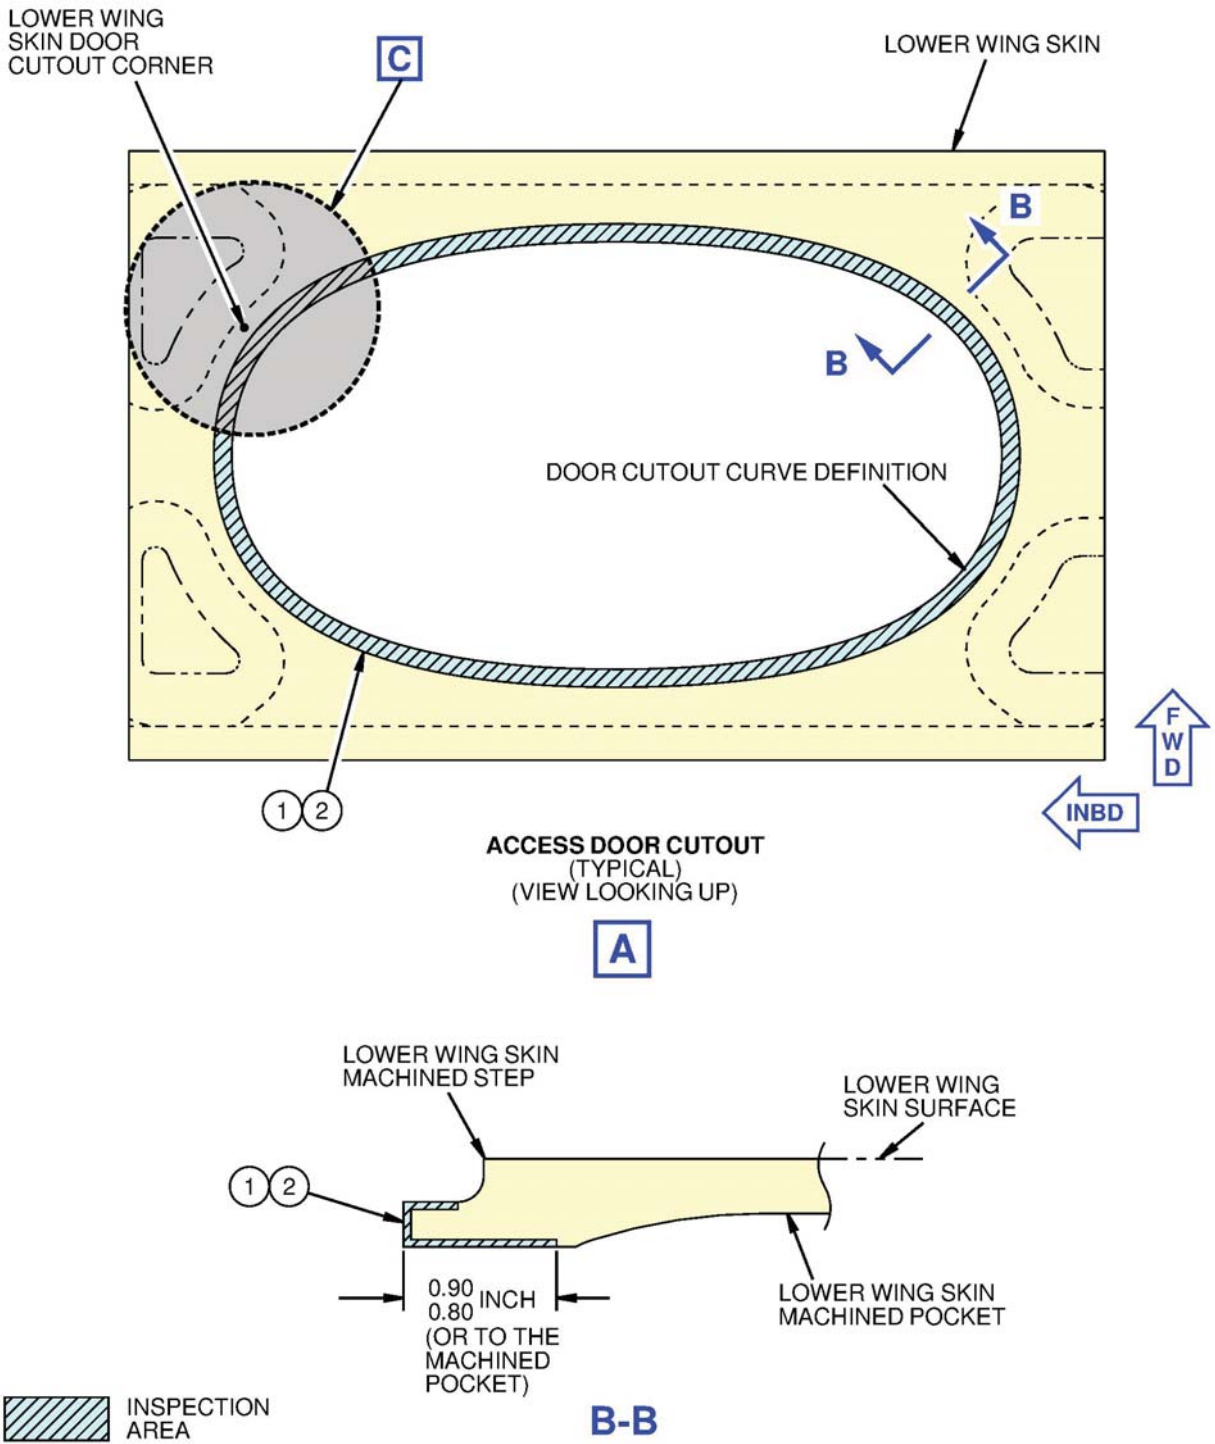
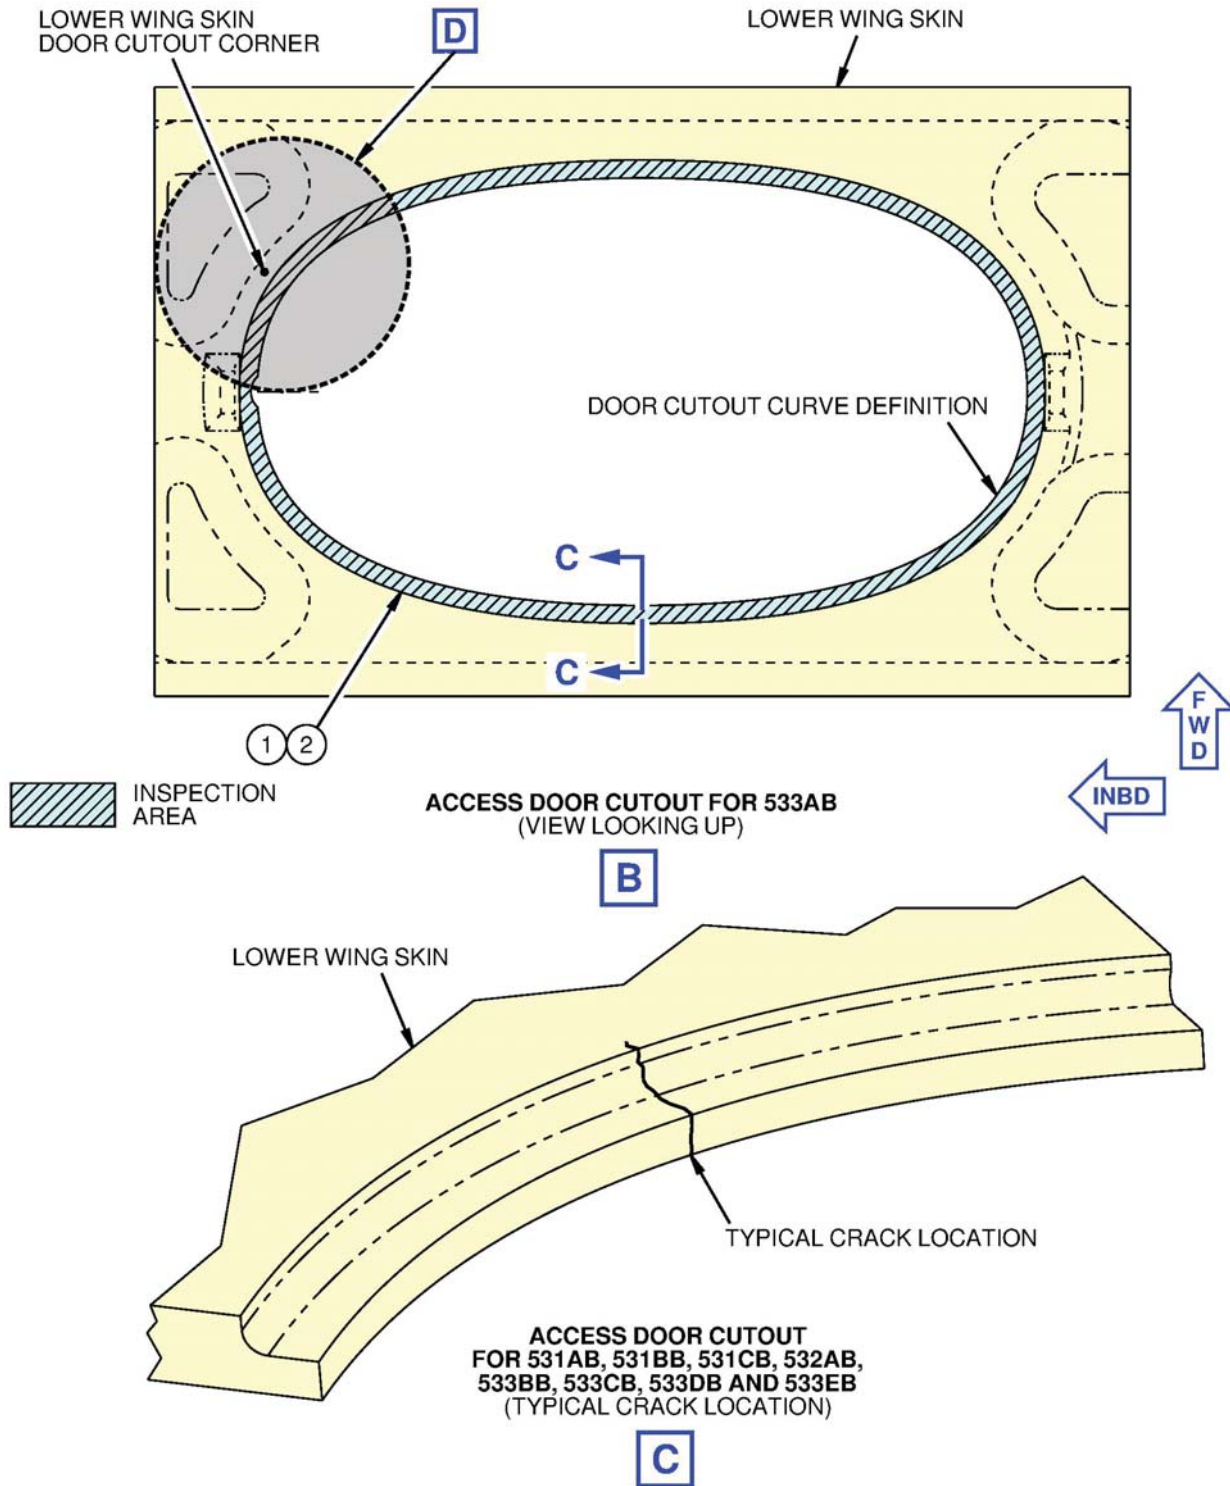
**FIGURE 3: LEFT WING - LOWER WING SKIN - FUEL TANK AND DRY BAY ACCESS DOOR CUTOUTS BETWEEN WING STATION (WS) 306.00 AND WS 520.50 WITH NO EXISTING REPAIR FOUND- DETAILED INSPECTION AND HIGH FREQUENCY EDDY CURRENT (HFEC) INSPECTION (SHEET 1 OF 5)**

ACCESS DOOR CUTOUT FOR 533AB  
(TYPICAL CRACK LOCATION)

Step	Task	Name	Identification	Qty	More Data
1	Inspect	Wing Skin	-	-	(a)
2	Inspect	Wing Skin	-	-	(b)
(a) Do a Detailed Inspection of the lower wing skin fuel tank and dry bay access door cutouts between WS 306.00 and WS 520.50 for any corrosion, fretting or crack.					
(b) Do a HFEC inspection of the wing lower skin fuel tank and dry bay access door cutouts between WS 306.00 and WS 520.50 for any crack. Refer to 777 NDT Manual Part 6, 51-00-01 as an accepted procedure.

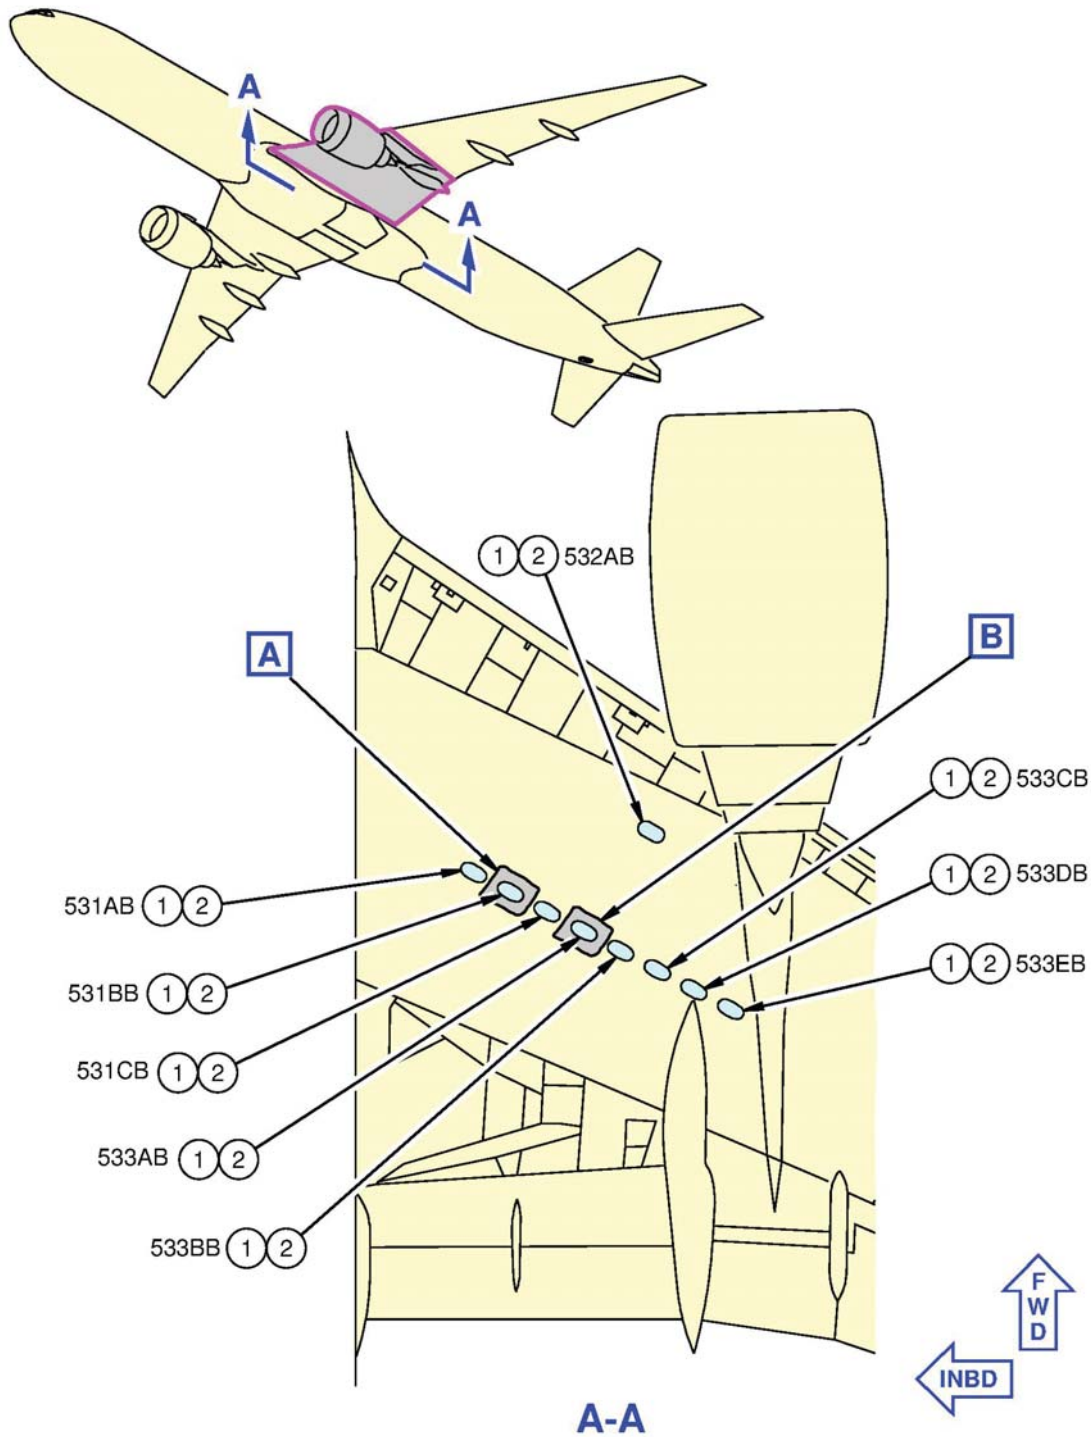
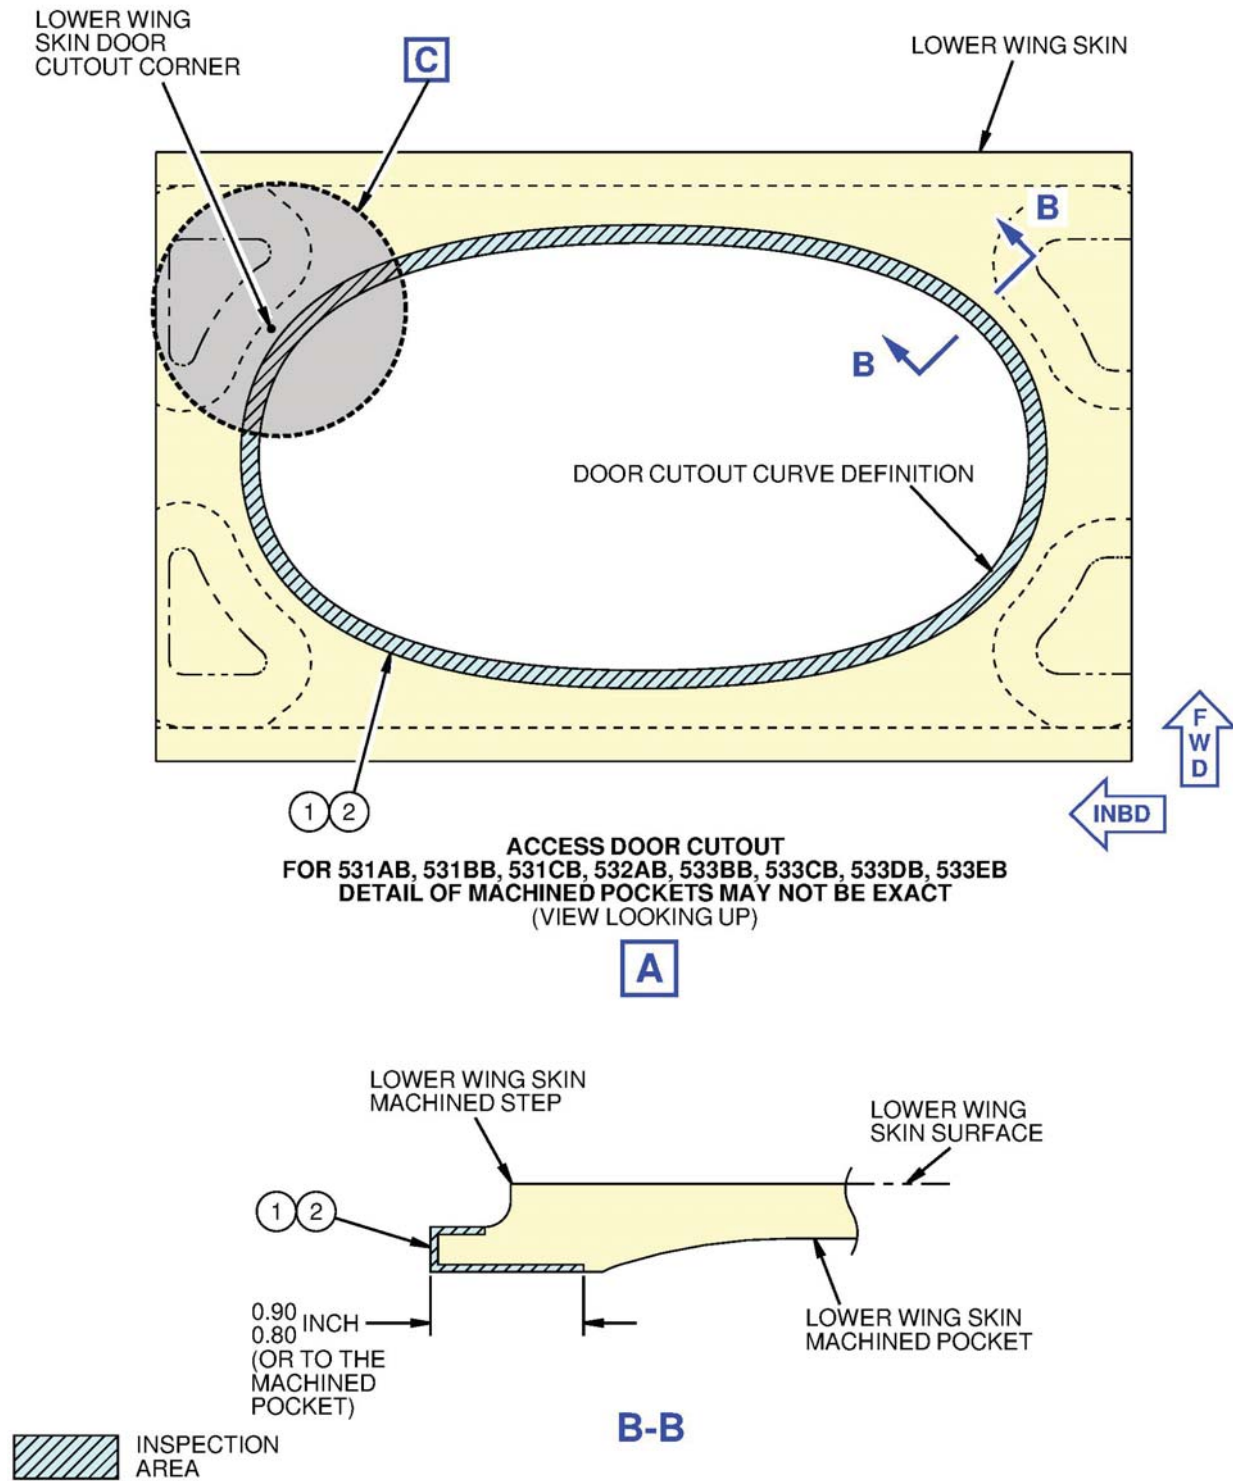
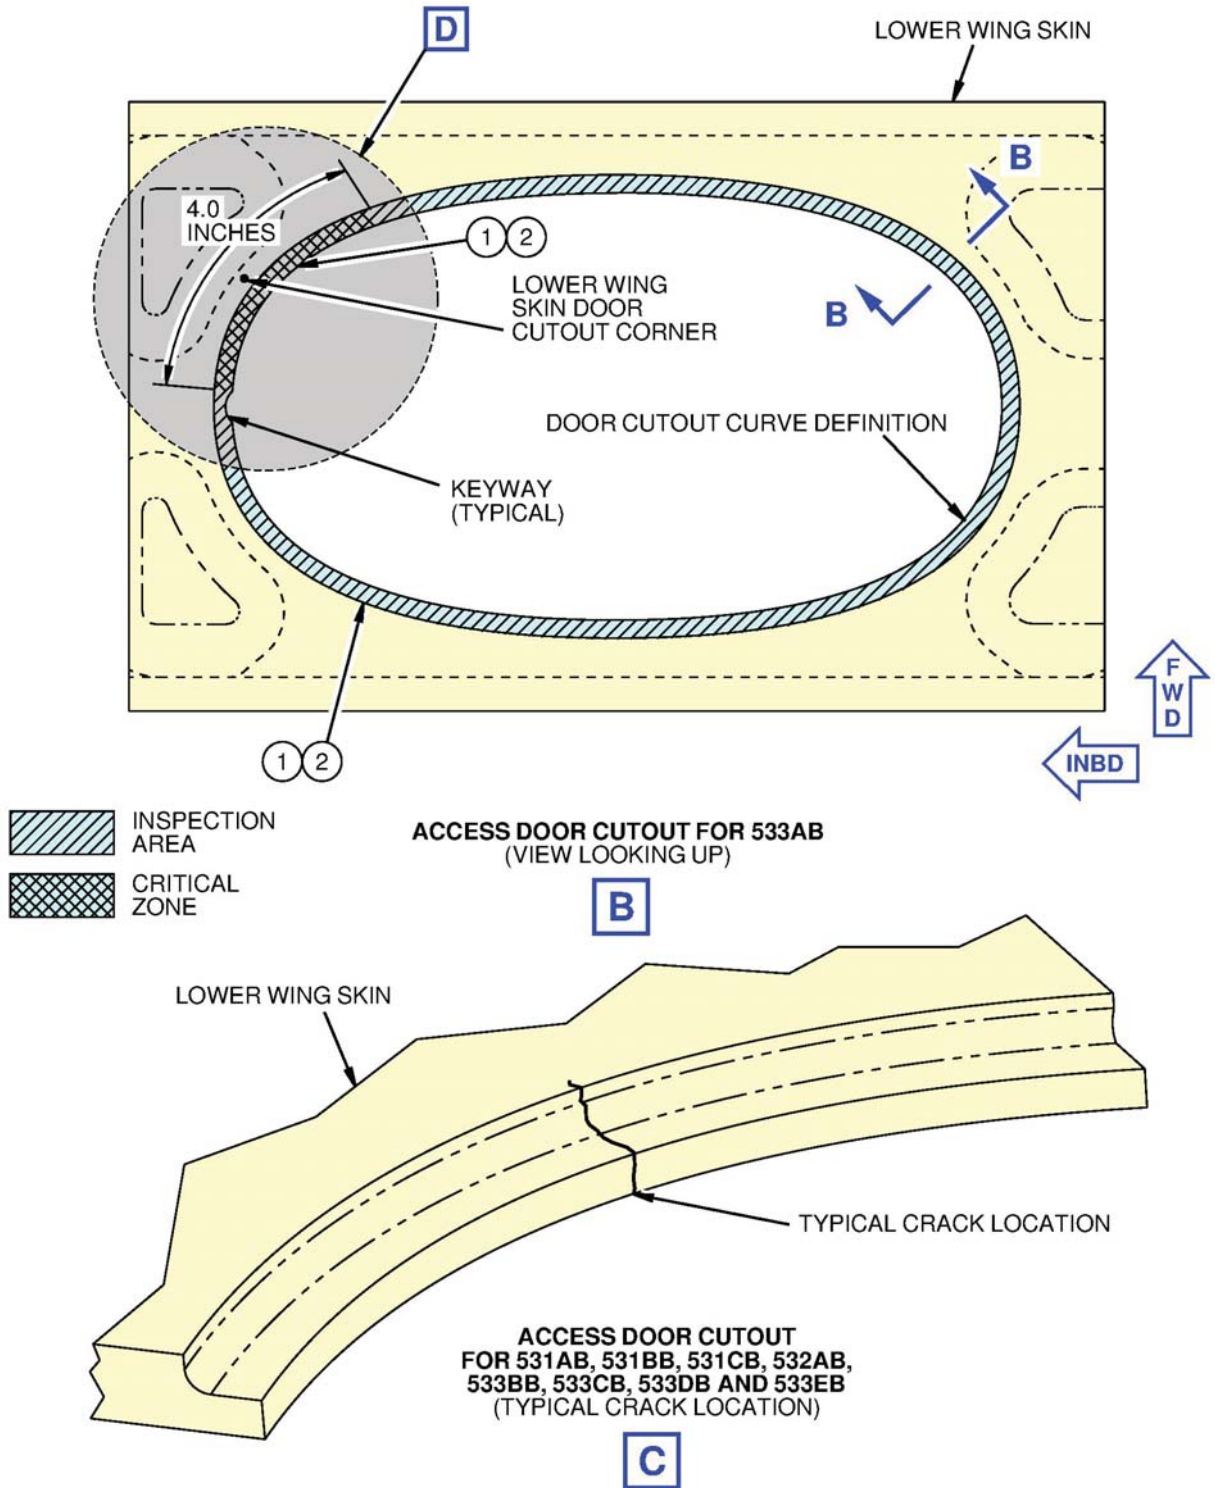
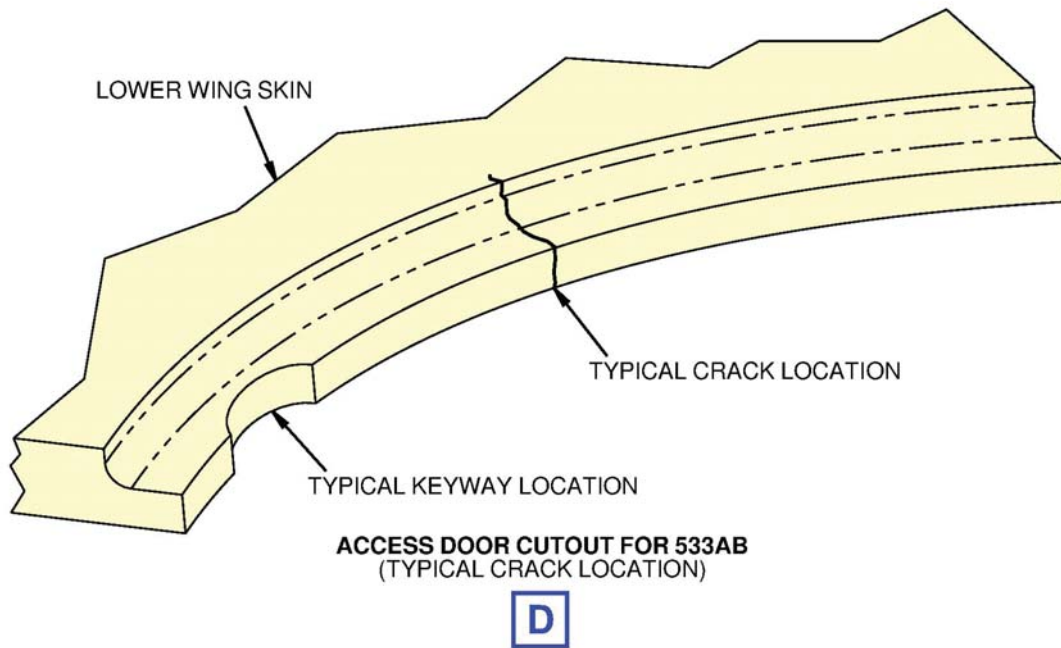
**FIGURE 4: LEFT WING - LOWER WING SKIN - TANK AND DRY BAY ACCESS DOOR CUTOUTS BETWEEN WING STATION (WS) 306.00 AND WS 520.50 WITH NO EXISTING REPAIR FOUND- DETAILED INSPECTION AND HIGH FREQUENCY EDDY CURRENT (HFEC) INSPECTION (SHEET 1 OF 5)**

**ACCESS DOOR CUTOUT  
FOR 531AB, 531BB, 531CB, 532AB, 533BB, 533CB, 533DB, 533EB  
DETAIL OF MACHINED POCKETS MAY NOT BE EXACT  
(VIEW LOOKING UP)**

<b>Step</b>	<b>Task</b>	<b>Name</b>	<b>Identification</b>	<b>Qty</b>	<b>More Data</b>
1	Inspect	Wing Skin	-	-	(a)
	Inspect	Wing Skin - Critical Zone	-	-	(a)
2	Inspect	Wing Skin	-	-	(b)
	Inspect	Wing Skin - Critical Zone	-	-	(b)
(a) Do a Detailed Inspection of the lower wing skin fuel tank and dry bay access door cutouts between WS 306.00 and WS 520.50 for any corrosion, fretting or crack.					
(b) Do a HFEC inspection of the wing lower skin fuel tank and dry bay access door cutouts between WS 306.00 and WS 520.50 for any crack. Refer to 777 NDT Manual Part 6, 51-00-01 as an accepted procedure.
