**Number:** 777-57A0118 RB  
Original Issue: June 23, 2020  
ATA System: 5725

**SUBJECT:** WINGS - Wing Lower Skin - Fuel Tank / Dry Bay Access Door Cutouts - Inspection and Repair.

## Requirements Bulletin

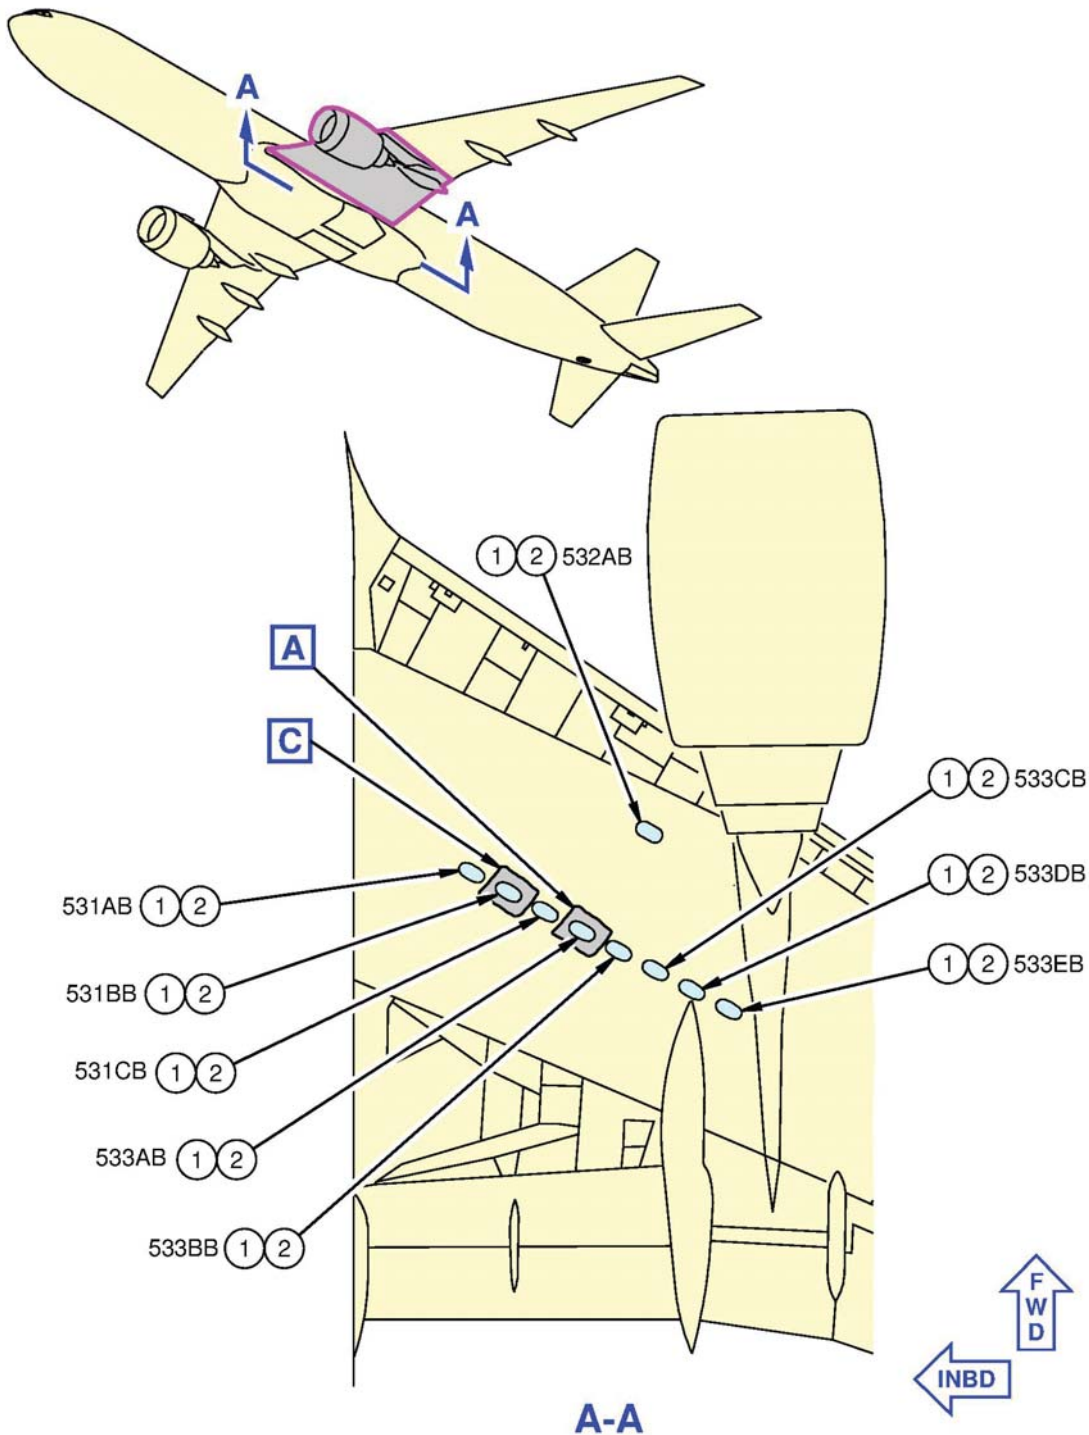
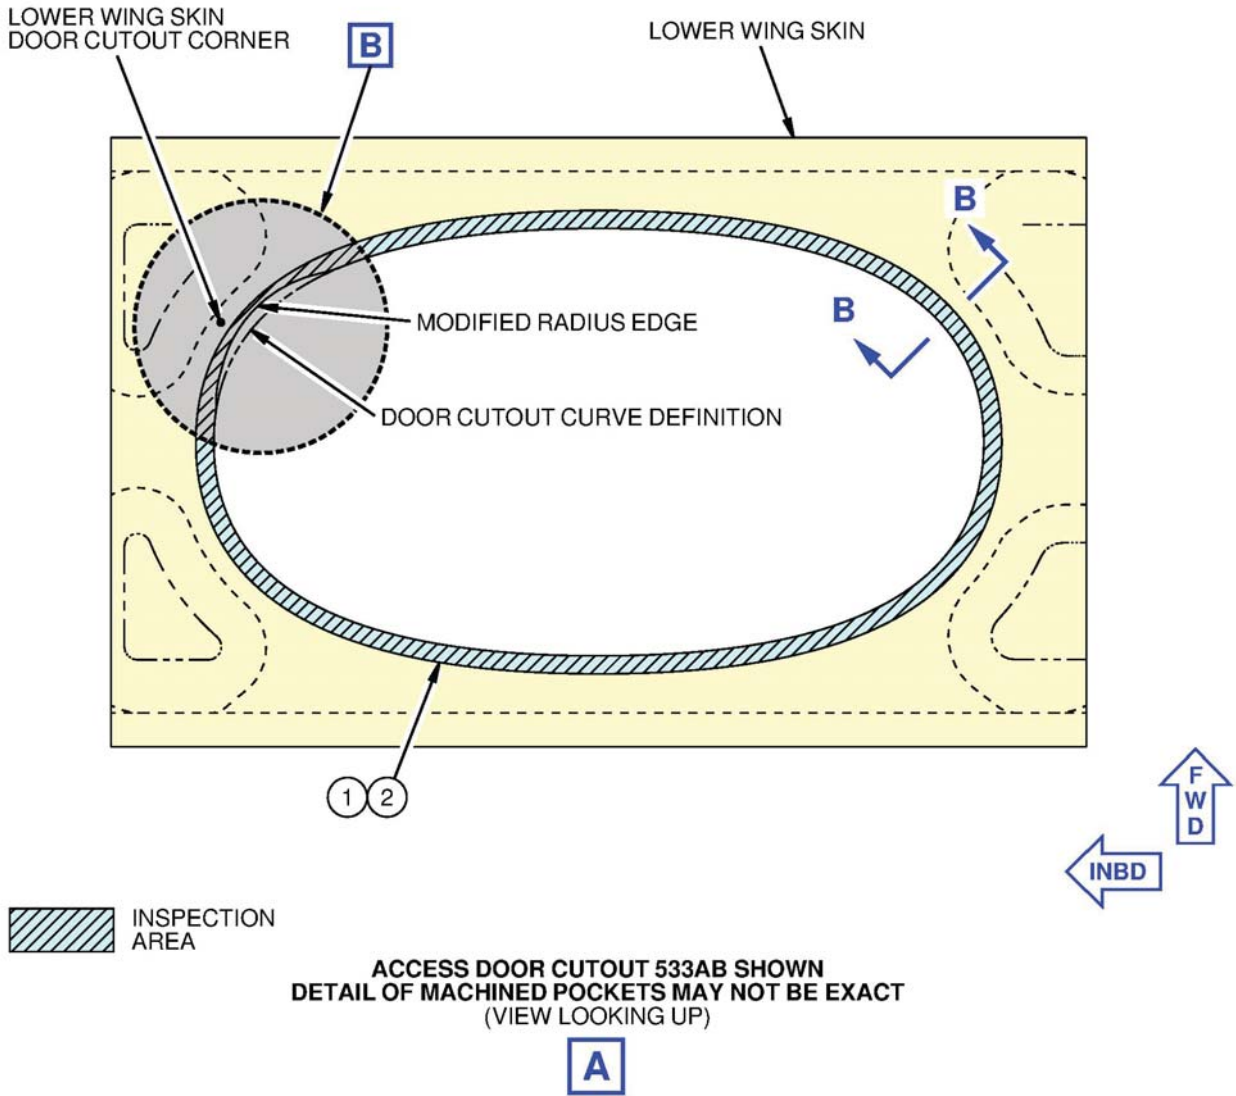
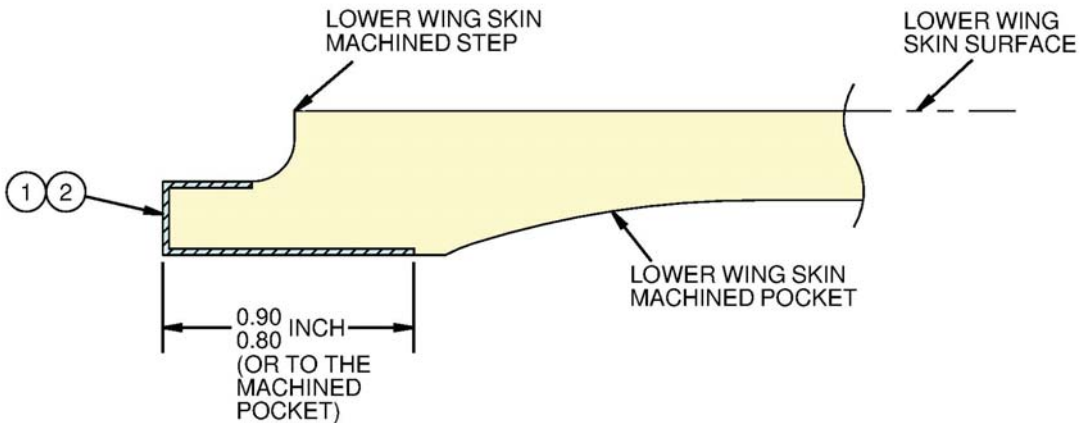
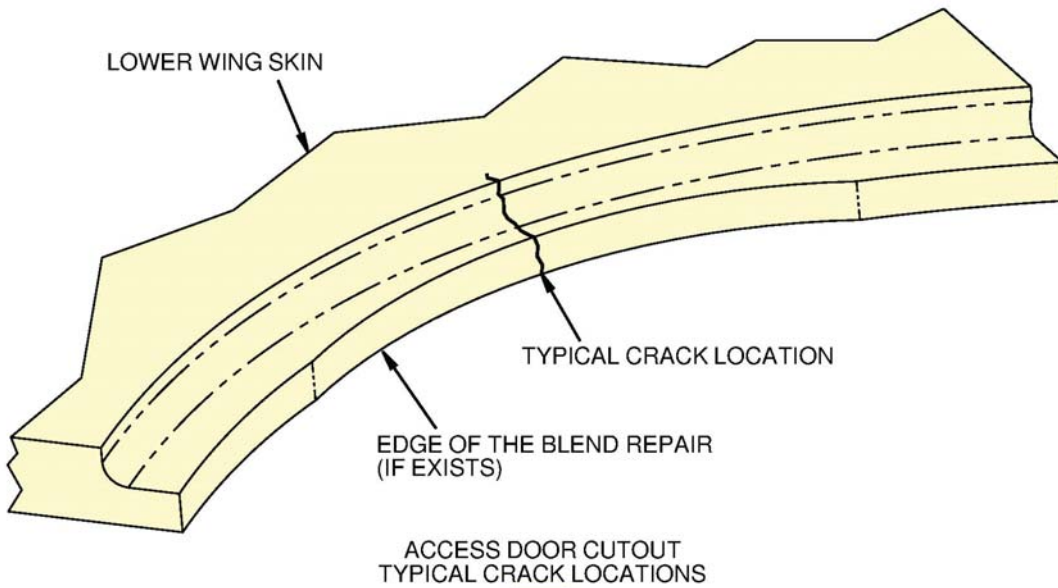
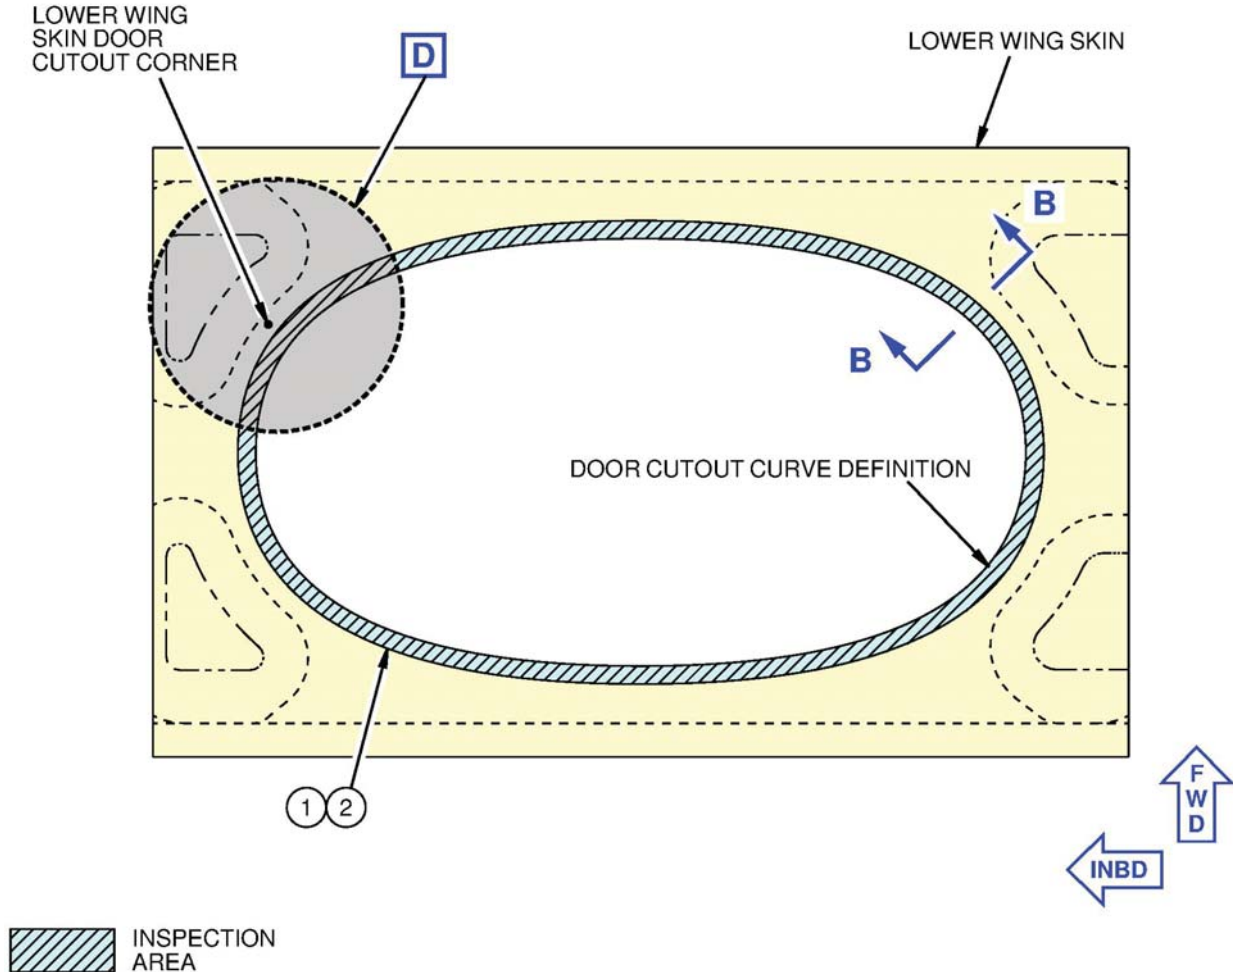
**FIGURE 5: LEFT WING - LOWER WING SKIN - FUEL TANK AND DRY BAY ACCESS DOOR CUTOUTS BETWEEN WING STATION (WS) 306.00 AND WS 520.50 WITH NO EXISTING REPAIR FOUND - DETAILED INSPECTION AND HIGH FREQUENCY EDDY CURRENT (HFEC) INSPECTION (SHEET 1 OF 5)**

**ACCESS DOOR CUTOUT  
FOR 531AB, 531BB, 531CB, 532AB,  
533BB, 533CB, 533DB AND 533EB  
(TYPICAL CRACK LOCATION)**

Step	Task	Name	Identification	Qty	More Data
1	Inspect	Wing Skin	-	-	(a)
2	Inspect	Wing Skin	-	-	(b)
(a) Do a Detailed Inspection of the lower wing skin fuel tank and dry bay access door cutouts between WS 306.00 and WS 520.50 for any corrosion, fretting or crack.					
(b) Do a HFEC inspection of the wing lower skin fuel tank and dry bay access door cutouts between WS 306.00 and WS 520.50 for any crack. Refer to 777 NDT Manual Part 6, 51-00-01 as an accepted procedure.

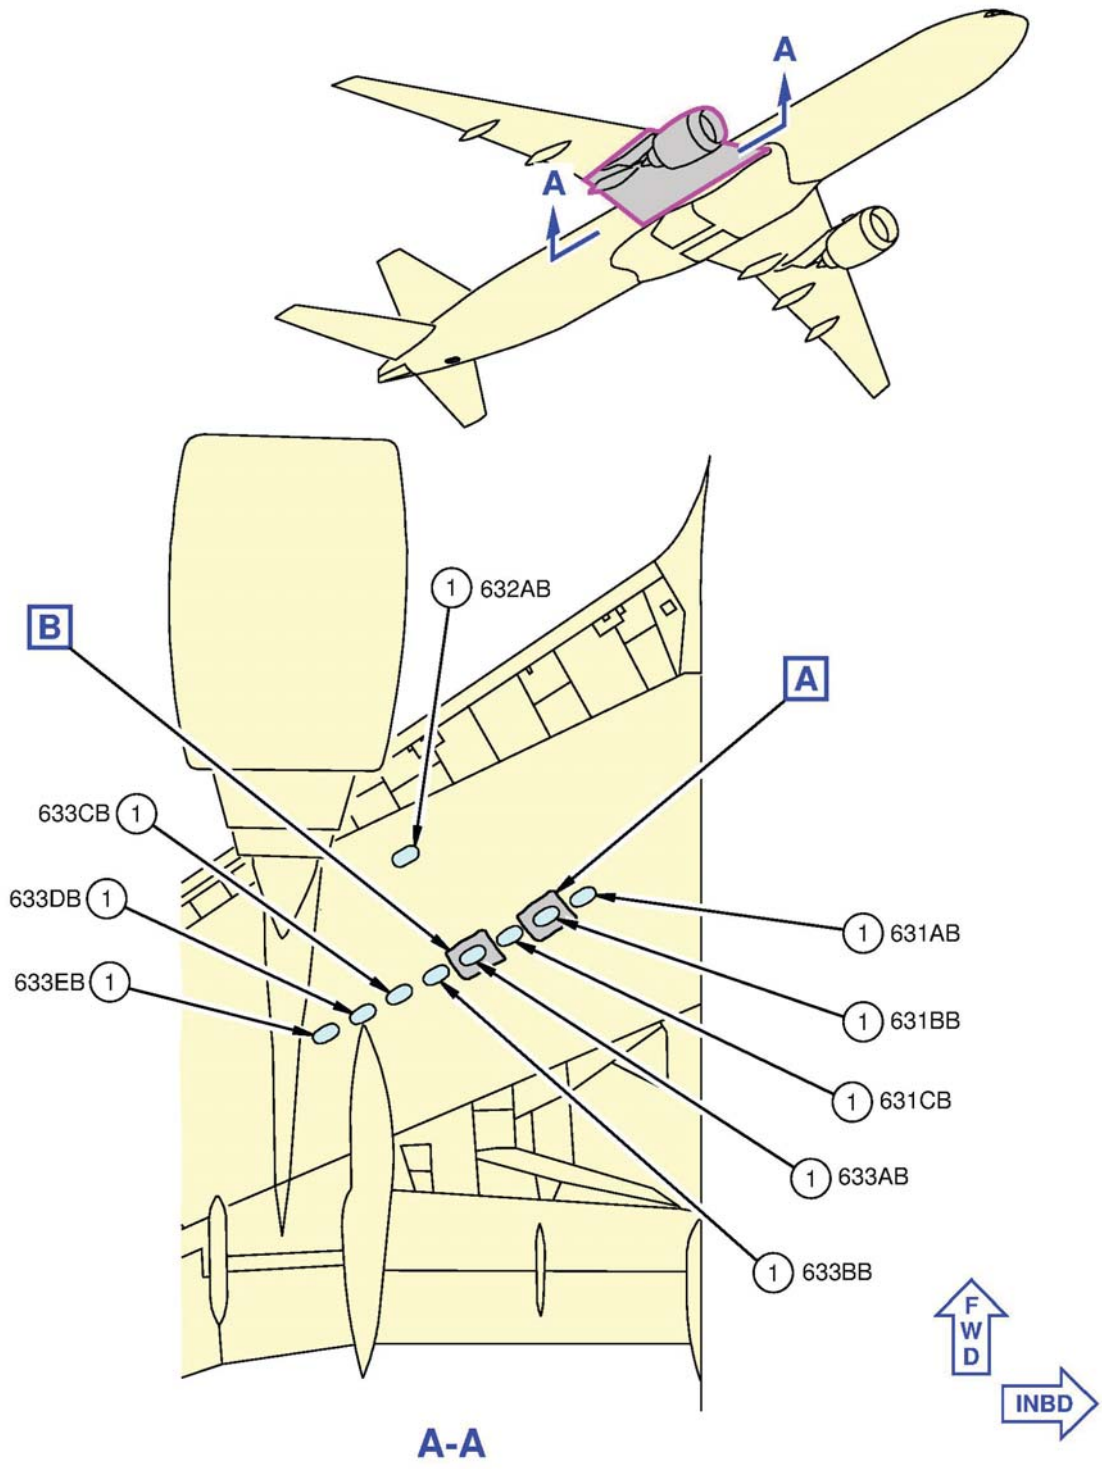
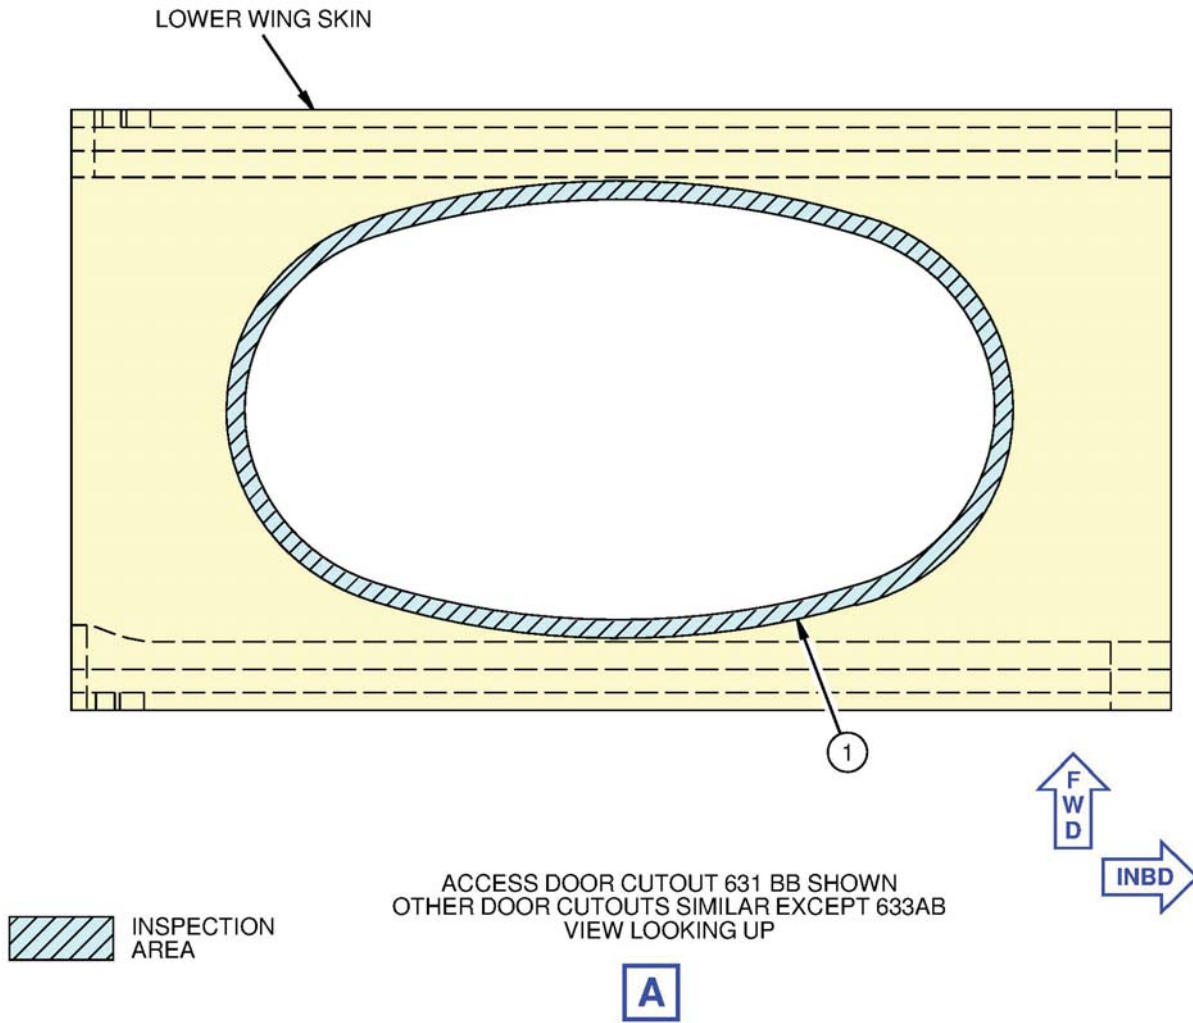
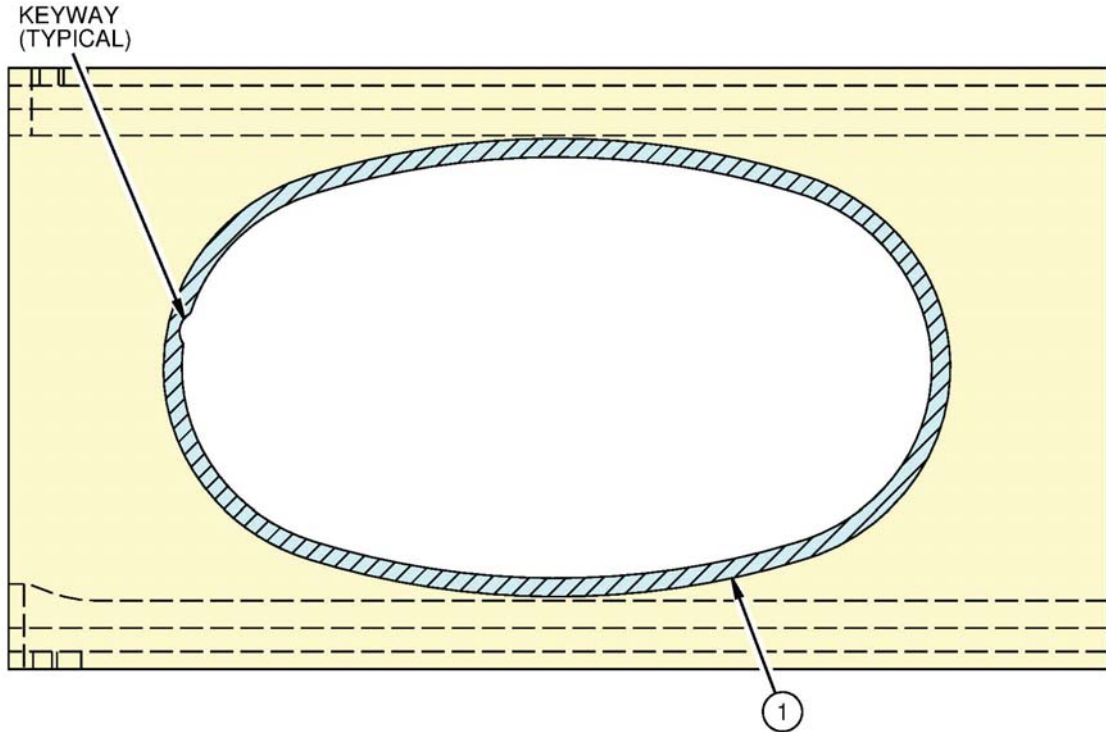
FIGURE 6: RIGHT WING - LOWER WING SKIN - FUEL TANK AND DRY BAY ACCESS DOOR CUTOUTS BETWEEN WING STATION (WS) 306.00 AND WS 520.50 - GENERAL VISUAL INSPECTION (GVI) (SHEET 1 OF 3)

ACCESS DOOR CUTOUT 633AB  
(VIEW LOOKING UP)

Step	Task	Name	Identification	Qty	More Data
1	Inspect	Wing Skin	-	-	(a)
(a) Do a GVI of the wing lower skin fuel tank and dry bay access door cutouts between WS 306.00 and WS 520.50 for any existing repairs.

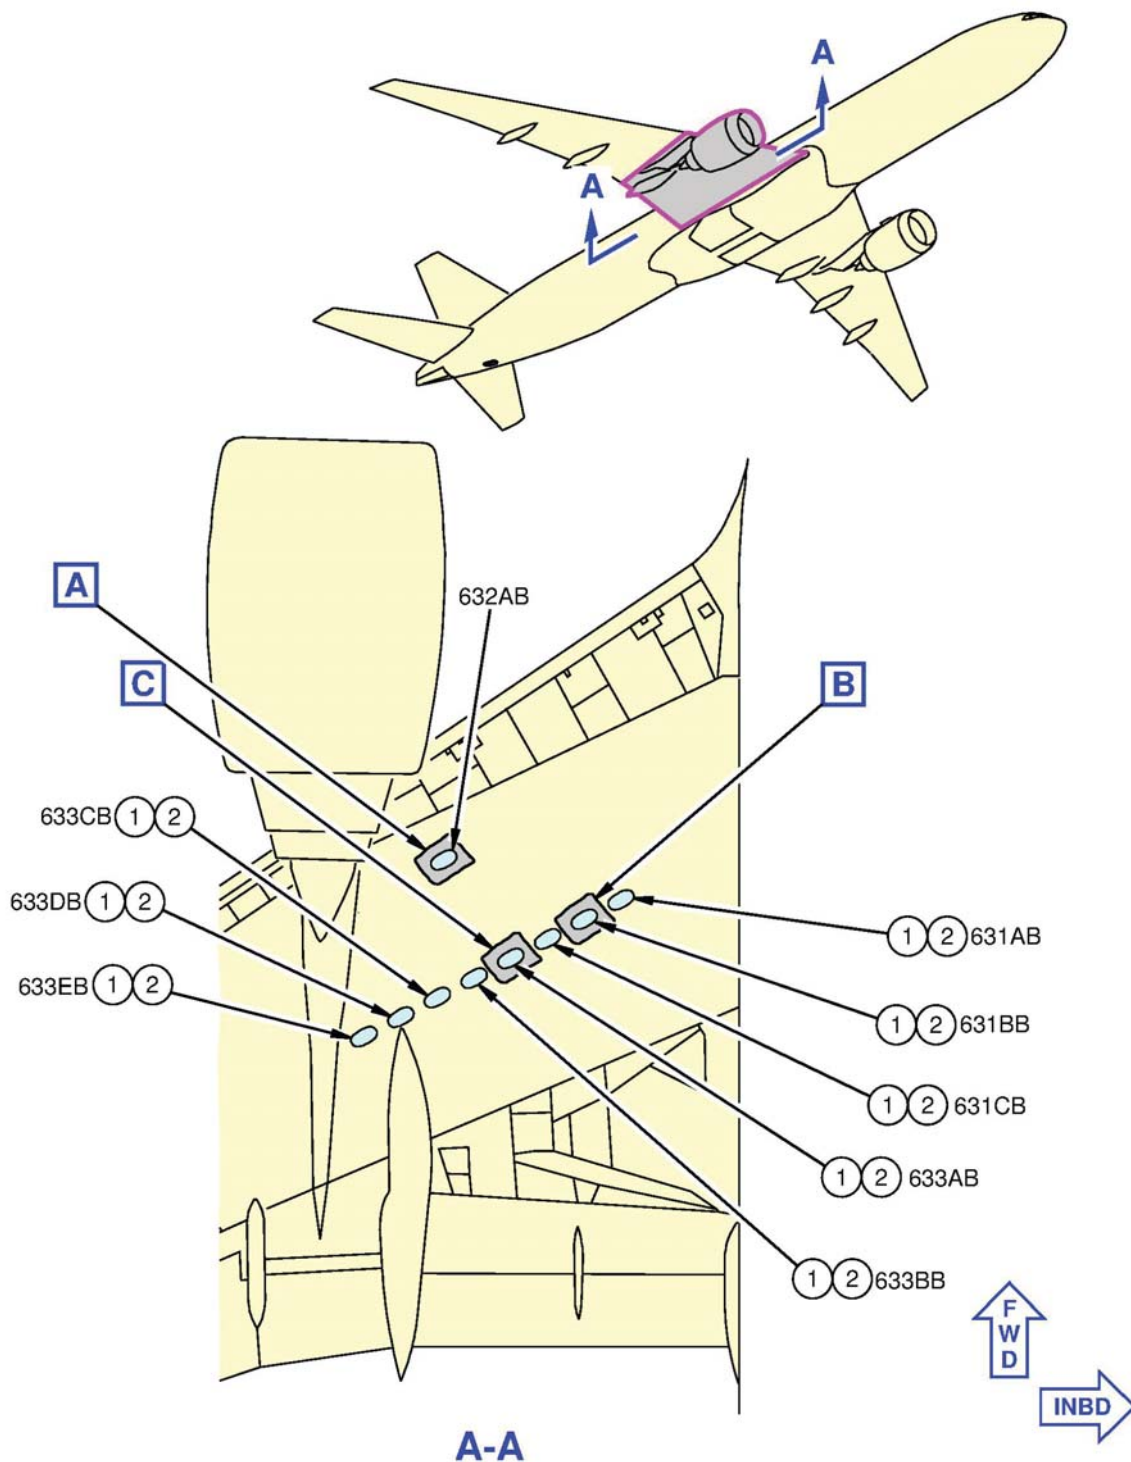
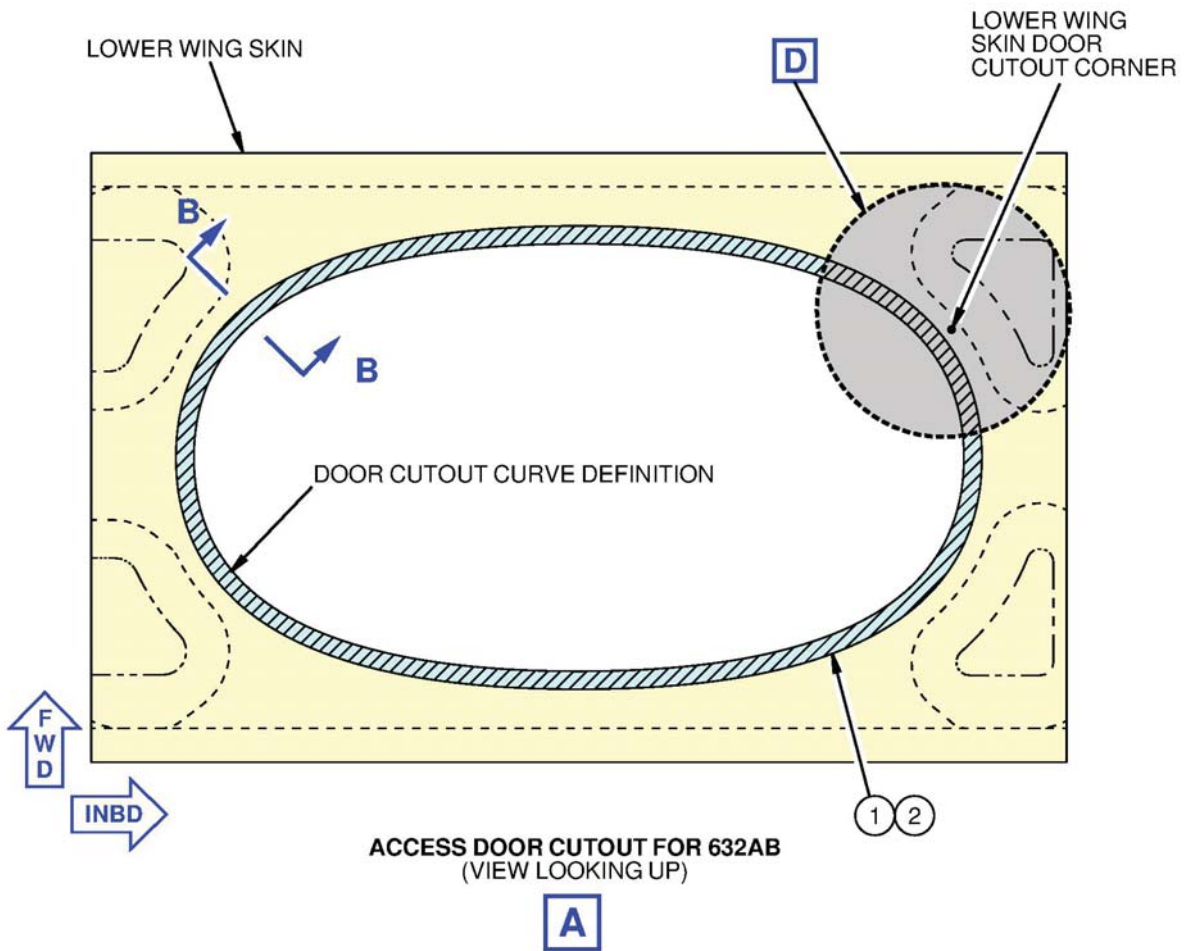
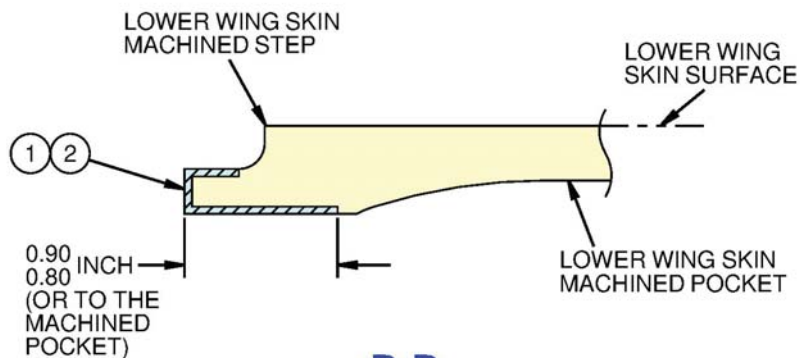
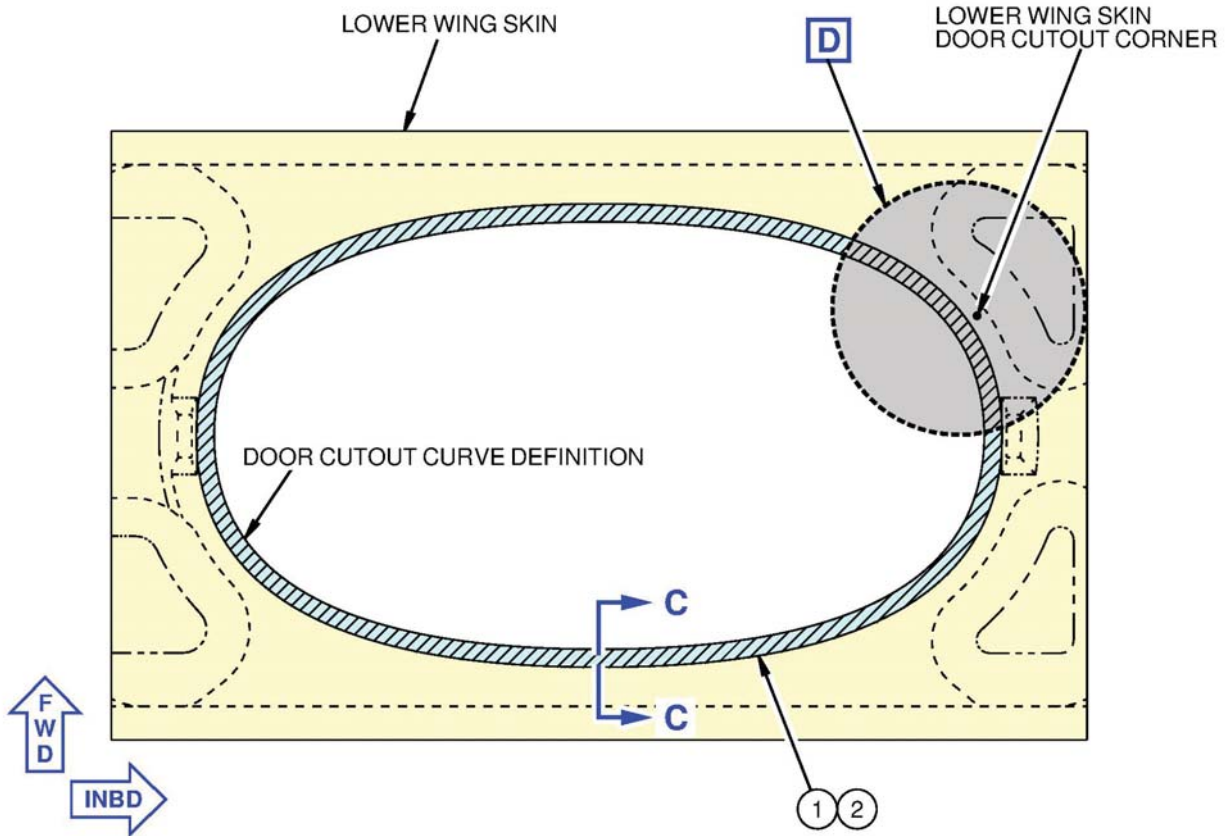
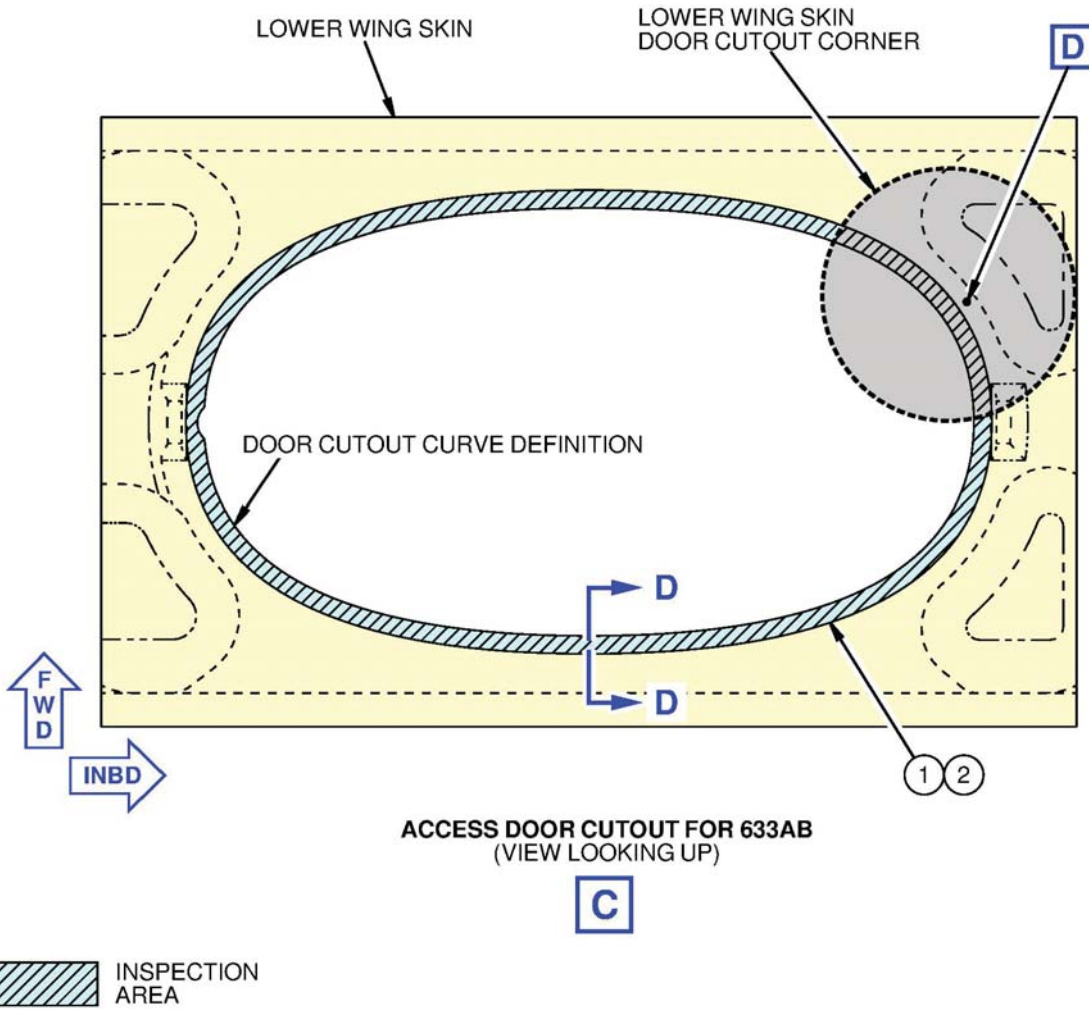
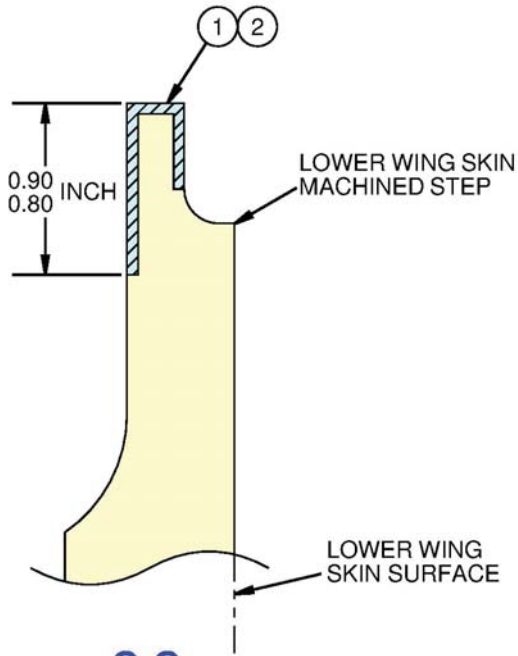
**FIGURE 7: RIGHT WING - LOWER WING SKIN - FUEL TANK AND DRY BAY ACCESS DOOR CUTOUTS BETWEEN WING STATION (WS) 306.00 AND WS 520.50 WITH NO EXISTING REPAIR - DETAILED INSPECTION AND HIGH FREQUENCY EDDY CURRENT (HFEC) INSPECTION (SHEET 1 OF 6)**

ACCESS DOOR CUTOUT FOR 633AB  
(VIEW LOOKING UP)

ACCESS DOOR CUTOUT  
(TYPICAL CRACK LOCATION)

<b>Step</b>	<b>Task</b>	<b>Name</b>	<b>Identification</b>	<b>Qty</b>	<b>More Data</b>
1	Inspect	Wing Skin	-	-	(a)
2	Inspect	Wing Skin	-	-	(b)
(a) Do a Detailed Inspection of the lower wing skin fuel tank and dry bay access door cutouts between WS 306.00 and WS 520.50 for any corrosion, fretting or crack.					
(b) Do a HFEC inspection of the wing lower skin fuel tank and dry bay access door cutouts between WS 306.00 and WS 520.50 for any crack. Refer to 777 NDT Manual Part 6, 51-00-01 as an accepted procedure.

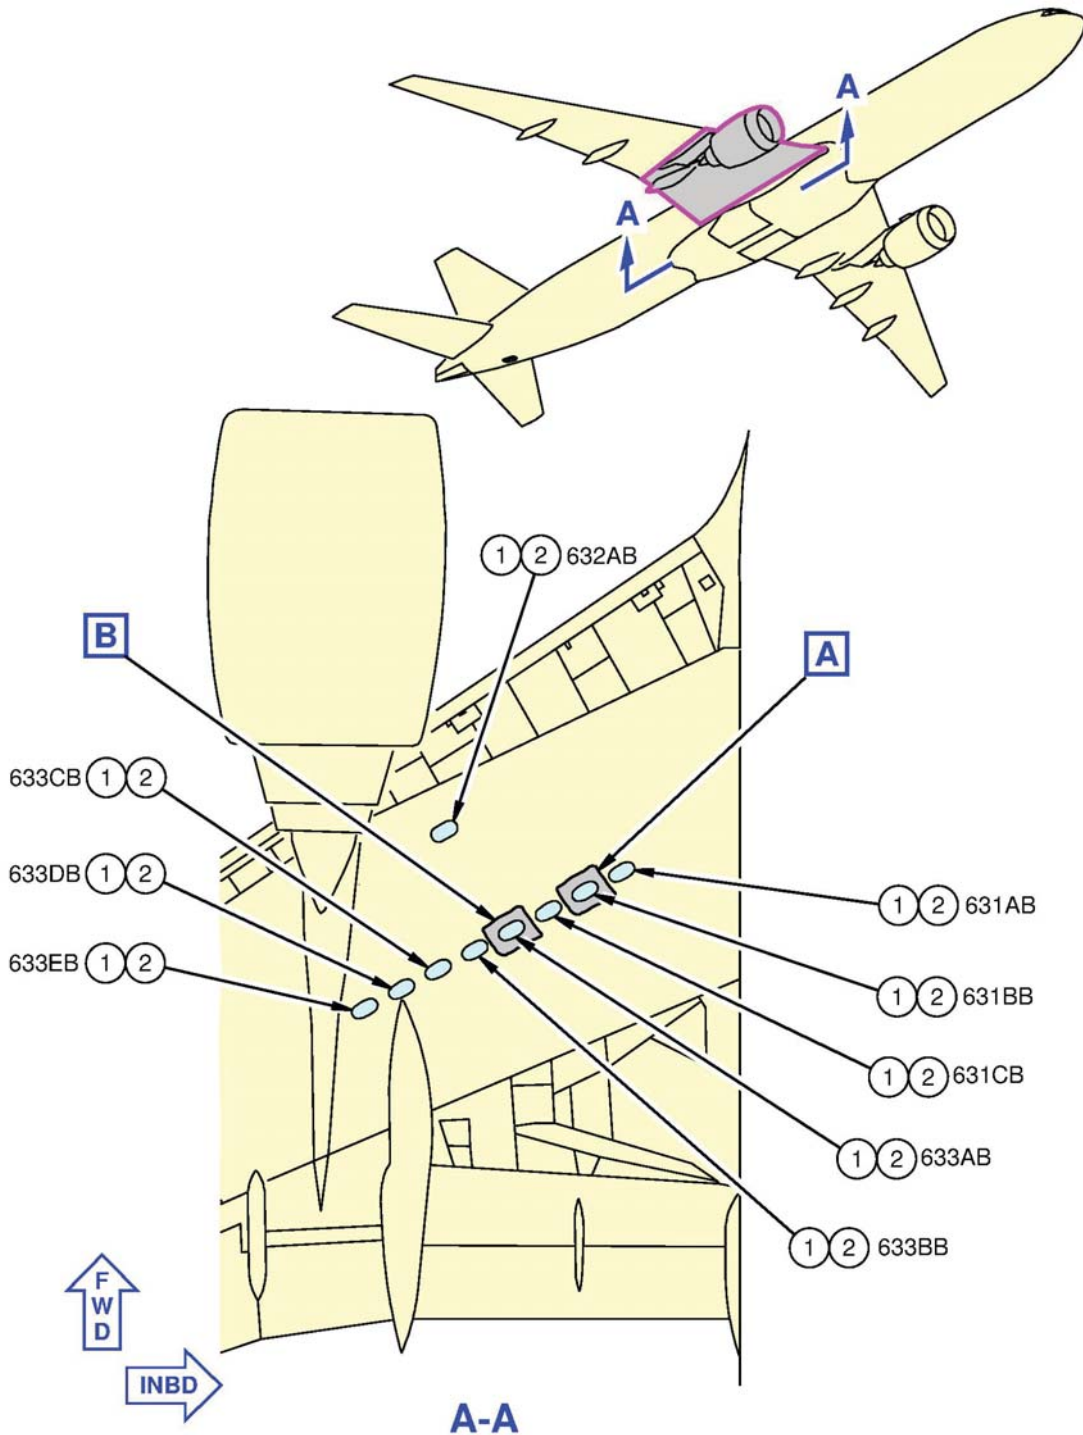
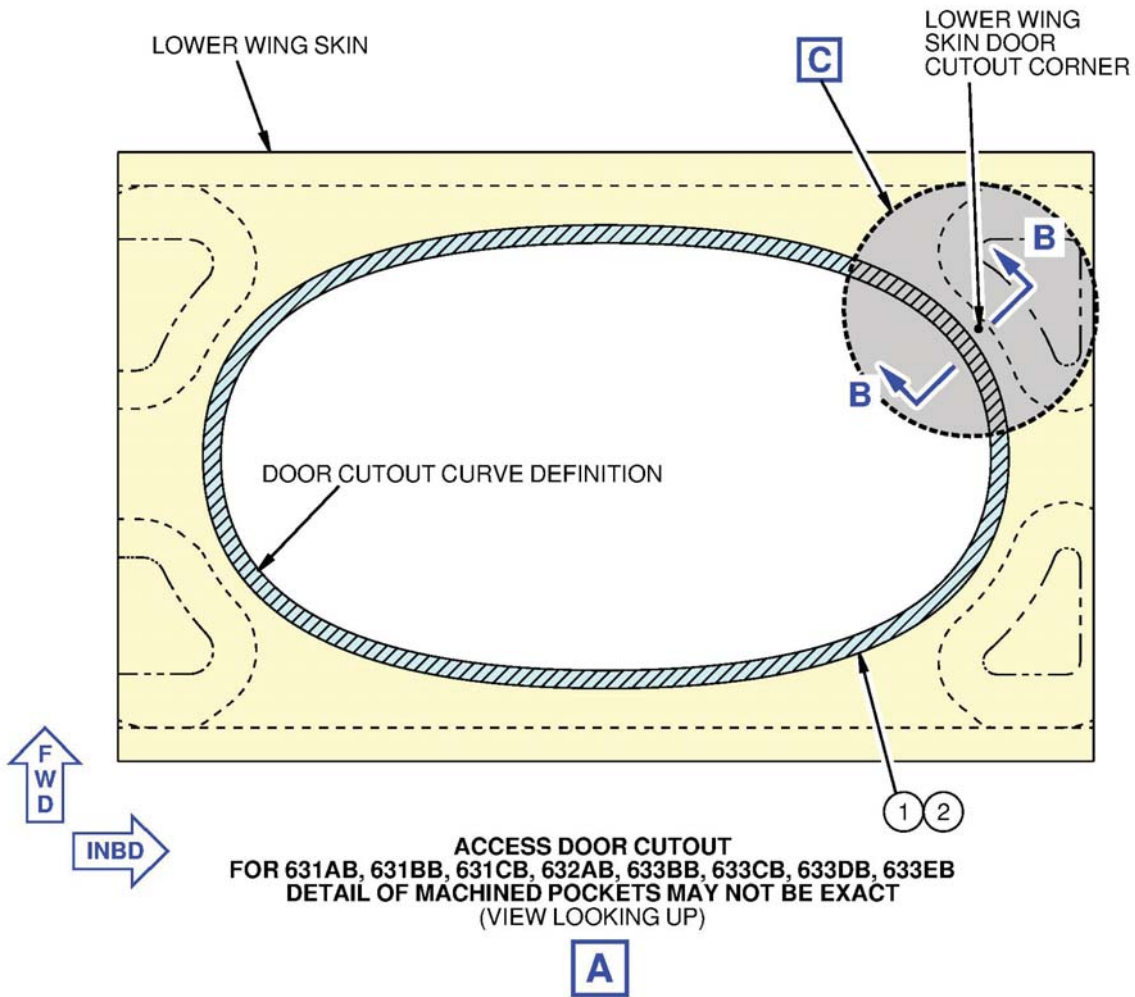
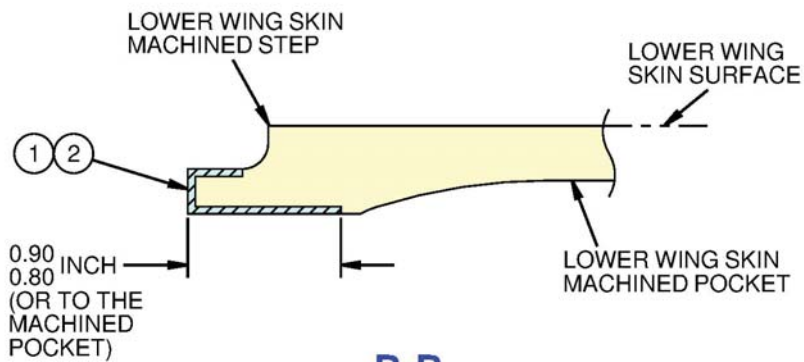
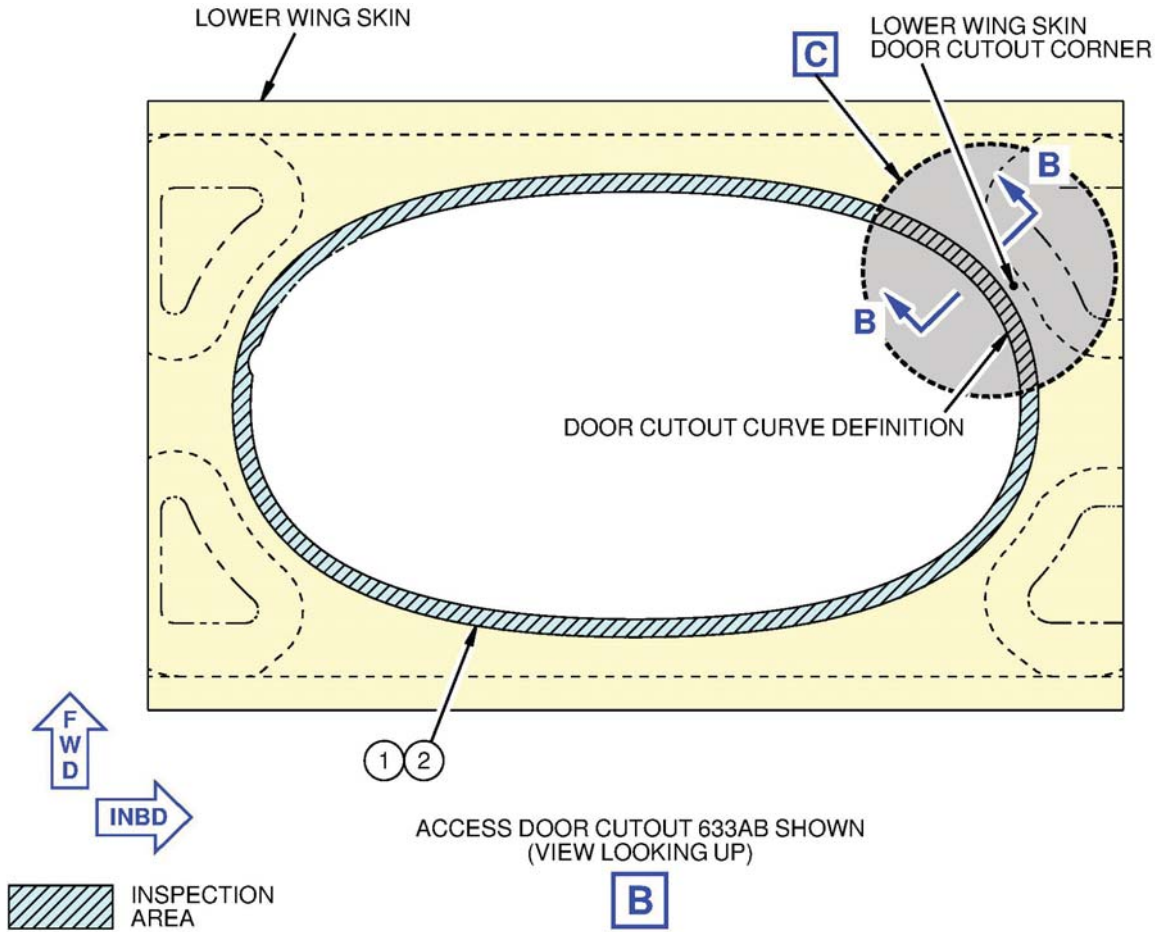
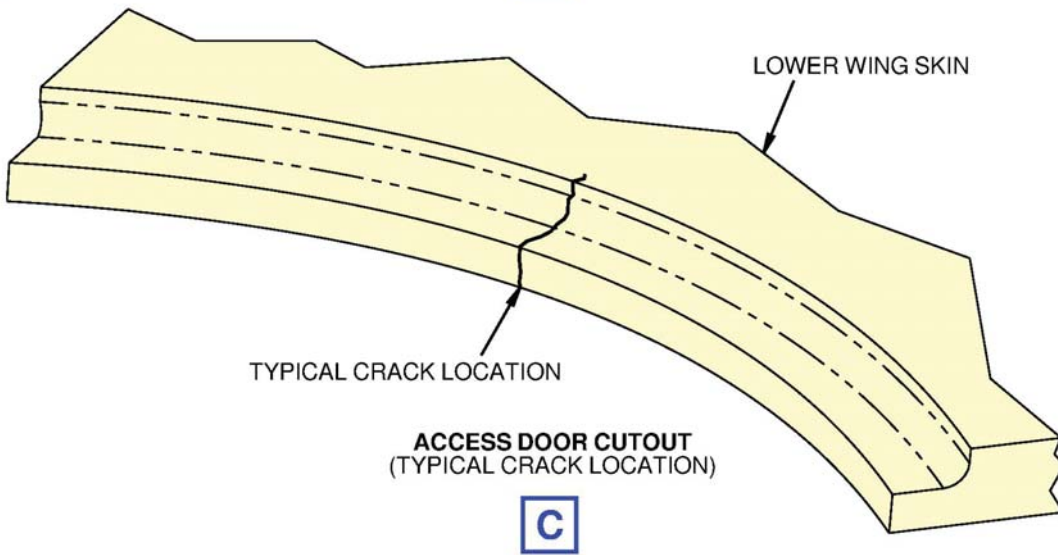
**FIGURE 8: RIGHT WING - LOWER WING SKIN - FUEL TANK AND DRY BAY ACCESS DOOR CUTOUTS BETWEEN WING STATION (WS) 306.00 AND WS 520.50 WITH NO EXISTING REPAIR - DETAILED INSPECTION AND HIGH FREQUENCY EDDY CURRENT (HFEC) INSPECTION (SHEET 1 OF 4)**

-	PART 2: CLOSE ACCESS
CONDITION 13: NO EXISTING REPAIR FOUND (a)	Do a Detailed Inspection and HFEC Inspection of the wing lower skin fuel tank and dry bay access door cutouts between WS 306.00 and WS 520.50 for any corrosion, fretting or crack.	FIGURE 8	APPENDIX B

<b>Step</b>	<b>Task</b>	<b>Name</b>	<b>Identification</b>	<b>Qty</b>	<b>More Data</b>
1	Inspect	Wing Skin	-	-	(a)
2	Inspect	Wing Skin	-	-	(b)
(a) Do a Detailed Inspection of the lower wing skin fuel tank and dry bay access door cutouts between WS 306.00 and WS 520.50 for any corrosion, fretting or crack.					
(b) Do a HFEC inspection of the wing lower skin fuel tank and dry bay access door cutouts between WS 306.00 and WS 520.50 for any crack. Refer to 777 NDT Manual Part 6, 51-00-01 as an accepted procedure.
