**Number:** 777-57A0118 RB  
Original Issue: June 23, 2020  
ATA System: 5725

**SUBJECT:** WINGS - Wing Lower Skin - Fuel Tank / Dry Bay Access Door Cutouts - Inspection and Repair.

## Requirements Bulletin

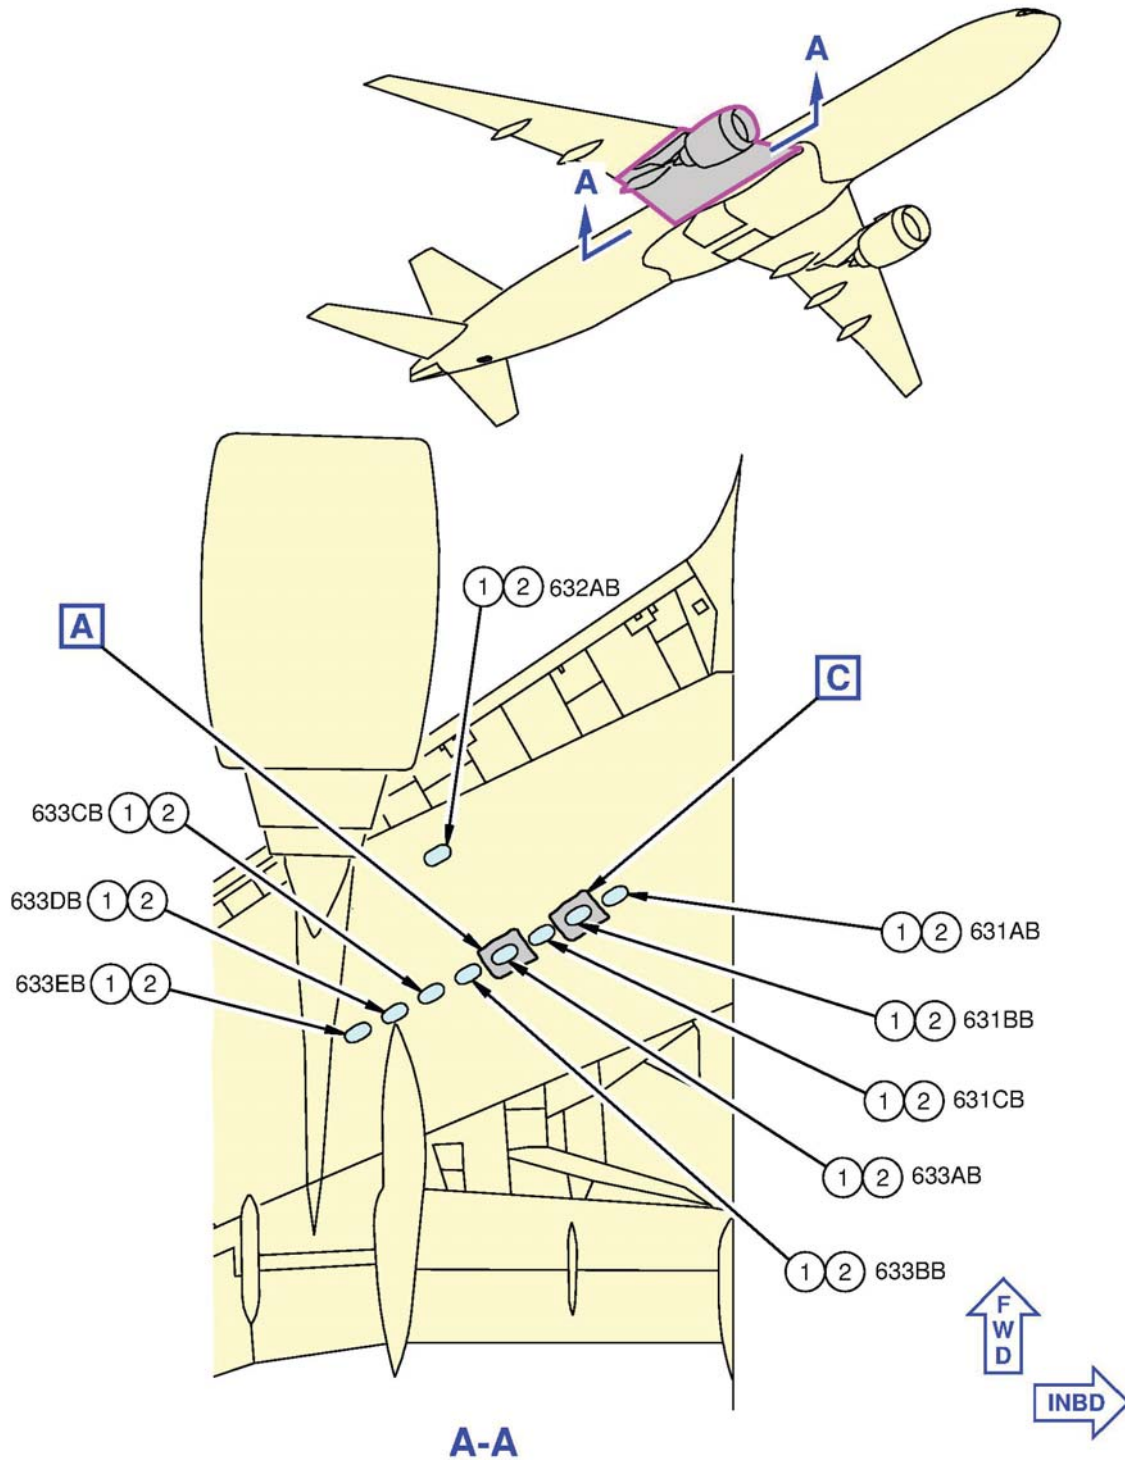
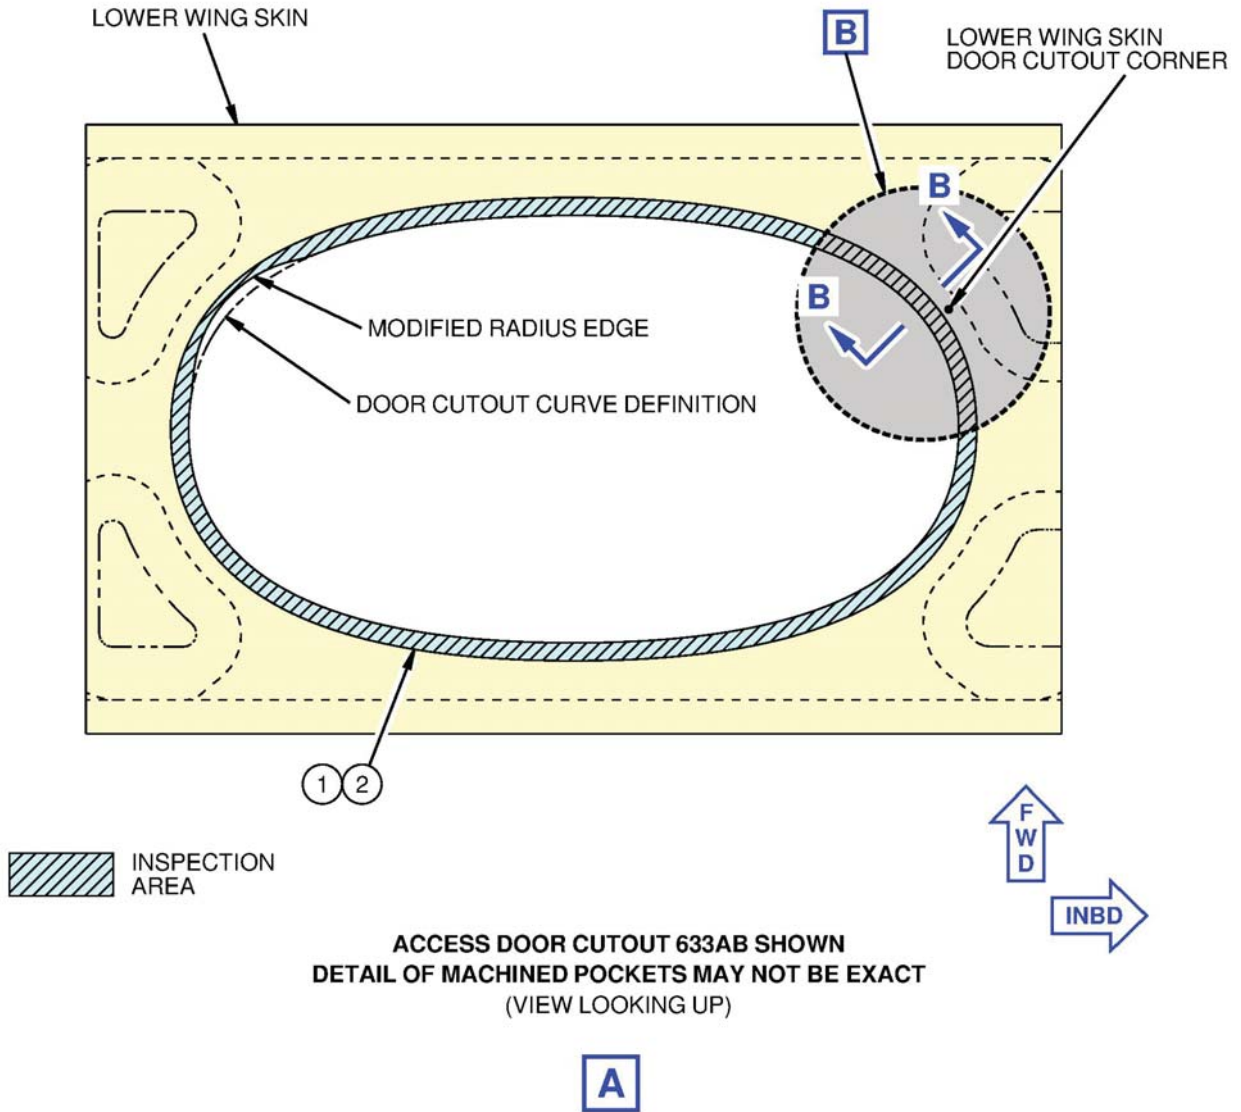
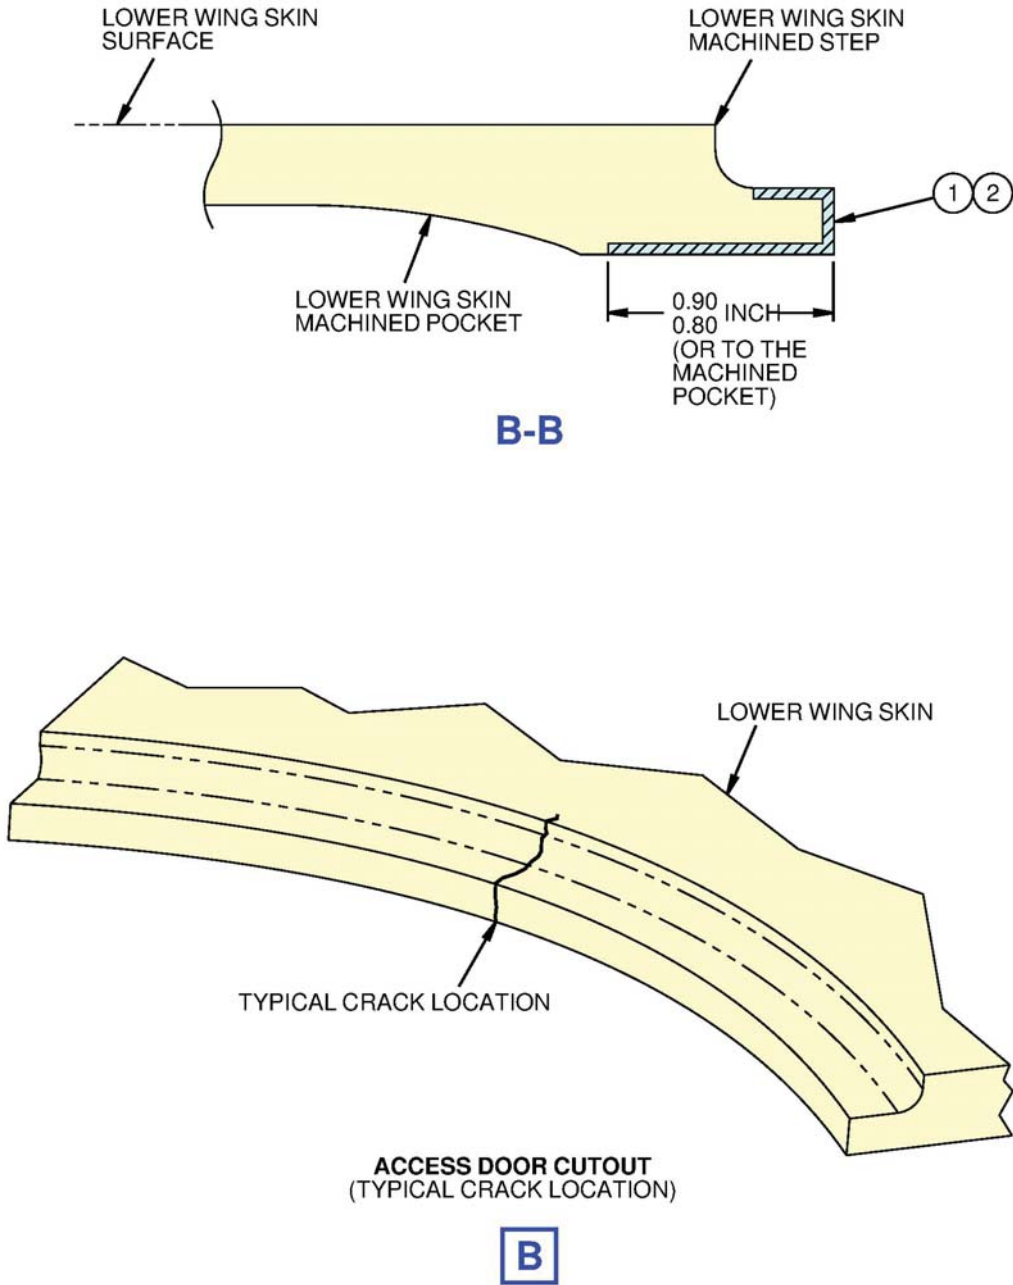
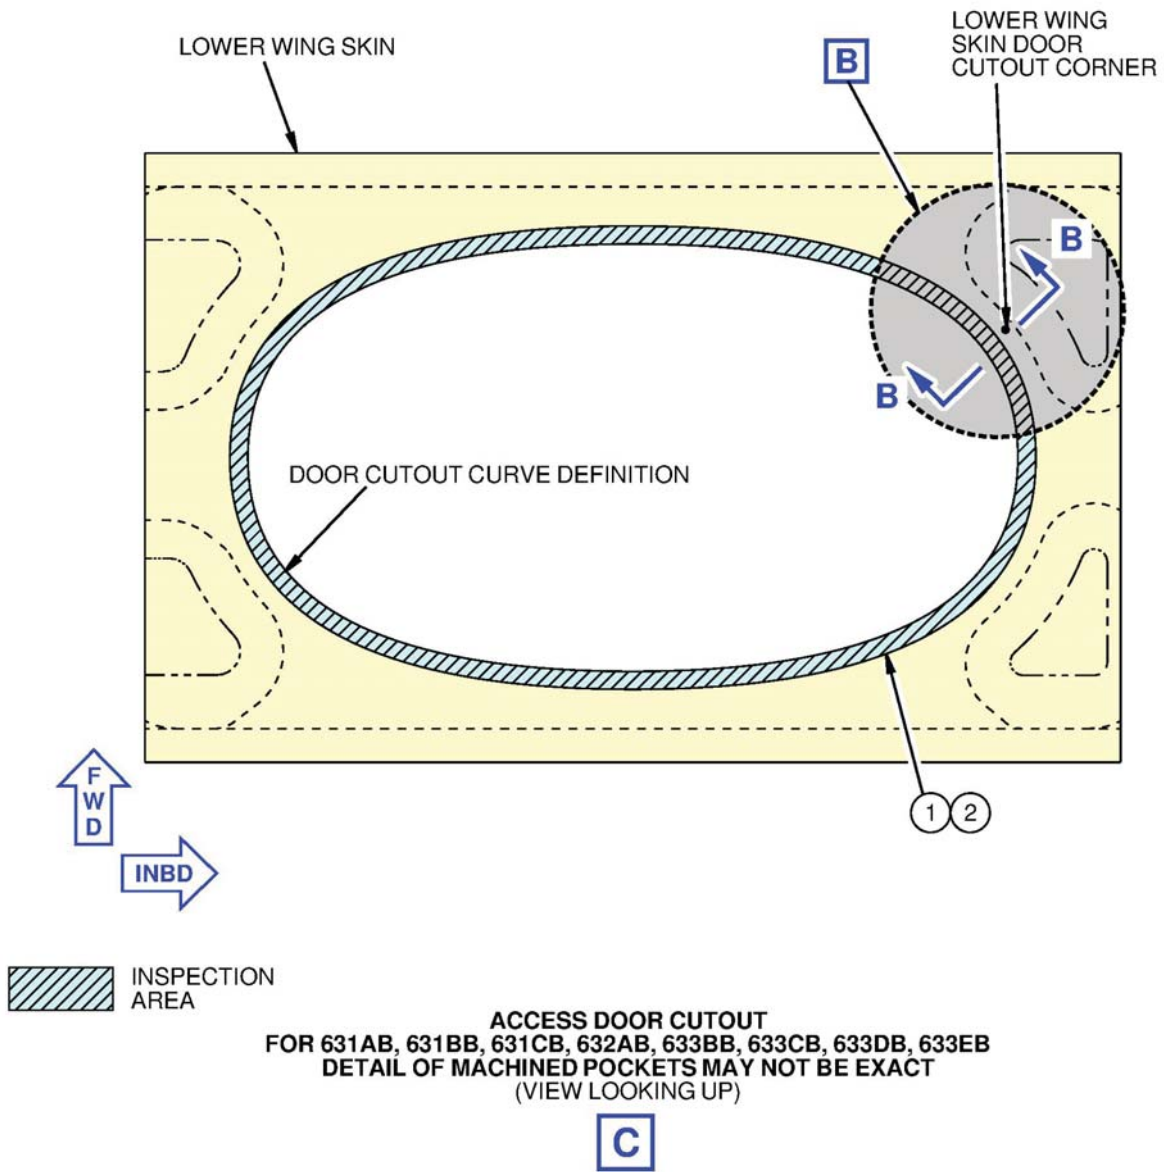
**FIGURE 9: RIGHT WING - LOWER WING SKIN - FUEL TANK AND DRY BAY ACCESS DOOR CUTOUTS BETWEEN WING STATION (WS) 306.00 AND WS 520.50 WITH NO EXISTING REPAIR FOUND - DETAILED INSPECTION AND HIGH FREQUENCY EDDY CURRENT (HFEC) INSPECTION (SHEET 1 OF 5)**

-	PART 2: CLOSE ACCESS
CONDITION 19: NO EXISTING REPAIR FOUND (a)	Do a Detailed Inspection and HFEC Inspection of the wing lower skin fuel tank and dry bay access door cutouts between WS 306.00 and WS 520.50 for any corrosion, fretting or crack.	FIGURE 9	APPENDIX B

<b>Step</b>	<b>Task</b>	<b>Name</b>	<b>Identification</b>	<b>Qty</b>	<b>More Data</b>
1	Inspect	Wing Skin	-	-	(a)
2	Inspect	Wing Skin	-	-	(b)
(a) Do a Detailed Inspection of the lower wing skin fuel tank and dry bay access door cutouts between WS 306.00 and WS 520.50 for any corrosion, fretting or crack.					
(b) Do a HFEC inspection of the wing lower skin fuel tank and dry bay access door cutouts between WS 306.00 and WS 520.50 for any crack. Refer to 777 NDT Manual Part 6, 51-00-01 as an accepted procedure.
