U.S. Department
of Transportation
**Federal Aviation
Administration**

Subject: Federal Aviation Administration (FAA) Approval of an Alternative Method of Compliance (AMOC) to Airworthiness Directives (AD) 2008-11-13, 2012-07-06, 2014-09-09, 2015-17-13, 2016-11-07, 2016-11-16 and 2015-25-08

References: (1) Boeing letter DLD4-21-00060, dated March 16, 2021
(2) Boeing 777 Maintenance Planning Data (MPD) Document, Section 9, D622W001-9, dated February 2021 (Watermark Not FAA Approved 3/12/2021 02:14 PM)
(3) Boeing 777 28-AWL-31 and 28-AWL-32 Revision—Teflon Sleeve & Cushion Clamp Assessment, D340W105-23, dated February 26, 2021

777-200/200LR/300/300ER/777F MAINTENANCE PLANNING DATA

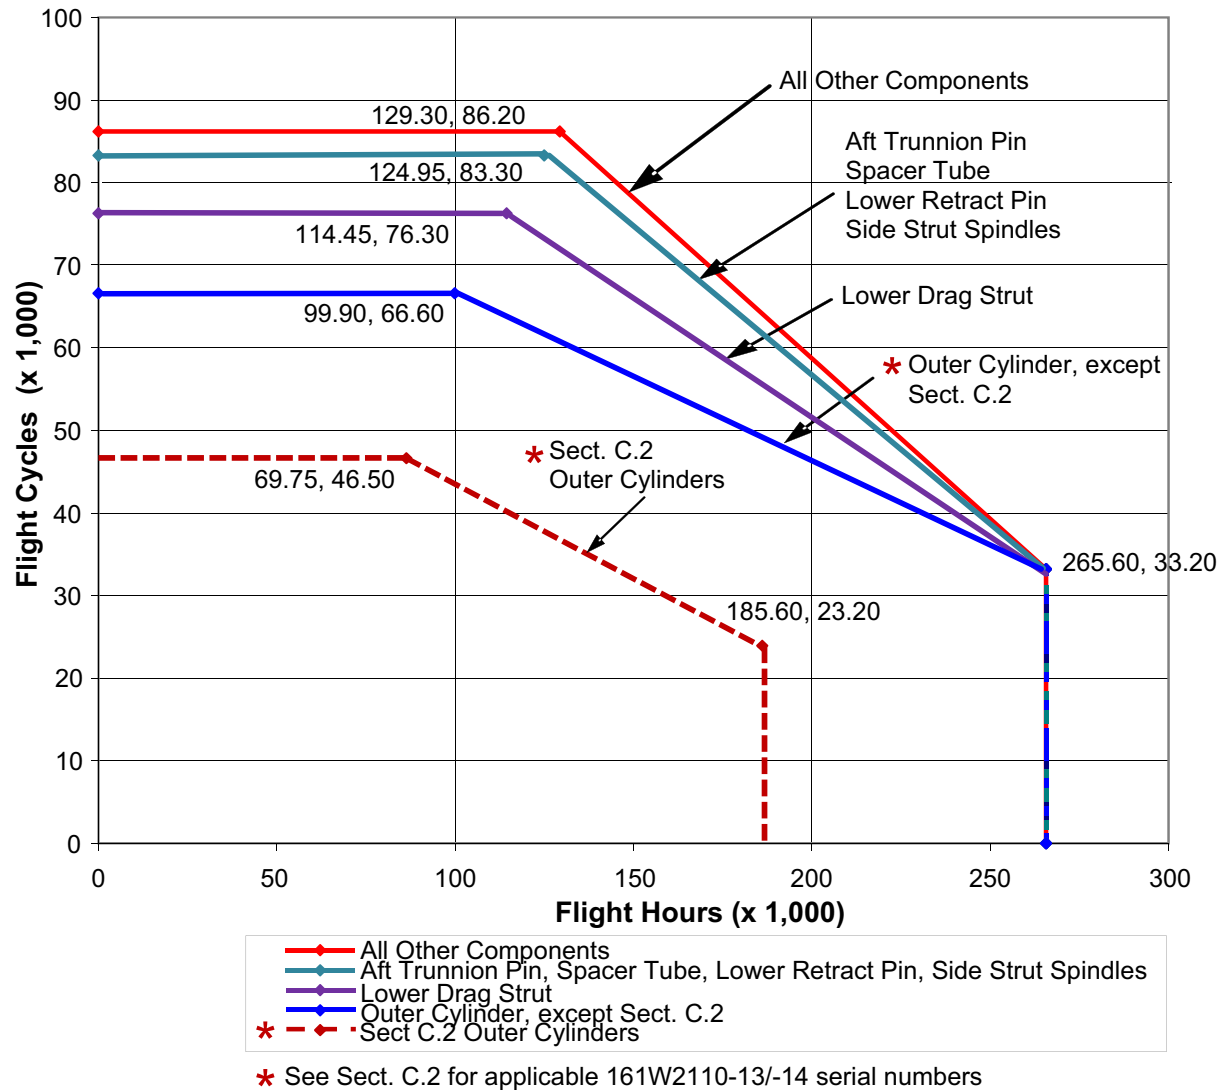
FIGURE 5. 777-200LR/300ER/777F MAIN LANDING GEAR SAFE-LIFE LIMITS

Revised Figure 5: 777-200LR/300ER/777F MLG Safe-Life Limits to reflect the addition of the life limit curve for outer cylinders as indicated in Section C.2.

777-200LR/300ER/777F Main Landing Gear Outer Cylinder NOTE: Life Limitation applies to P/N 161W2110-13 (LH) and 161W2110-14 (RH) Outer Cylinders with Serial Numbers: 161W2110-13: S/N WHM5001, WHM5002, WHM5003, WHM5007, WHM5017, WHM5021, WHM5023, WHM5033, WHM5039, WHM5041, WHM5045, WHM5047, WHM5053. 161W2110-14: S/N WHM5002, WHM5003, WHM5008, WHM5010, WHM5012, WHM5014, WHM5020, WHM5032, WHM5036, WHM5040, WHM5046, WHM5048, WHM5052.	Figure 5
